# APPENDIX J

## SAFE ROUTES TO SCHOOL SAFETY AUDITS

SRTS Safety Audits were piloted at six schools in the Laredo Independent School District (LISD) in Spring 2025 to demonstrate recommended approaches to identifying priority safety and access issues for active student travel to school.

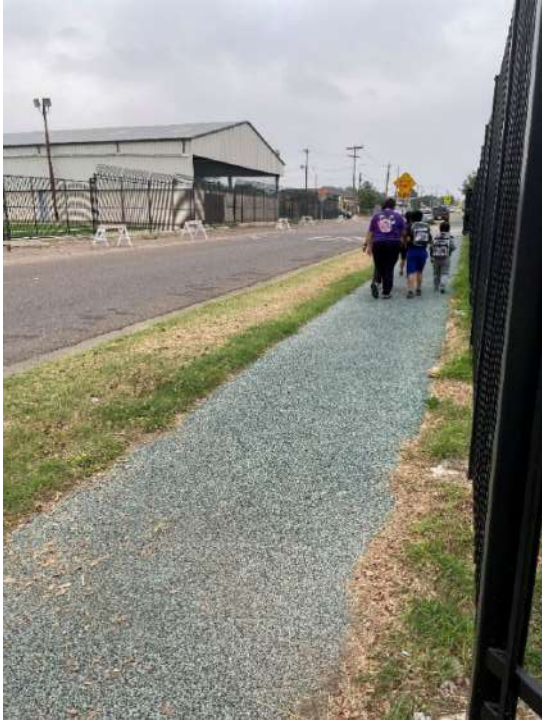
Figure 5: Family walking to school on Ash St

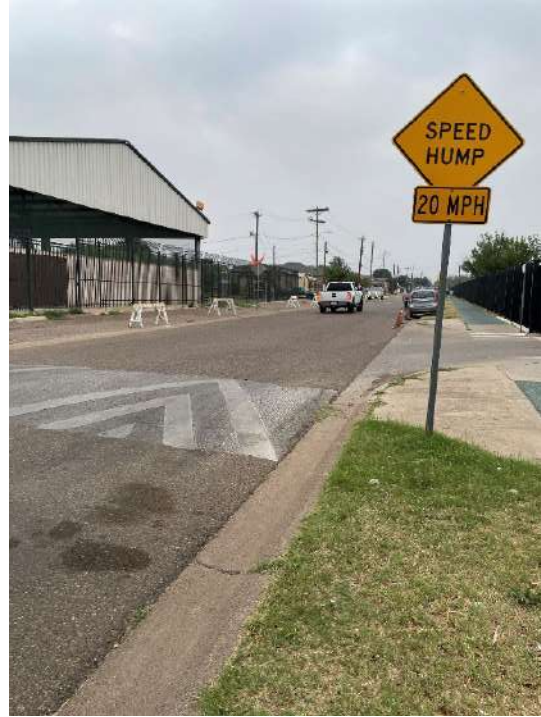
- Parked cars obstruct the visibility of the crosswalk at Ash Street and Springfield Avenue.
  - Drivers are speeding on Springfield Avenue, well above the school zone speed limit. Drivers turning right also do not yield when students are crossing the street, even when a crossing guard is present.

Figure 6: Cars parked on shoulder of Ash St by carpool lane entrance. Wooden barricades on other shoulder to prevent parking.

Map ID	Location	Issue	Recommendation
		Parked cars obstruct sight lines on E Ash St.	Restrict parking in advance of the crosswalk on E Ash St.
		Crossing across E Ash St lacks appropriate crossing signage.	Install school crossing signs with downward pointing arrows for crossing across E Ash St.
		All curb ramps do not appear to be ADA compliant.	Reconstruct or repair existing curb ramps on the southwest, northwest and northeast corners.
13	Locust St (Monterrey Ave to Springfield Ave)	Observed motor vehicle speeds appear to exceed the speed limit.	Install speed feedback signs. There are existing traffic calming measures, such as speed humps, west of Monterrey Ave on Locust St. It is recommended to extend these measures to Springfield Ave.
		School advance warning signs and school speed limit signs are missing east of Monterrey Ave.	There are existing school zone signs west of Monterrey Ave. Install a new school advanced warning sign and a new school speed limit sign east of Monterrey Ave.

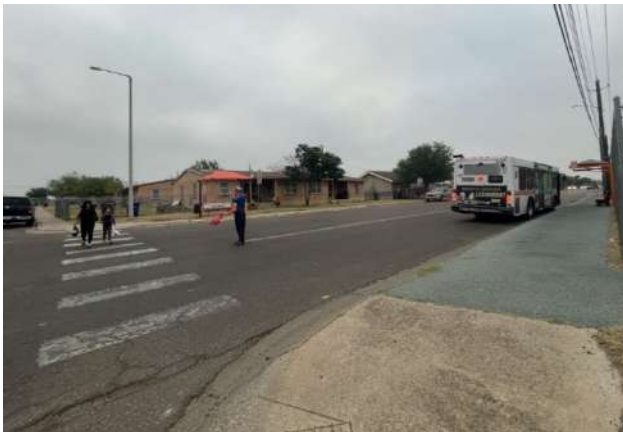
- A crossing guard is stationed at Ash Street and Springfield Avenue. A Webb County constable is sometimes present at this location to help direct traffic but was not there during observations on May 6<sup>th</sup>. Pedestrians were observed having difficulty finding gaps in traffic to stop and needed assistance from the crossing guard.

Figure 7: Family crossing Springfield Ave with help of crossing guard

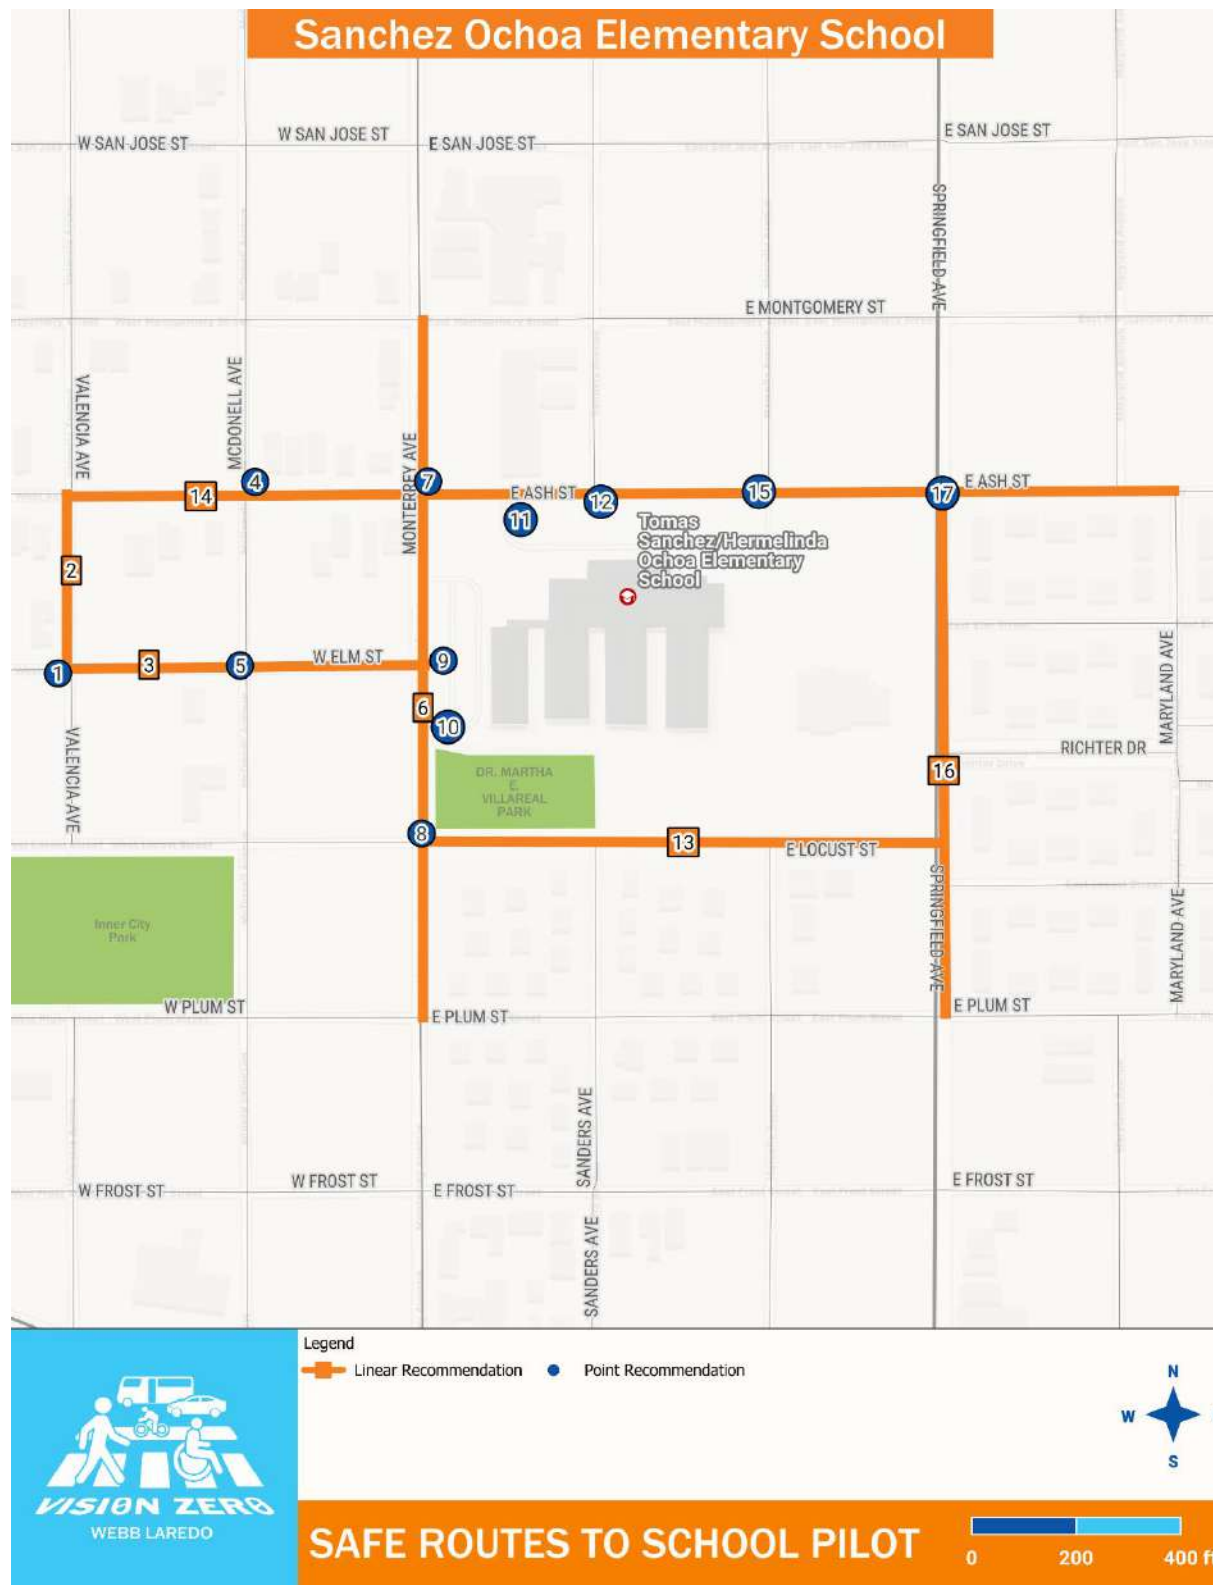
Figure 8: Map of Sanchez-Ochoa Elementary School Infrastructure Recommendations

Map ID	Location	Issue	Recommendation
1	W Elm St & Valencia Ave	Crosswalks are unmarked. No stop bars on W Elm St.	Install new high-visibility crosswalks across Valencia Ave and mark new stop bars on W Elm St.
		The pavement at this intersection is in poor condition and may present a tripping hazard for crossing pedestrians.	Assess condition of pavement prior to installing marked crosswalk.
		Crossings lack appropriate crossing signage.	Install school crossing signs with downward pointing arrows for north and south leg crosswalks.
		All curb ramps are not aligned with crossing. Curb ramps on the east side of Valencia Ave are not ADA compliant.	Assess curb ramps for improved alignment. Reconstruct or repair existing curb ramps.
2	Valencia Ave (Ash St to Elm St)	Sidewalk on the east side of road is too narrow. Roadway and sidewalk on this segment are covered in dirt and mud.	Reconstruct sidewalk and clear off debris. Assess area for source of debris to identify potential drainage issues.

3	W Elm St (Valencia Ave to Monterrey Ave)	Sidewalks on both sides of the road lack sufficient buffer, are narrowed by overgrown grass and are often blocked by parked cars.	Reconstruct sidewalks to widen or install buffer from roadway. Clear debris and restrict parking on sidewalks.
4	W Ash St & McDonell Ave	Crosswalks are unmarked on McDonell Ave. No stop bars on McDonell Ave.	Install new high-visibility crosswalks across McDonell Ave and mark new stop bars on McDonell Ave.
		The pavement at this intersection is in poor condition and may present a tripping hazard for crossing pedestrians.	Assess condition of pavement prior to installing marked crosswalk.
		Crossings lack appropriate crossing signage.	Install school crossing signs with downward pointing arrows.
		Curb ramps on the south side are not aligned with the crossing and are not ADA compliant	Assess curb ramps for improved alignment. Reconstruct or repair both curb ramps on the south side. Clear debris from curb ramps.

Map ID	Location	Issue	Recommendation
5	W Elm St & McDonell Ave	Concern about the lack of driver yielding. This intersection is part of the flow of carpool traffic.	Study the intersection for All-Way Stop Control (AWSC).
		All crosswalks are unmarked. No stop bars on W Elm St.	Install new high-visibility crosswalks on all approaches and mark new stop bars on W Elm St.
		The pavement at this intersection is in poor condition and may present a tripping hazard for crossing pedestrians.	Assess condition of pavement prior to installing marked crosswalk.
		Crossings lack appropriate crossing signage.	Install school crossing signs with downward pointing arrows.
		All curb ramps are not ADA compliant. There is not enough space behind ramps on the south side of the intersection. Existing curb ramps do not have detectable warning surfaces.	Reconstruct or repair existing curb ramps.
6	Monterrey Ave (Montgomery St to Plum St)	Sidewalk on the west side of the road is too narrow and is obstructed by parked cars.	Reconstruct sidewalk on the west side of Monterrey Ave to be at least 5 feet in width. Restrict parking on sidewalks and consider marking on-street parking lanes to encourage improved parking behaviors.

Monterrey Ave is designed for higher speeds and is missing pavement markings.	Install speed feedback signs.  Install traffic calming measures within school zone such as roundabout, speed humps, chicanes, or pinch points, or narrow travel lanes (may require additional study).  Add centerline pavement marking and mark on-street parking.
7	Monterrey Ave & Ash St*	There is concern about drivers using both directions of travel lanes to turn onto Ash St from Monterrey Ave.	Install hardened centerline for cars headed south on Monterrey Ave and turning left onto Ash St to encourage drivers to stay in the proper lanes.
		Parked cars at the intersection make pedestrians less visible and obstruct the eastern and western crosswalks.	Install curb extensions on Ash St on the west and east sides of the intersection.  Restrict parking in advance of crosswalks on Ash St.
		All approaches have faded crosswalk marking and faded stop bars	Remark existing crosswalks and remark existing stop bars on all approaches.

Map ID	Location	Issue	Recommendation
		The northeast, northwest, and southeast curb ramps are missing detectable warning surfaces. All curb ramps do not appear to be ADA compliant.	Reconstruct or repair existing curb ramps.
8	Monterrey Ave & E Locust St	All approaches have faded crosswalk markings and faded stop bars	Remark existing crosswalks and remark existing stop bars on all approaches.
		Tree overgrowth obstructs the stop sign for eastbound traffic on Locust St.	Trim trees to improve stop sign visibility.
		Curb ramps on the west side of Monterrey Ave do not appear to be ADA compliant. Curb ramps are missing detectable warning surfaces.	Reconstruct or repair both curb ramps on the west side of the intersection.
9	W Elm St & Monterrey Ave	Concern about driver turning movements and speeds turning from Monterrey Ave onto W Elm Street after exiting the ECC drop-off lane. Drivers are not yielding to pedestrians crossing Monterrey Ave. ECC drop-off entrance and exit driveways are offset from W Elm St.	Install curb extensions on the northwest and southwest corners of W Elm St.  Install rectangular rapid flashing beacons (RRFBs) for the centered crossing of Monterrey Ave to access school.

Crossings across Monterrey Ave and across W Elm St are unmarked. No stop bar on W Elm St.	Install new high-visibility crosswalks on the north and west side of the intersection. Mark a new stop bar on W Elm St.
		The pavement at this intersection is in poor condition and may present a tripping hazard for crossing pedestrians.	Assess condition of pavement prior to installing marked crosswalk.
		Both crossings lack appropriate crossing signage.	Install school crossing signs with downward pointing arrows for both proposed crossings.
		All curb ramps do not appear to be ADA compliant.	Reconstruct or repair existing curb ramps on northwest, northeast and southwest corners.
10	Monterrey Ave & ECC driveway	There are concerns about driver turning movements or speeds into the ECC driveway.	Install curb radius reduction for both radii of the ECC driveway.
		Crossing is unmarked across ECC driveway.	Install new high-visibility crosswalk across the ECC driveway.

Curb ramps are missing for ECC driveway crossing.	Install new curb ramps for ECC driveway.
11	E Ash St & school's eastern driveway (carpool entrance)	There are concerns about drivers' turning movement or speeds out of the school driveway.	Install curb radius reduction for both radii of the school driveway.
		Crosswalk marking is faded across the school driveway.	Remark existing crosswalk across school driveway.
		Curb ramps at the school driveway do not appear to be ADA compliant.	Reconstruct or repair existing curb ramps across school driveway.
12	E Ash St & Sanders Ave	No crosswalk across Sanders Ave and no stop bar.	Install a new high-visibility crosswalk across Sanders Ave and mark new stop bar.

14	Ash St (Valencia Ave to Maryland Ave)	Existing speed limit may not be appropriate for neighborhood or school zone context. Ash St designed for higher speeds.	Install speed feedback signs. There are existing traffic calming measures, such as speed humps, directly in front of the school. It is recommended to extend these measures along Ash St to Valencia Ave to Monterrey Ave.
		Sidewalk is less than 4 feet wide on both sides of Ash St from Monterrey Ave to Valencia Ave. There are some areas where it is overgrown or obstructed by parked cars.	Reconstruct sidewalks on both sides of Ash St from Monterrey Ave to Valencia Ave. Restrict parking on sidewalks and relocate obstructions like the basketball hoop.
		School speed limit signs and advanced warning signs are missing east of Springfield Ave.	Install a new school advanced warning sign and a new school speed limit sign east of Springfield Ave.

15	E Ash St & Marcella Ave	Crosswalk on E Ash St on the east side of Marcella Ave is faded. Crosswalk and stop bar on Marcella Ave are missing.	Remark existing crosswalk. Install a new high-visibility crosswalk and stop bar on Marcella Ave.
		Crossing lacks appropriate crossing signage for crosswalk across E Ash St.	Install school crossing signs with downward pointing arrows.

Map ID	Location	Issue	Recommendation
		Curb ramps are missing detectable warning surfaces and are not aligned with curb cuts across E Ash St. There is no curb ramp on the southeast corner.	Reconstruct or repair existing curb ramps on the north side of E Ash St. Install new curb ramp on the southeast corner of the intersection.
16	Springfield Ave (E Ash St to E Plum St)*	Observed motor vehicle speeds appear to exceed the speed limit. Springfield Ave is designed for higher speeds. This segment of Springfield Ave is wider as the road narrows to the north and to the south.	Conduct speed study to consider speed management measures or other traffic calming measures such as roundabout, speed humps, chicanes, or pinch points, or narrow travel lanes (may require additional study). Study for reduced speed limit.  Study Springfield Ave for road diet – stripe east side of the roadway for on-street parking, install mid-block crossing with median island and RRFBs. Consider a transit lane or pull off area for bus stops on this corridor. Consider installing floating bus stops as part of road diet.

Map ID	Location	Issue	Recommendation
		Curb ramps on the east side of Springfield Ave do not appear to be ADA compliant.	Reconstruct or repair existing curb ramps.

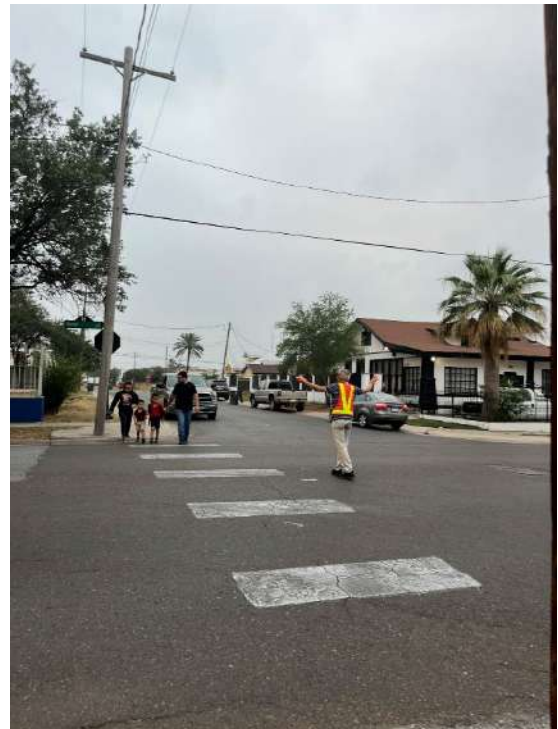
- Parents often parked on the south leg of McPherson Avenue and crossed Market Street with children despite high-speed traffic, creating a hazardous condition.

Figure 11: The Assistant Principal directing traffic while also serving as a crossing guard at the intersection of Market St and McPherson Ave

Map ID	Location	Issue	Recommendation
3	McPherson Ave & Market St*	There is concern about the lack of driver yielding. Pedestrians/bicyclists are unable to find sufficient gaps in traffic.	Install curb extensions on both sides of Market St.  Install RRFBs to increase visibility and driver awareness.
		Crosswalks on all approaches except the south leg are faded. The crosswalk on the south leg is missing. Stop bars on McPherson Ave are faded or missing.	Remark existing crosswalks. Install a new high-visibility crosswalk on the south leg. Mark the new stop bar and remark the faded one on McPherson Ave.
		Crossing lacks signage.	Install school crossing signs with downward pointing arrows.
		The curb ramp on the southeast corner does not appear to be ADA compliant and is not aligned with the crosswalk.	Assess curb ramps for improved alignment. Reconstruct or repair the existing curb ramp.
4	Rosario St (McClelland Ave to N Loring Ave)	Sidewalk is missing and discontinuous.	Install new sidewalk and ADA-compliant curb ramps where missing.  Fill gaps in the discontinuous sidewalk along the north side of the corridor, particularly on the school block and the adjacent block to the east.  Evaluate crosswalk and stop bar needs at intersecting streets.

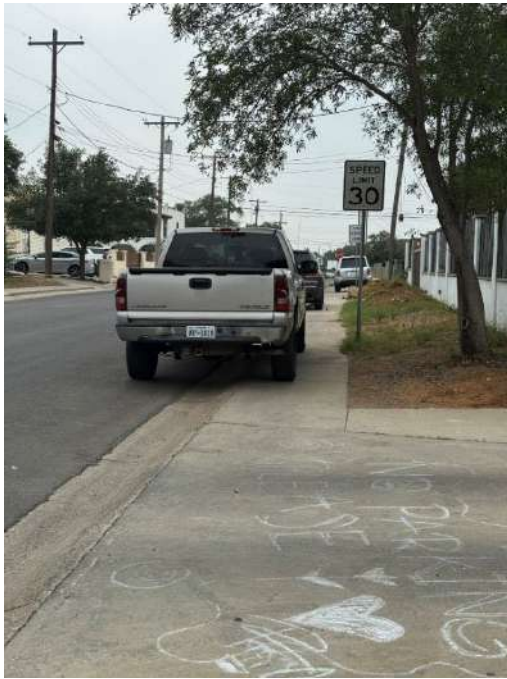
Figure 12: Cars were observed parking on the rolled curb, obstructing the sidewalks

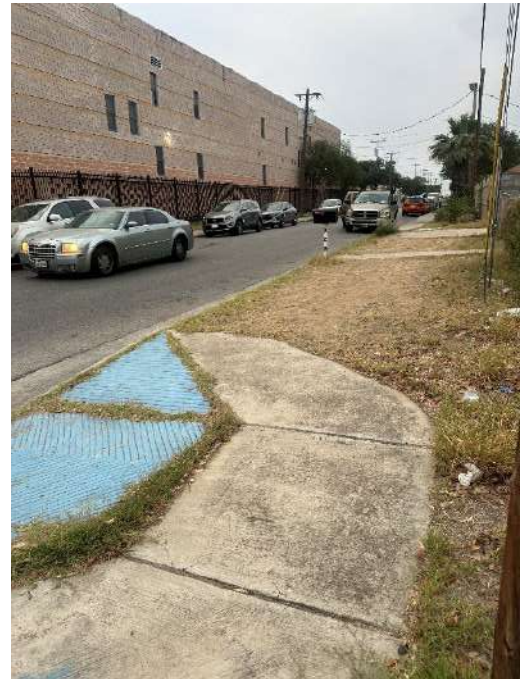
- Drivers on McPherson Avenue queued in both directions near Rosario Street, blocking intersections and crosswalks.
- Vehicles routinely rolled through stop signs at McPherson Avenue & Rosario Street.

Figure 13: Parents/caregivers dropping off students on both sides of McPherson Ave. Most of the sidewalks at McPherson Ave & Rosario St are not ADA compliant

Map ID	Location	Issue	Recommendation
1	McPherson Ave & Rosario St	There are concerns about the lack of driver yielding and about driver turning movements and speeds.	Install curb radii reductions on the north side of McPherson Ave to slow turning speeds and keep vehicles clear of the crosswalk.
		Crosswalks on the north and east side of the intersection are faded and the crosswalk on the west side of the intersection is unmarked. Stop bars on all approaches are faded or missing and existing stop bars appear too close to the crosswalk.	Remark existing crosswalks and install a new high-visibility crosswalk on the west side of the intersection.  Add missing stop bars and assess existing stop bar locations before remarking.
		Overgrown trees are impacting driver sight distance and visibility of pedestrians.	Trim back trees on the northeast side to improve visibility and access to the sidewalk.
		Curb ramps do not appear to be ADA compliant and are not aligned with crosswalks. The curb ramp on the northeast corner is missing.	Assess curb ramps for improved alignment. Reconstruct or repair existing curb ramps.  Install a new curb ramp on the northeast corner.

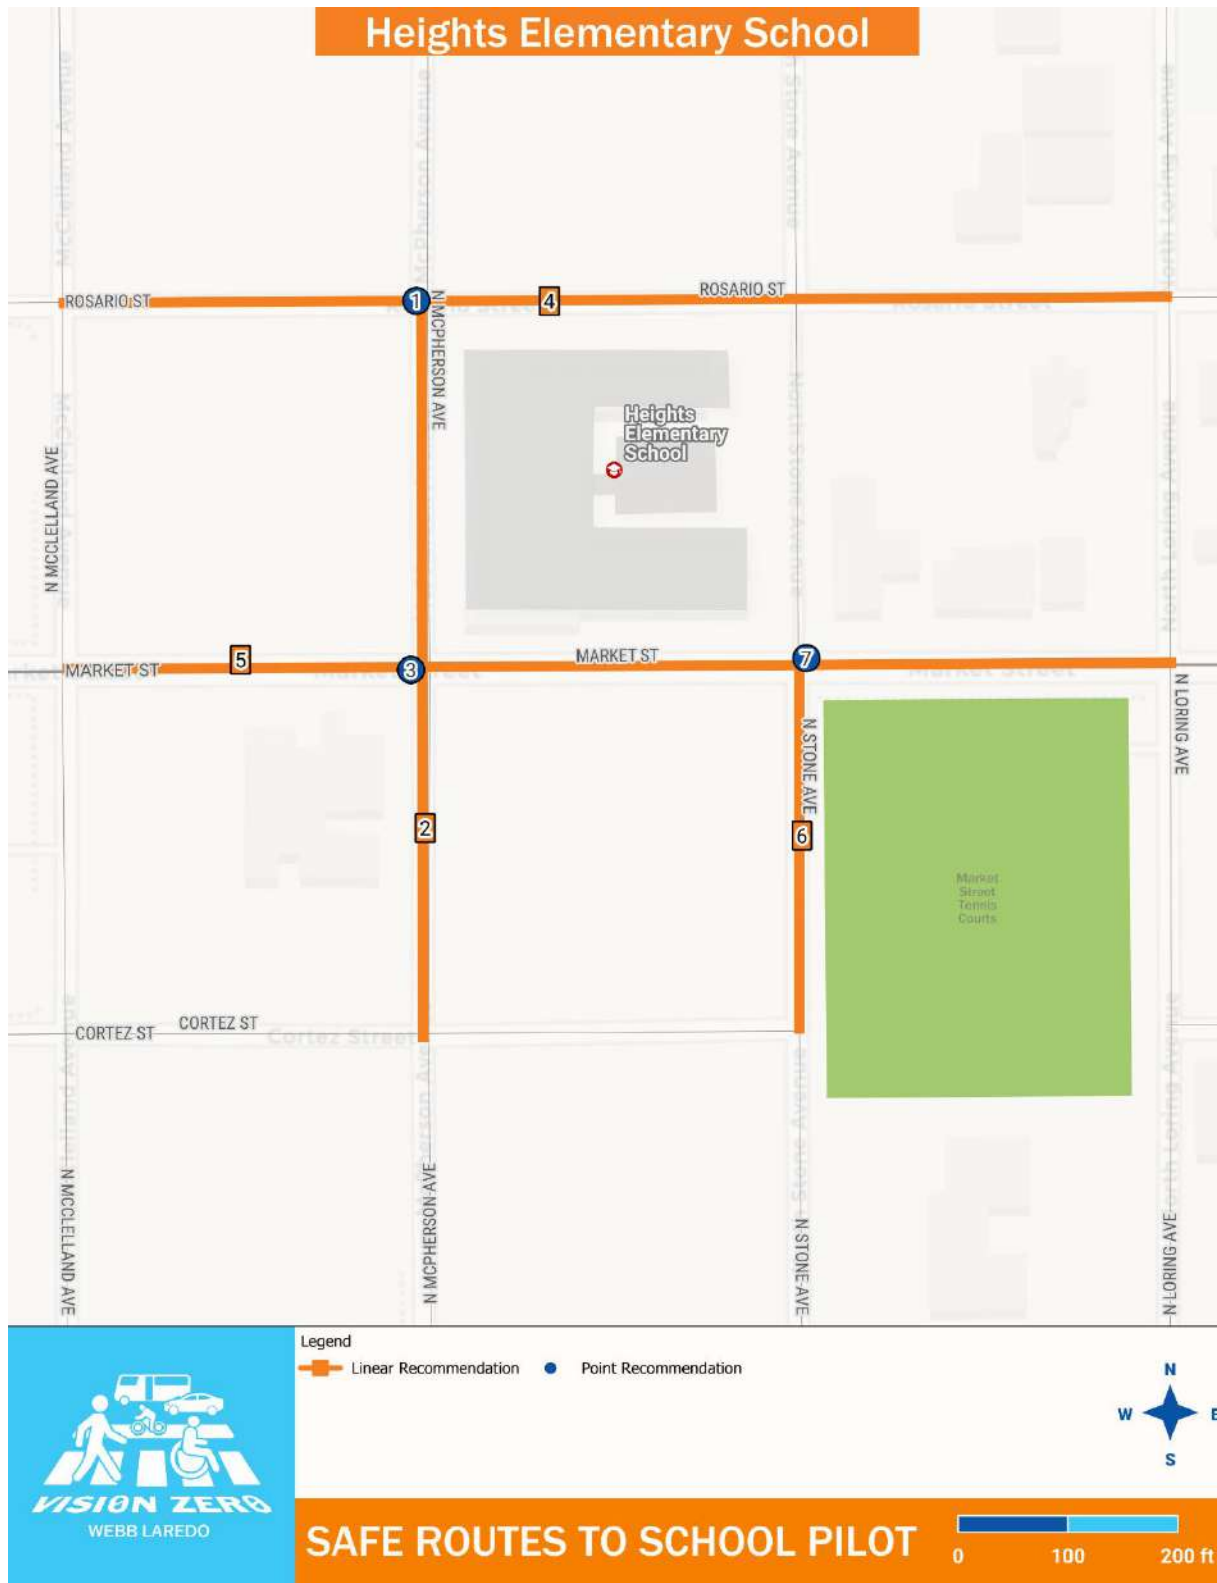
Figure 14: Map of Heights Elementary School Infrastructure Recommendations

2	McPherson Ave (Rosario St to Cortez St)	Observed motor vehicle speeds appear to exceed the speed limit.	Conduct a speed study to evaluate the extent of speeding, especially northbound during the arrival window when McPherson Ave operates as one-way.  Use study to consider speed management measures or other traffic calming measures such as roundabout, speed humps, chicanes, or pinch points, or narrow travel lanes (may require additional study). Study for reduced speed limit.
		The sidewalk on the west side of McPherson Ave has a gap near the intersection of Rosario St, and sidewalks on both sides of the street are uplifted, collapsed, or cracked.  Sidewalks on both sides are obstructed by vegetation or parked vehicles.	Reconstruct broken areas, fill sidewalk gaps, and realign the sidewalk near the Market St intersection.  Restrict parking on sidewalks and consider marking on-street parking lanes to encourage improved parking behaviors.

5	Market St (N Loring Ave to McClelland Ave)	Observed motor vehicle speeds appear to exceed the speed limit. Market St is designed for higher speeds.	Conduct speed study to consider speed management measures or other traffic calming measures such as roundabout, speed humps, chicanes, or pinch points, or narrow travel lanes (may require additional study). Study for reduced speed limit and evaluate for improvements with nearby intersections.
		Sidewalk is cracked, uplifted, or discontinuous on both sides of the street.	Reconstruct or repair damaged sidewalks and fill gaps along both sides of the corridor. Focus on the south side for major repairs and address obstructions on the north side near N Loring Ave.

Map ID	Location	Issue	Recommendation
6	Stone Ave (Market St to Cortez St)	Conflict between cars and pedestrians north of Stone Ave at the Market St intersection.	Block off southbound vehicular traffic on Stone Ave between Market St and Cortez St during drop-off and pick-up hours.  Consider converting one lane of Stone Ave into a pedestrian pathway to reduce conflicts. Study this block further for potential restricted vehicle access.
		The sidewalk on the east side is not easily accessible; the sidewalk on the west side is obstructed by cars parking too close to the curb.	Reconstruct sidewalks on both sides to add a buffer from the street.  Conduct a study to evaluate parking reconfiguration options to improve pedestrian access and connectivity between Market St and Cortez St.
7	N Stone Ave & Market St*	People walking or biking cannot safely cross due to the lack of driver yielding and large traffic gaps.	Install a median crossing island with a “Stop Here For Pedestrians” sign.  Install RRFBs for crossing of Market St.

Crosswalk markings on the north leg are not high visibility, and the crosswalk across the southern leg is unmarked. Stop bar markings are faded or placed too close to the crosswalk.	Install a new high-visibility crosswalk on the south side where unmarked and remark existing crosswalk north of Stone Ave with high-visibility markings.  Assess existing stop bar locations before remarking.
		Curb ramps are not ADA compliant. Missing curb ramps on the northeast and southwest corners.	Reconstruct or repair existing curb ramps. Install new curb ramps on the northeast and southwest corners.

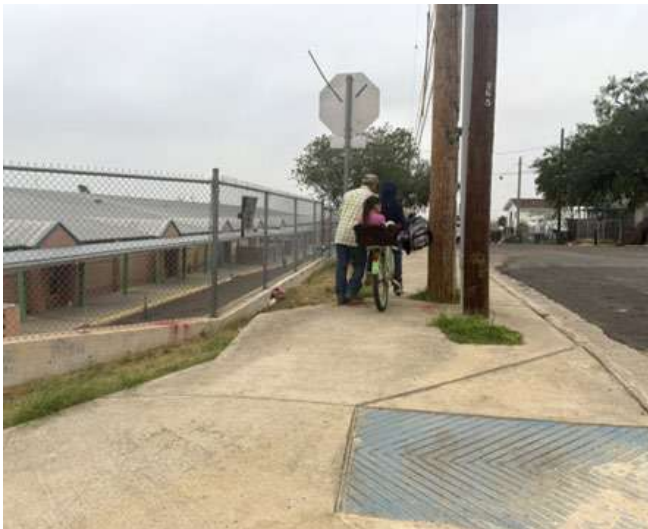
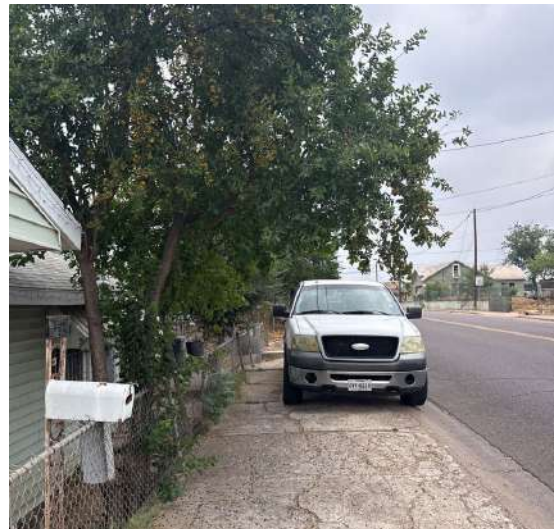
- Springfield Avenue has heavy traffic in both directions, and it is difficult to cross at the intersection with O’Kane Street. Student crossings were facilitated by one school crossing guard and one Webb County Constable, but families were observed crossing after the school start time, after the crossing guard had left. Observed students walking on the road to avoid sidewalk obstructions on the west side of Springfield Avenue.

Figure 16: Observed obstructions on O'Kane St (Left) and Springfield Ave (Right)

Map ID	Location	Issue	Recommendation
1	Springfield Ave (O'Kane St to Reynolds St)	Multiple sidewalk obstructions were observed on the west side of Springfield Ave, including a parked truck, overhanging vegetation, a utility pole and school flash sign located in the middle of the sidewalk.	Relocate the utility pole and school flashing sign. Trim overhanging vegetation on the western shoulder of Springfield Ave, north of the Springfield Ave and O'Kane St intersection. Additionally, restrict parking on sidewalks and consider marking an on-street parking lane to encourage improved parking behaviors.
2	Springfield Ave & O'Kane St	Pedestrians/bicyclists are unable to find sufficient gaps to cross Springfield Ave on the southern side of the intersection.	Install advanced pedestrian warning signs, as well as advanced yield markings with "Stop Here For Pedestrians" signs located 30-50 ft. in advance of the crosswalk. Install school crossing signs with downward pointing arrows at the crosswalk.  Install curb extensions on the southern corners of the intersection to reduce the pedestrian crossing distance.

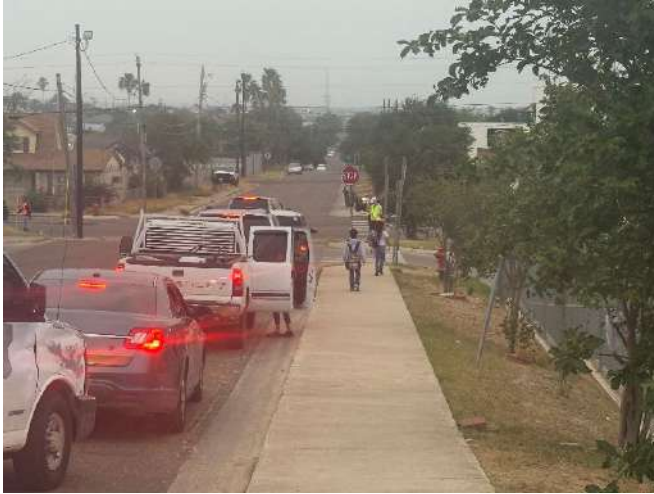
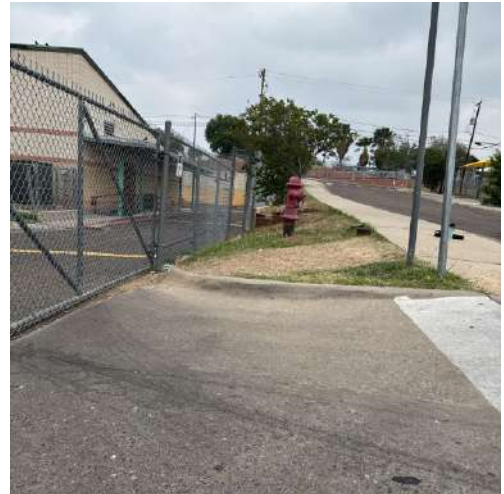
- A great number of parents and caregivers park on Lexington Avenue, Maryland Avenue and O’Kane Street and walk their students to the school building instead of using the pick-up/drop-off loop. Parents who park on the North and eastern sides of O’Kane Street and Lexington Avenue, respectively, observed crossing the street with their students at unofficial crossing locations, although most used the crosswalks at Maryland Avenue and O’Kane Street, and Lexington Avenue and O’Kane Street. Parents were also observed parking on the curb, obstructing the sidewalk.

Figure 17: Parents parking on Lexington Ave with students walking to school campus through carpool exit (Left).  
Sidewalk gap for students entering school campus from Lexington Ave (Right)

Discontinuous sidewalk: No sidewalk connection between the existing sidewalk on the western shoulder of Lexington Ave to the school campus.	Fill gaps in the discontinuous sidewalk and install a ramp connection.
		Crosswalk markings across the school driveway are faded.	Remark existing high-visibility crosswalk across school driveway.
		Curb ramps across the school driveway do not appear to be ADA compliant.	Reconstruct or repair existing curb ramps to be ADA compliant.

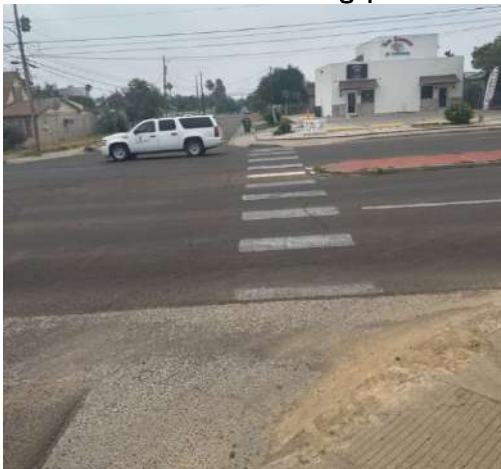
Figure 18: Difficult crossing across Clark Blvd with misaligned curb ramp

Map ID	Location	Issue	Recommendation
9	Clark Blvd & Lexington Ave	The uncontrolled crossing of Clark Blvd had a long crossing distance. Concern about the lack of driver yielding and multiple dangerous conditions (drivers stopping in one lane for a crossing pedestrian obstructs the pedestrian from the view of a driver in the second lane).	Install advanced pedestrian warning signs and advanced yield markings with “Stop Here For Pedestrians” signs located 30-50 ft. in advance of the existing crosswalk. Install school crossing signs with downward pointing arrows at crosswalks. Install median crossing islands and study the crossing for a Pedestrian Hybrid Beacon (PHB).
		Crosswalk markings across Clark Blvd are faded and the north and south crossings across Lexington Ave are unmarked.	Remark existing high-visibility crosswalk across Clark Blvd and install high-visibility crosswalks across Lexington Ave.

The southwest ramp does not appear aligned with the west crossing across Clark Blvd. All existing curb ramps do not appear to be ADA compliant.	Assess the southwest curb ramp for improved alignment and reconstruct or repair existing curb ramps to be ADA compliant.
10	Lexington Ave & O’Kane St	The crossing guard expressed concern about driver stop sign compliance on the west approach of the intersection. The east and west crossing across O’Kane St may be difficult for drivers to see or anticipate due to roadway curvature.	Install curb extensions at all four corners of the intersection.
		East crossing across O’Kane St is unmarked and all existing crosswalk markings faded, No stop bar on the west approach of O’Kane St.	Install new high-visibility crosswalks at the east leg and remark the existing sidewalks. Mark a new stop bar on O’Kane St.
		Existing curb ramps do not appear to be ADA compliant.	Reconstruct or repair existing curb ramps to be ADA compliant.

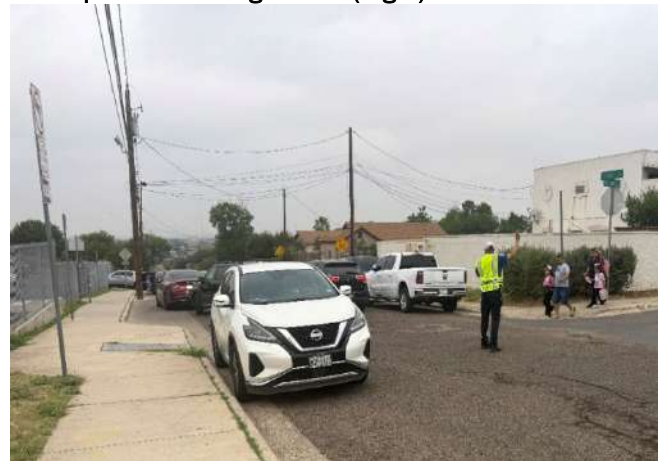
Figure 19: Crossing guard aiding students crossing at Maryland Ave and O'Kane St

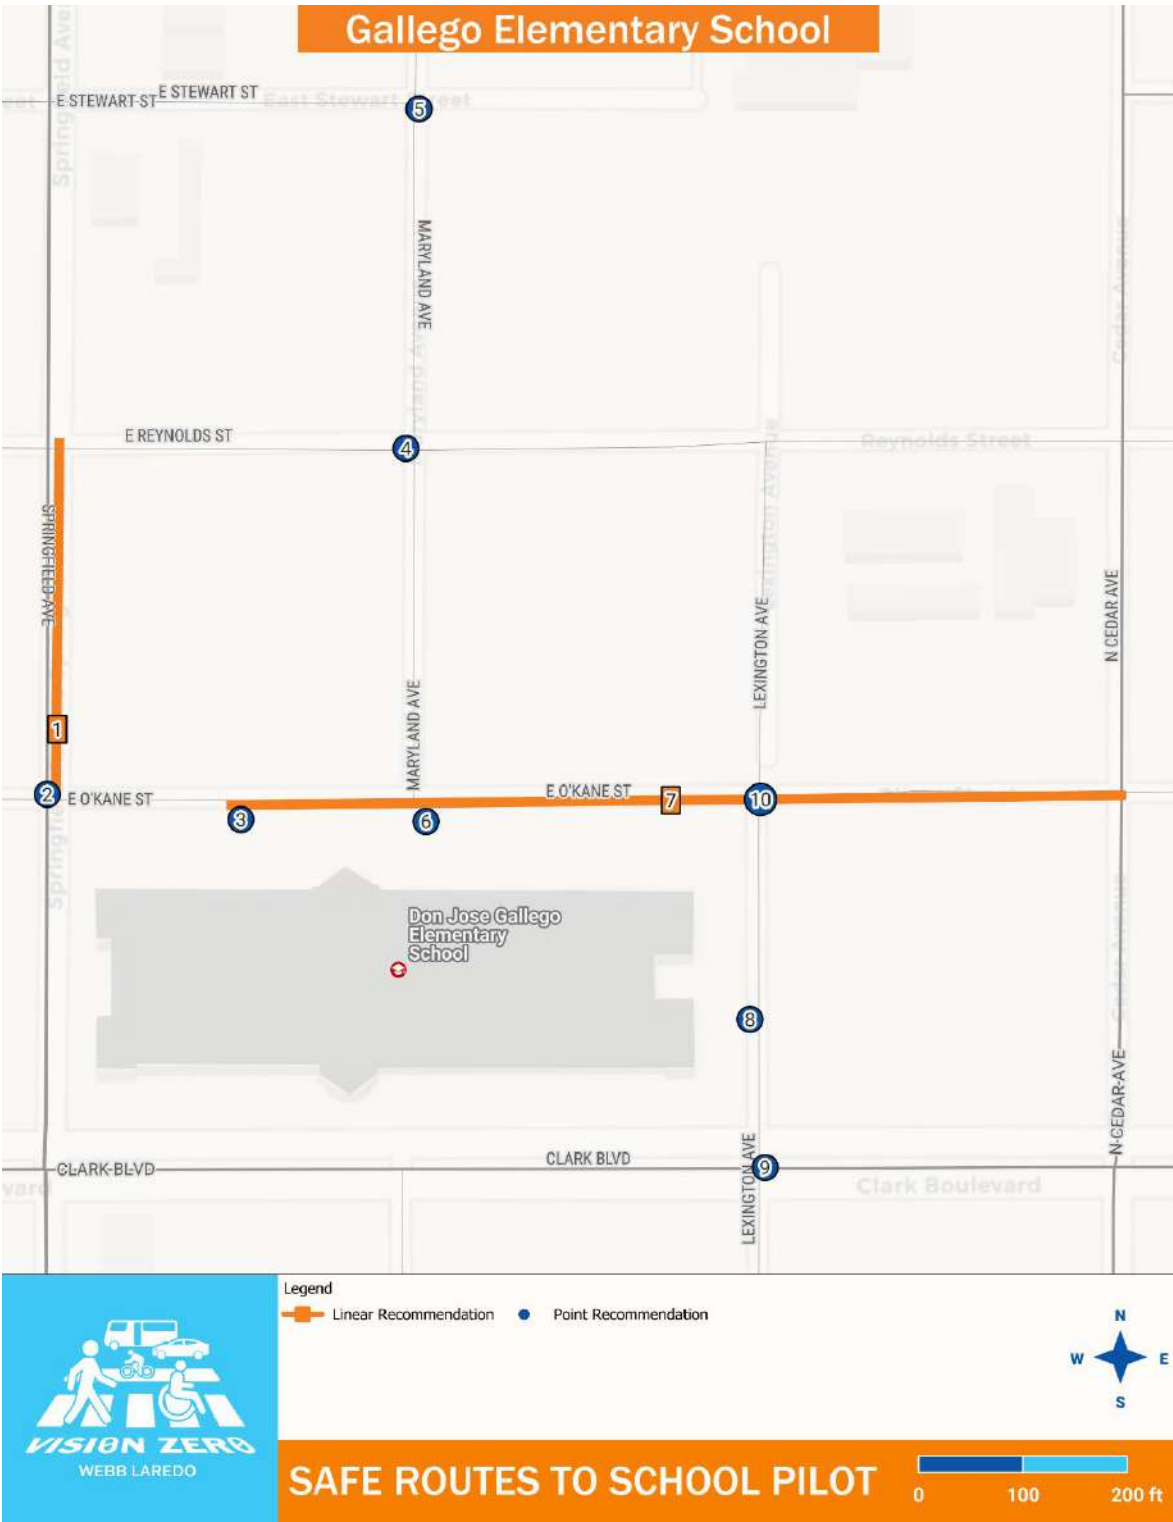
Figure 20: Map of Gallego Elementary School Infrastructure Recommendations

All existing curb ramps do not appear to be ADA compliant.	Reconstruct or repair existing curb ramps to be ADA compliant with detectable warning surfaces.
		Crosswalk markings at all existing crossings are faded. Both stop bars on O'Kane St are also faded.	Remarks existing crosswalks and stop bars.
3	O'Kane St & carpool entrance*	Concern about the lack of driver yielding for parents who park opposite the school and walk students across O'Kane St to the school entrance. Parked cars obstruct sight lines.	Convert the existing speed hump on O'Kane St east of the school driveway to a raised crosswalk, install curb ramps, and install school crossing signs with downward pointing arrows. Alternatively, explore installing curb extensions and high-visibility crosswalk across O'Kane St west of the existing speed hump.

Crosswalk markings across the school driveway are faded.	Remark existing crosswalk.
Map ID	Location	Issue	Recommendation
4	Maryland Ave & Reynolds St	Crossings across the southern and western legs are unmarked. No stop bar at stop-controlled approaches on the eastern and western legs.	Install new high-visibility crosswalks at the southern and western legs. Mark new stop bars at stop-controlled approaches.
		The southern crossing across Maryland Ave lacks appropriate crossing signage.	Install advanced pedestrian warning signs and school crossing signs with downward pointing arrows.
		Parked cars obstruct sight lines of the west crossing across Reynolds St.	Install curb extensions on the northwest and southwest corners of the intersection.
		Curb ramps on the western and southern legs of the intersection do not appear to be ADA compliant.	Reconstruct or repair existing curb ramps to be ADA compliant.

Map ID	Location	Issue	Recommendation
6	O’Kane St & Maryland Ave*	Concern about driver turning movements or speeds and lack of driver yielding to students crossing Maryland Ave and O’Kane St. Both crossings are unmarked and the western crossing of O’Kane St lacks appropriate crossing signage. Parked cars obstruct sight lines for both crossings, and there is no stop bar at the stop-controlled approach on Maryland Ave.	<p>Install advanced pedestrian warning signs on O’Kane St east of the intersection. Install school crossing signs with downward pointing arrows at the crosswalk.</p> <p>Install new high-visibility crosswalks at the northern and western legs. Mark new stop bars at stop-controlled approaches.</p> <p>Install school crossing signs with downward pointing arrows at the new crosswalk on O’Kane St.</p> <p>Install curb extensions on the northwest and northeast corners of the intersection for the crossing of Maryland Ave, and southwest for the crossing of O’Kane to reduce the pedestrian crossing distance, improve pedestrian visibility, and reduce the vehicle turning radius.</p>

Curb ramps on the northeast, northwest, and southwest corners of the intersection do not appear to be ADA compliant.	Reconstruct or repair existing curb ramps to be ADA compliant.
7	O’Kane St (Cedar Ave to school driveway)	Observed motor vehicle speeds appear to exceed the speed limit.	Install speed hump to the east of Maryland Ave and O’Kane St intersection.
		Multiple obstructions were observed on both sides of O’Kane St, including vehicles parked on the sidewalk and utility poles in the middle of the sidewalk.	Restrict parking on sidewalks and consider marking on-street parking lanes on both sides of O’Kane St to encourage improved parking behaviors. Relocate fixed obstructions.
		School advanced warning sign is missing.	Install a school advanced warning sign.
8	Lexington Ave & carpool exit	Concern about the lack of drivers yielding to students crossing carpool lanes on the school campus.	Install raised crosswalks with high-visibility markings.

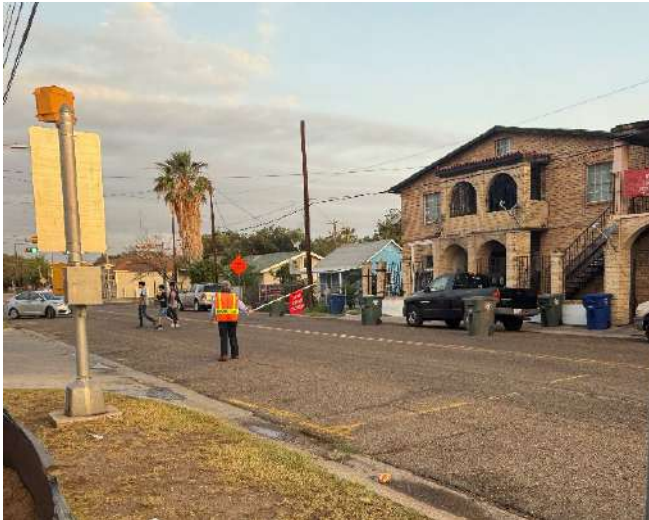
Figure 22: Crossing guard helping students cross Garden St

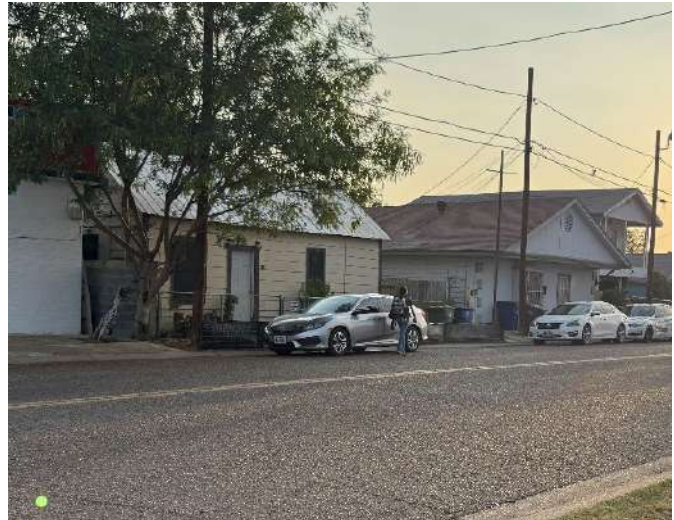
- Drivers turning left from Garden Street into the school driveway tend to turn at relatively high speeds.
- Cars parked on the sidewalk blocked the sidewalk for students walking on Juarez Avenue, the northernmost side of Garden Street and on Santa Maria Avenue. Students observed walking on the road or crossing midblock to avoid obstructions.

Figure 23: Student walking on road to avoid obstructed sidewalk on the north side of Garden St

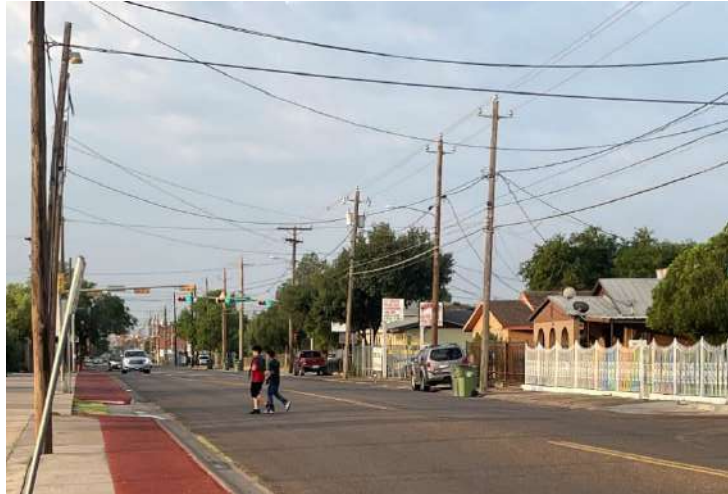
Figure 24: High school and middle school students crossing Santa Maria Ave mid-block

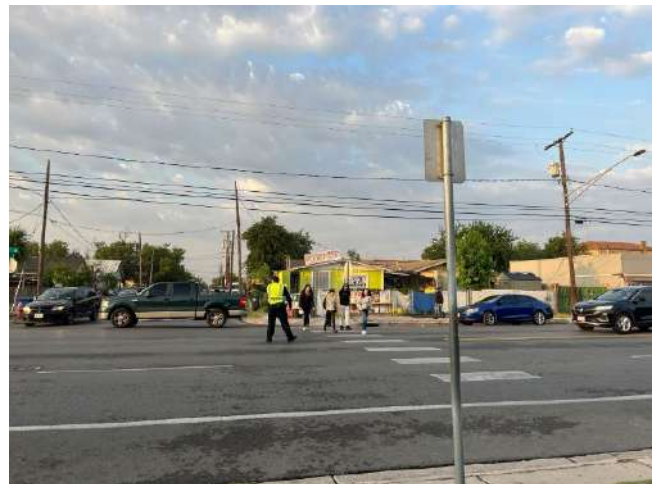
Figure 27: Students crossing at Park St & Juarez Ave

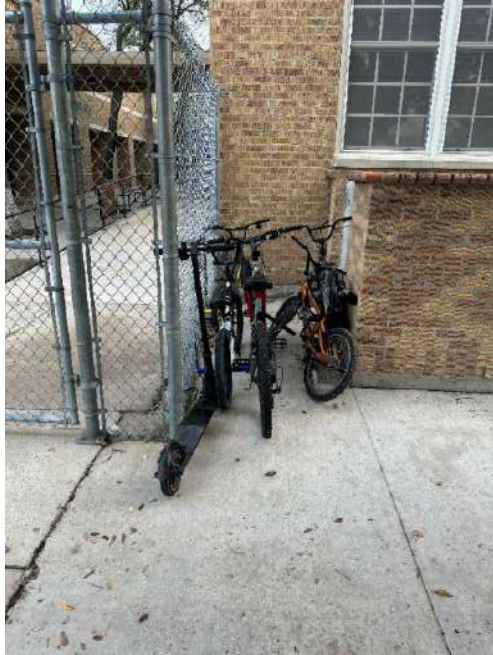
**Figure 28: Lack of bike parking forced students to lock their bikes to the fences of the HVAC units**

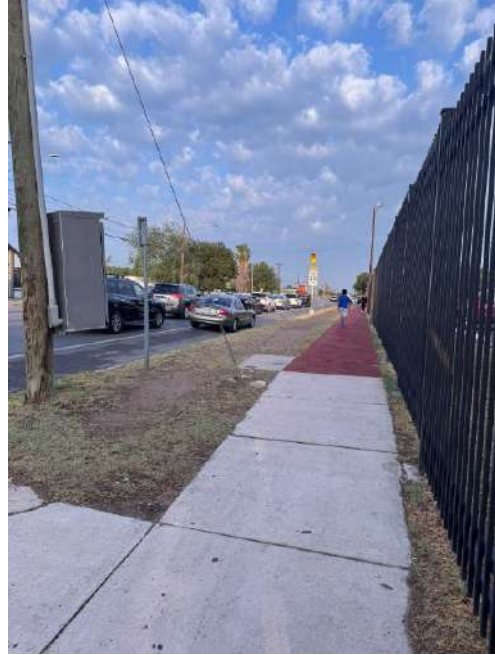
**Figure 29: A vehicle was double parked along Park St to facilitate the drop-off of a late-arriving student.**

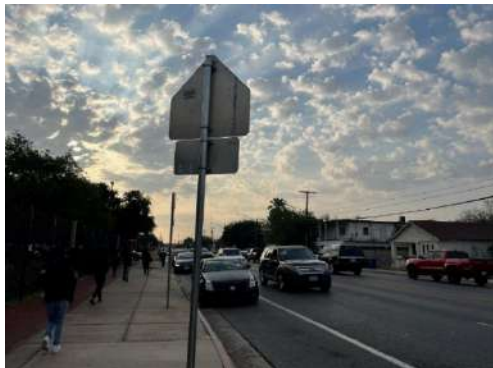
**Figure 30: Pedestrians were observed being dropped off on the shoulder of Park St**

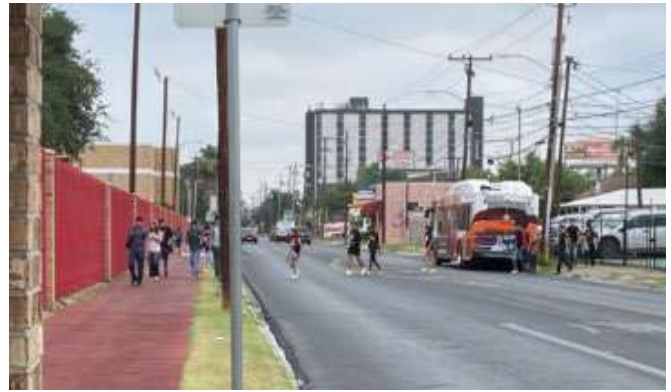
Figure 33: Student crossing San Bernardo Ave from transit bus stop at Bruni St

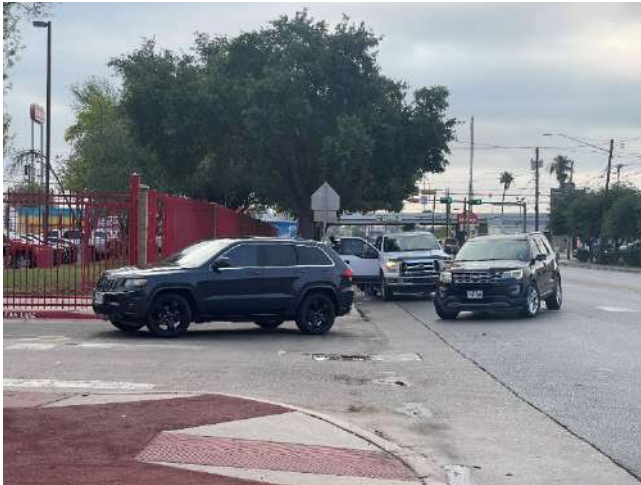
Figure 34: Improper drop-off in shoulder on Park St blocks school traffic

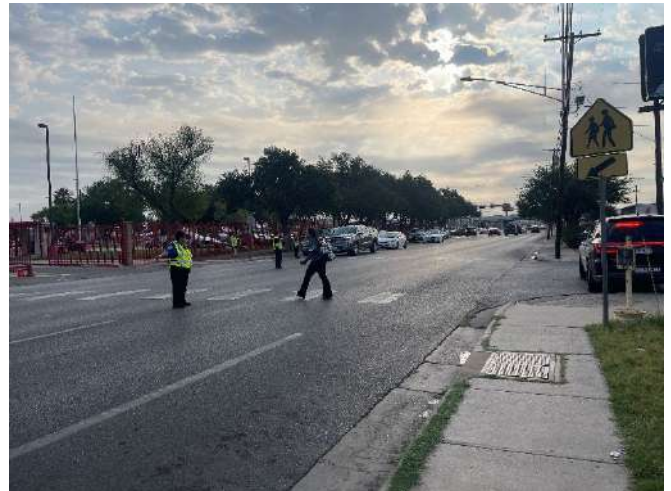
Figure 35: Officers stationed at San Agustin Ave and Park St to help direct traffic and cross students
