# APPENDIX J

## SAFE ROUTES TO SCHOOL SAFETY AUDITS

SRTS Safety Audits were piloted at six schools in the Laredo Independent School District (LISD) in Spring 2025 to demonstrate recommended approaches to identifying priority safety and access issues for active student travel to school.

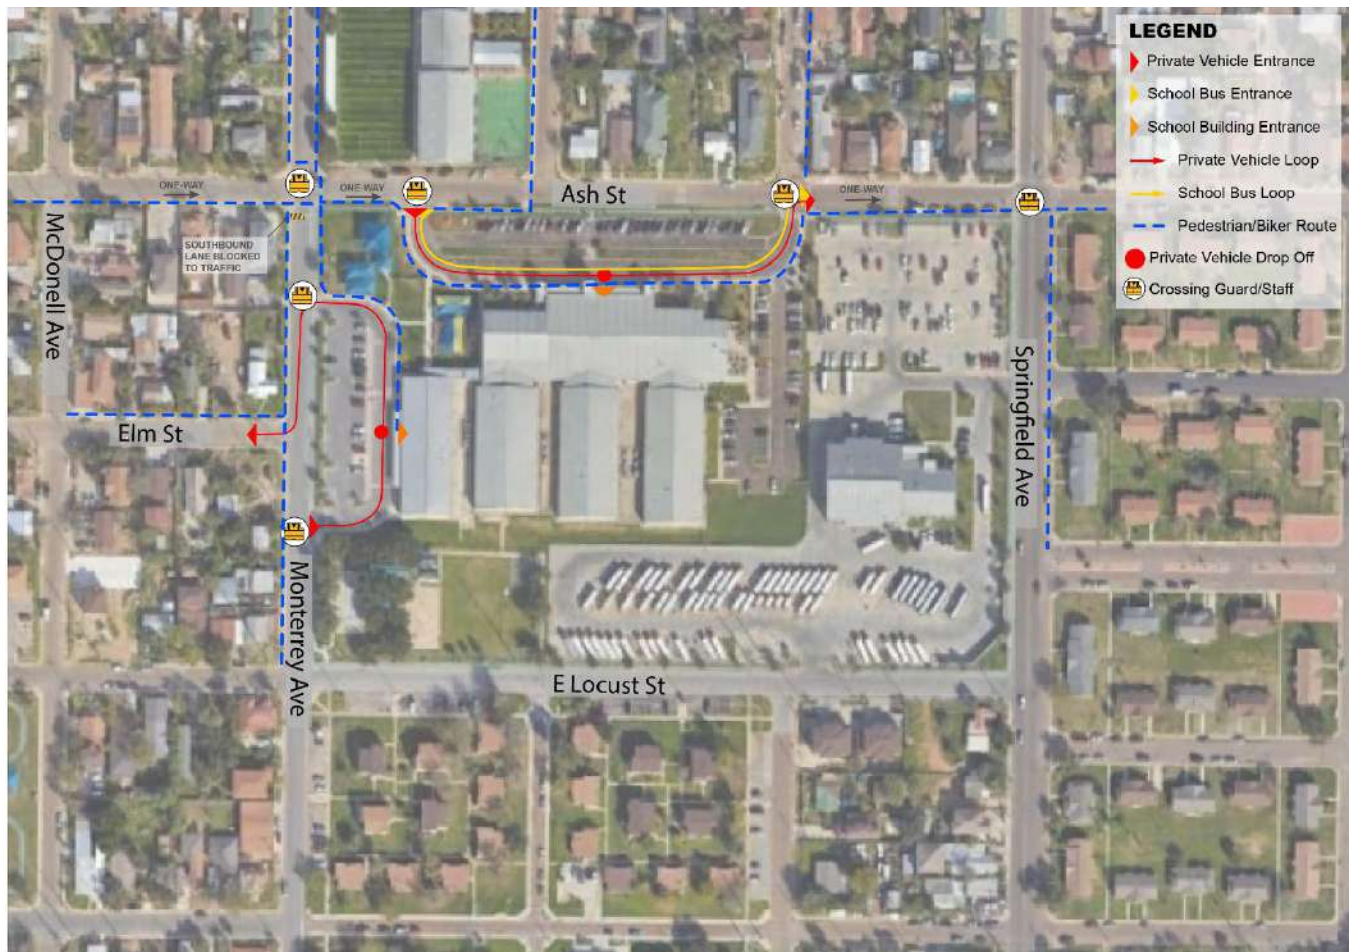
Figure 4: Map of Sanchez-Ochoa Elementary School Arrival/Dismissal

- A crossing guard is stationed at Ash Street and Springfield Avenue. A Webb County constable is sometimes present at this location to help direct traffic but was not there during observations on May 6<sup>th</sup>. Pedestrians were observed having difficulty finding gaps in traffic to stop and needed assistance from the crossing guard.

- Most students walked with their parents or in groups. Most students are walking from the north on Monterrey Avenue and from the west on Ash Street. Students were observed walking from the south and east on Springfield Avenue to cross at Ash Street. There are pedestrian gates on Monterrey Avenue and Ash Street that separate pedestrian traffic from vehicular traffic.

- Drivers observed making relatively fast turns onto Elm Street at the Monterrey Avenue and Elm Street intersection. When exiting the drop-off line, drivers also drove away at relatively high speeds and did not appear to be looking out for pedestrians.

- Lighting infrastructure is limited at key crossings. In conditions of darkness, there may be reduced visibility of students and crossing guards.

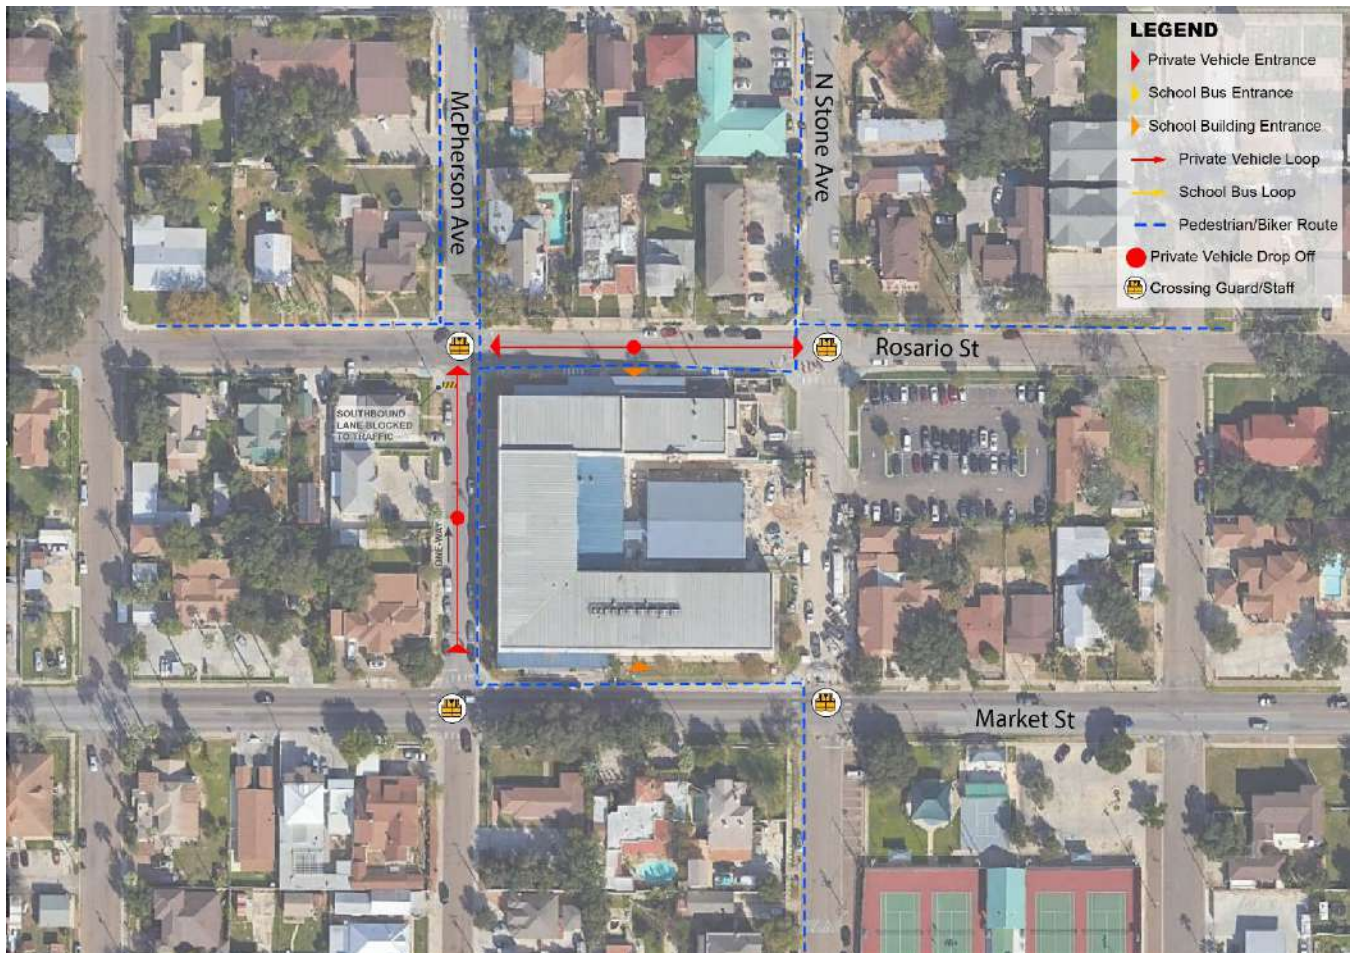
Figure 9: Map of Heights Elementary School Arrival/Dismissal

- Parents often parked on the south leg of McPherson Avenue and crossed Market Street with children despite high-speed traffic, creating a hazardous condition.

- Drivers on McPherson Avenue queued in both directions near Rosario Street, blocking intersections and crosswalks.
- Vehicles routinely rolled through stop signs at McPherson Avenue & Rosario Street.

- Many students walked partway to school, often using roadways instead of sidewalks due to obstructions or lack of facilities.
- After crossing guards left at 7:45 AM, parents and students continued to cross without supervision, increasing the risk.

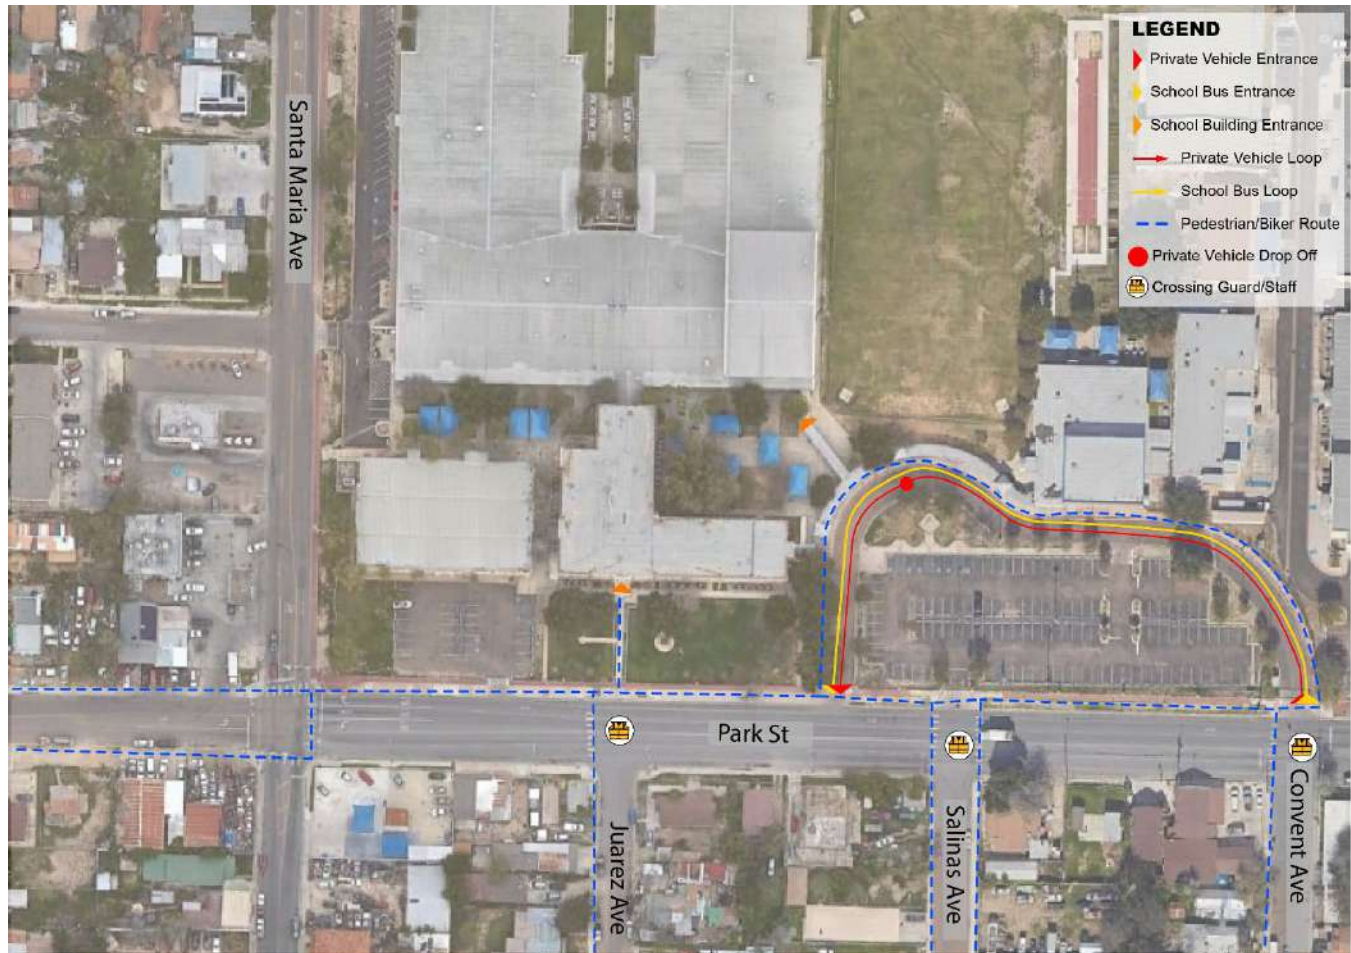
Figure 25: Map of Christen Middle School Arrival/Dismissal

- Crossing guards were missing or delayed at Park Street & Salinas Avenue and Park Street & Santa Maria Avenue, leading to high-risk crossings.
- A police officer and a school-appointed guard helped at Juarez Avenue and a midblock point between Salinas Avenue and Convent Avenue, but coverage was limited.

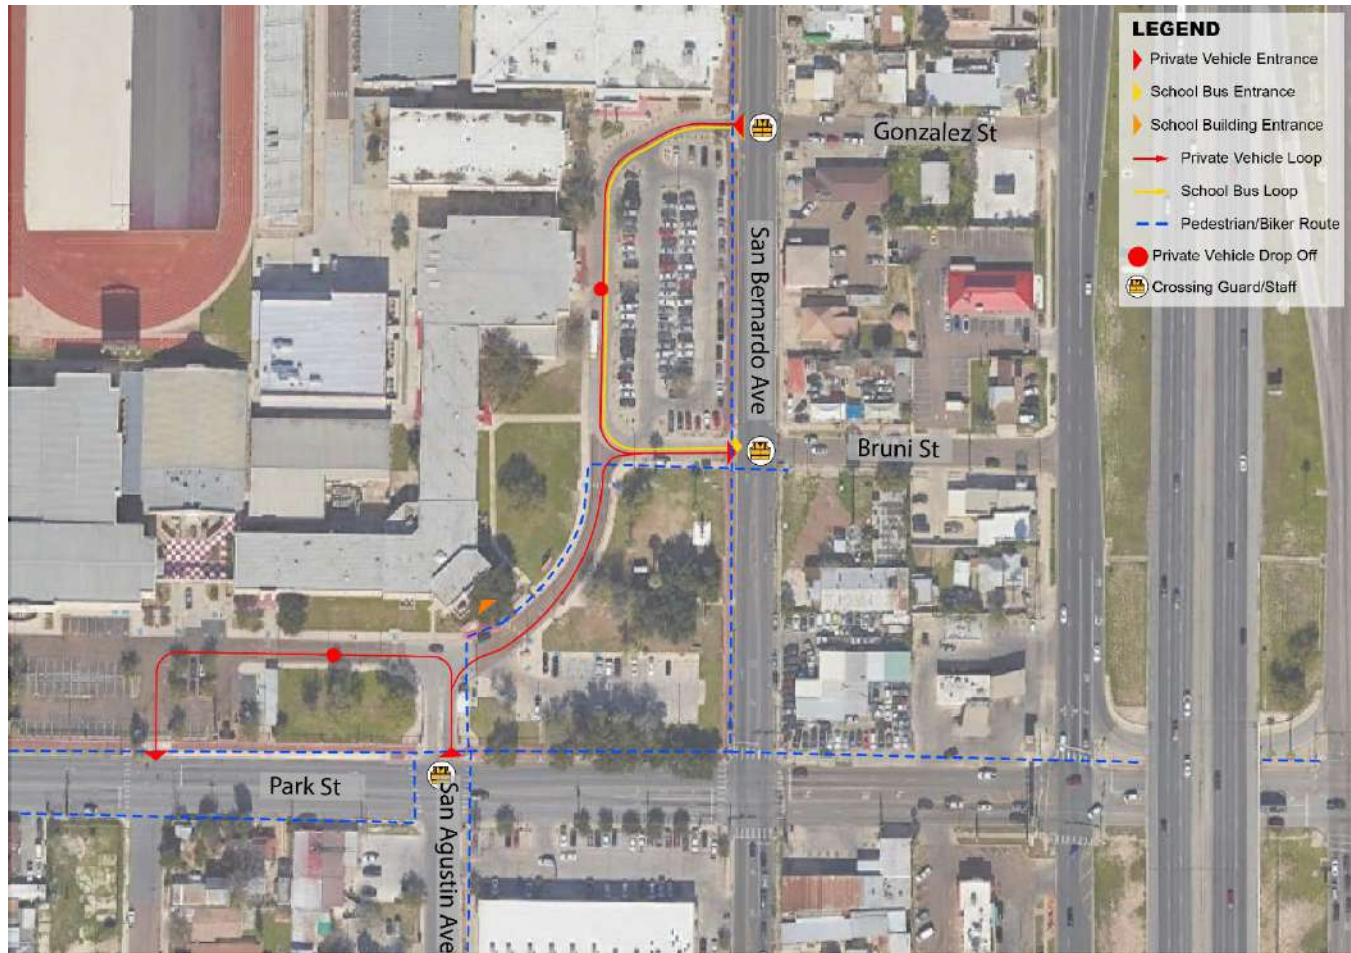
Figure 31: Map of Martin High School Arrival/Dismissal

- Drivers on San Bernardo Avenue generally follow the instructions of the crossing guards which are stationed at Gonzalez Street and Bruni Street.
  - Drivers that dropped students off in the bike lane on San Bernardo Avenue would try to make a U-turn to head back north, but the crossing guard made them continue heading south.

- Entry speeds into the carpool lane entrance on San Bernardo Avenue were high if traffic was not backed up. Southbound traffic on San Bernardo Avenue only backed up during peak drop-off period around 8:15 AM but was never more than five to ten cars.
