APPENDIX F

CAPITAL PLAN

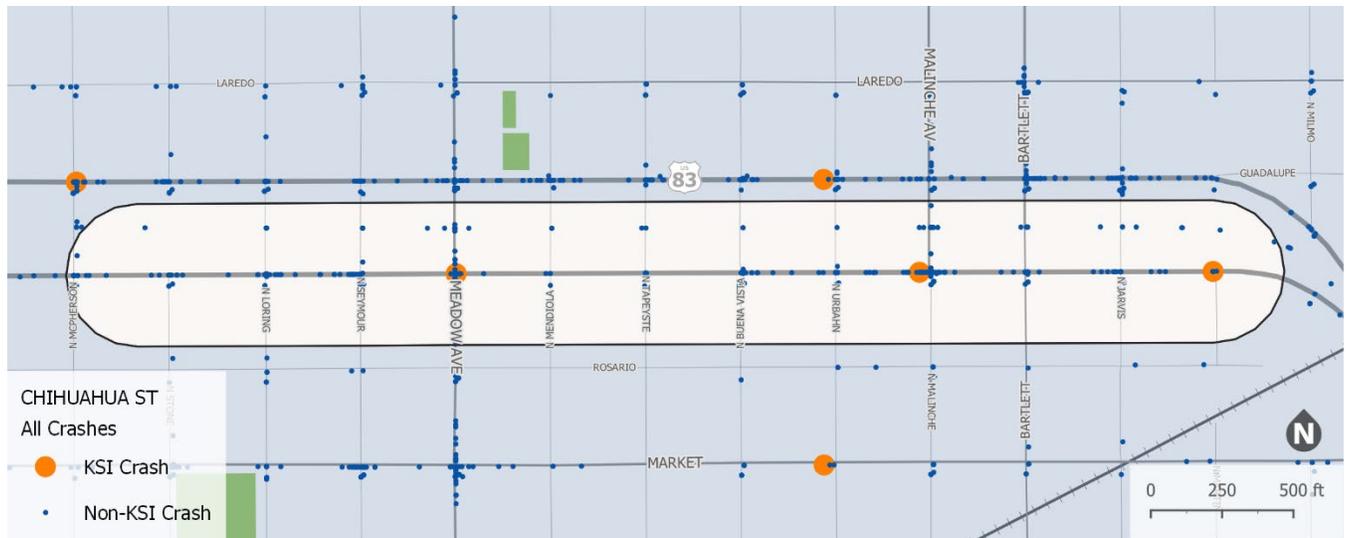
Figure 8: Crash map of the Chihuahua Street corridor

Figure 8 and Table 7 show the spatial distribution of crashes in the Chihuahua Street corridor. It is apparent that most of the crashes occurred at intersections and KSI crashes occurred at intersections with signal control in place.

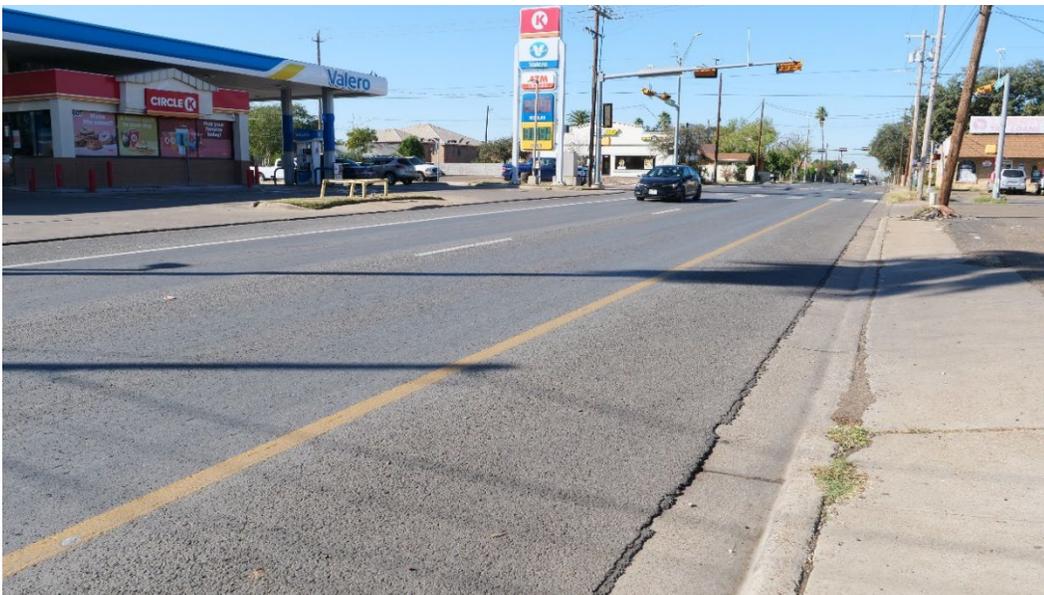
Figure 9: Wide shoulders and numerous driveways along Chihuahua Street

- Install vertical separation for bike lane
- Consolidate access points
- Install additional lighting

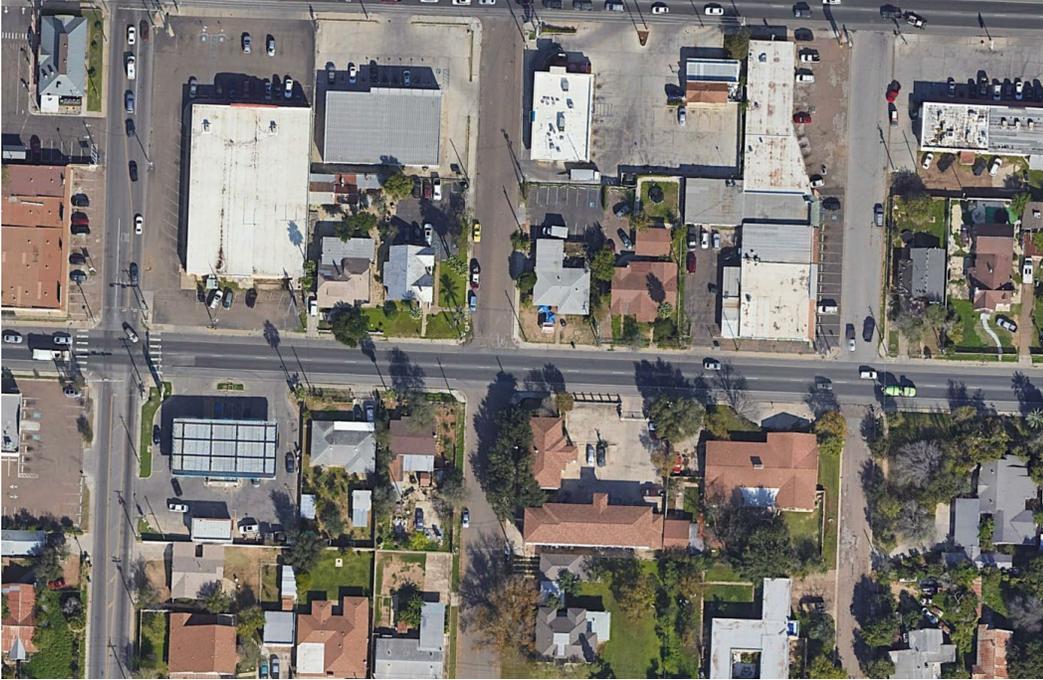
Figure 10: High density of commercial and residential driveways on Chihuahua Street

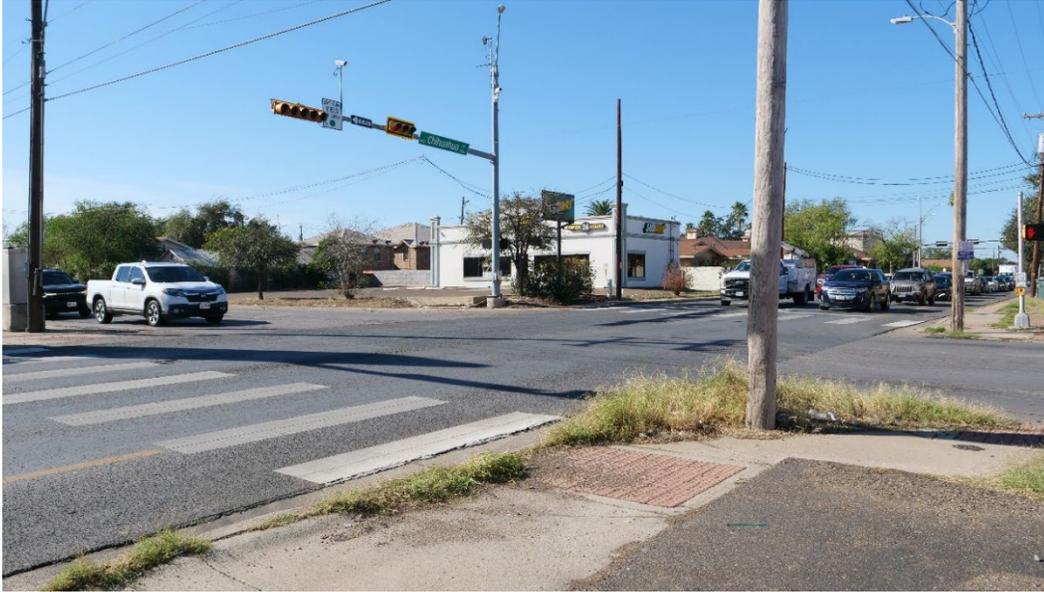
Figure 11: An intersection in need of crosswalk markings and curb ramp upgrades (Meadow Avenue)

- Implement leading pedestrian interval
- Refresh/install high-visibility crosswalks
- Improve curb ramp accessibility

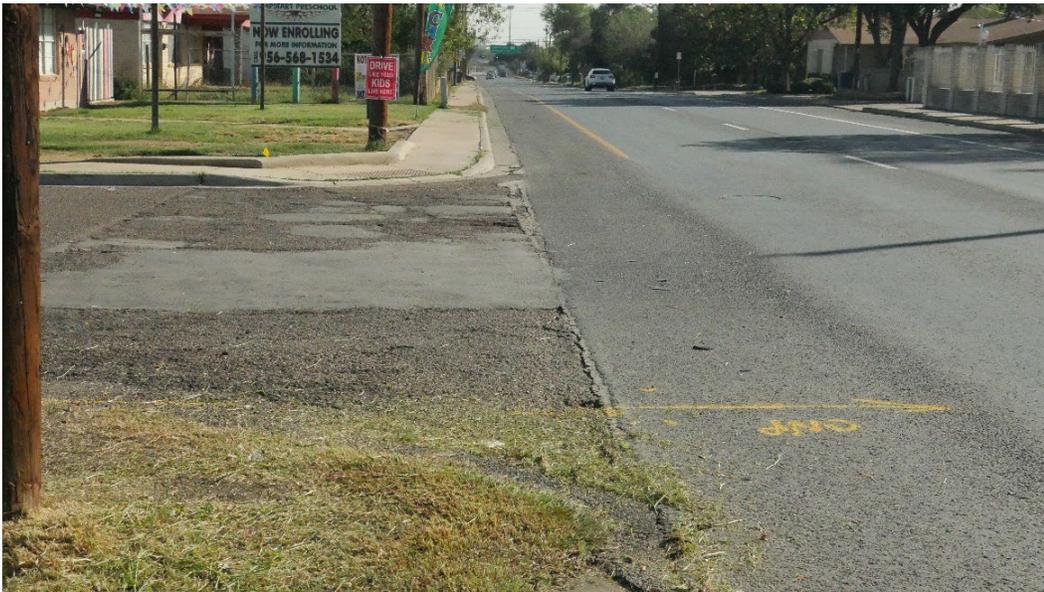
Figure 12: Wide entrance to Mendiola Avenue

Stone, Loring, and Mendiola Avenues act as local neighborhood streets and have pavement widths of approximately 33 feet at their intersections with Chihuahua Street. Curb extensions should be implemented at these intersections to shorten the distance pedestrians need to cross and to slow cars down as they enter the residential and commercial areas lining Chihuahua Street. Continental style crosswalks should also be installed to alert drivers that they are entering a pedestrian space.

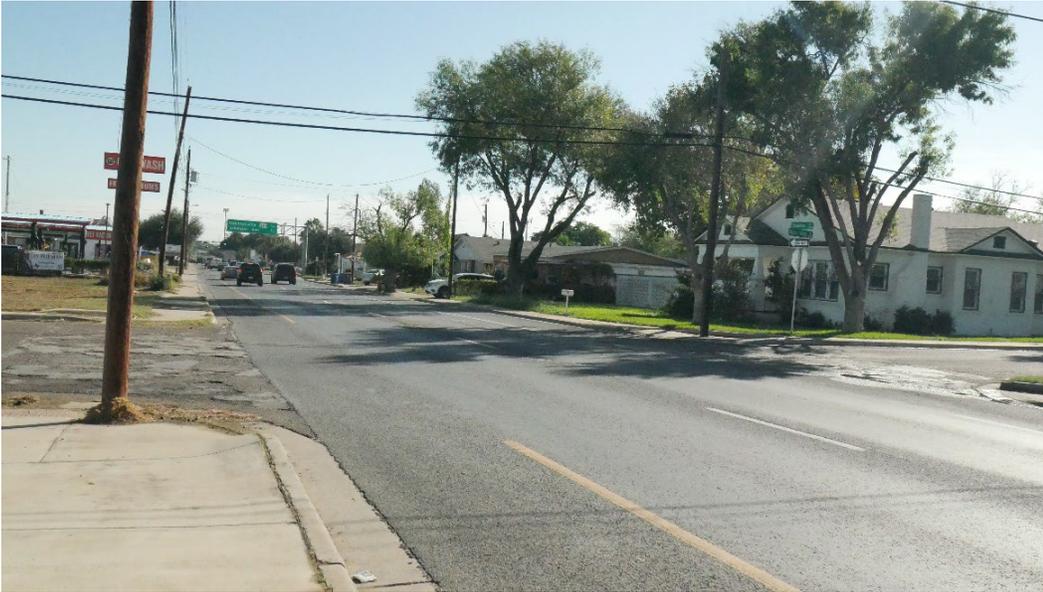
Figure 13: Intersection of Chihuahua Street and Buena Vista Avenue

Between Meadow Avenue and Malinche Avenue, there is a 1,600-foot stretch of Chihuahua Street which does not have an opportunity for pedestrian crossings. A pedestrian hybrid beacon should be installed at the west leg of the intersection of Buena Vista Avenue and Chihuahua Street to close the gap in the pedestrian network.

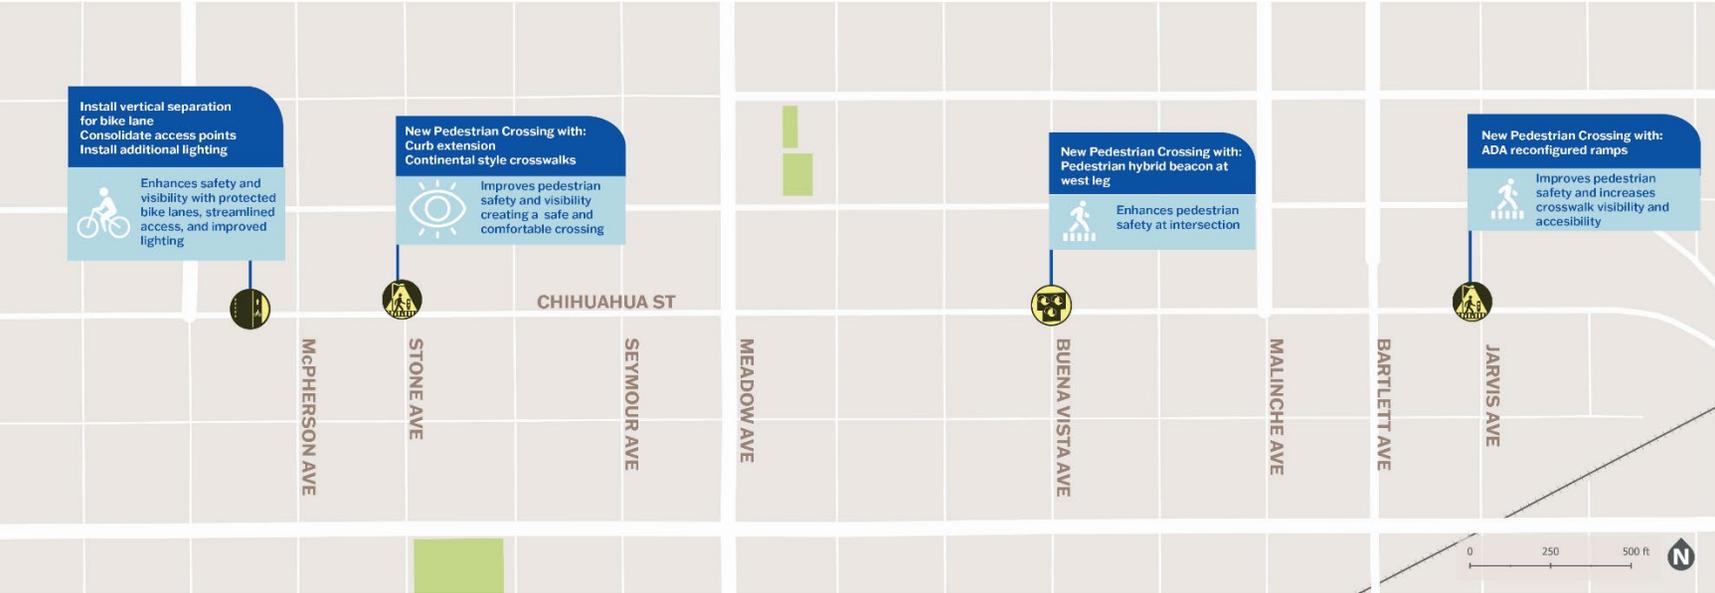
Figure 14: Countermeasure map for the Chihuahua Street corridor

Countermeasure recommendations for the Chihuahua Street corridor are summarized in Table 13 and Figure 14. Costs are based on TxDOT Bid Averages in fall of 2024 and project cost estimates from the 2025-2029 Laredo Capital Improvement Plan (CIP). Construction, engineering, and contingency are included in these costs. All assumptions are detailed in the Countermeasures Toolkit.

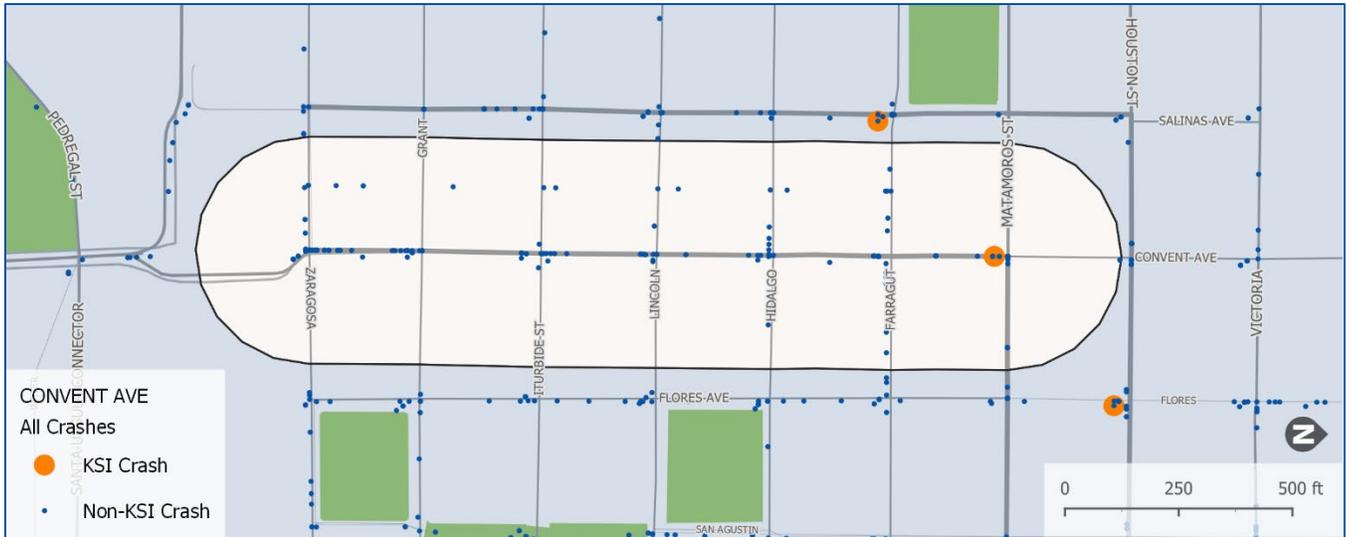
Figure 16 - Crash map of the Convent Avenue corridor

Figure 16 and Table 16 shows the spatial distribution of crashes in the Convent Avenue corridor. It is apparent that most of the crashes occurred at intersections and the KSI crashes occurred at an intersection with signal control in place. The intersections with the most crashes were Zaragoza Street and Farragut Street. One KSI crash occurred at Matamoros Street.

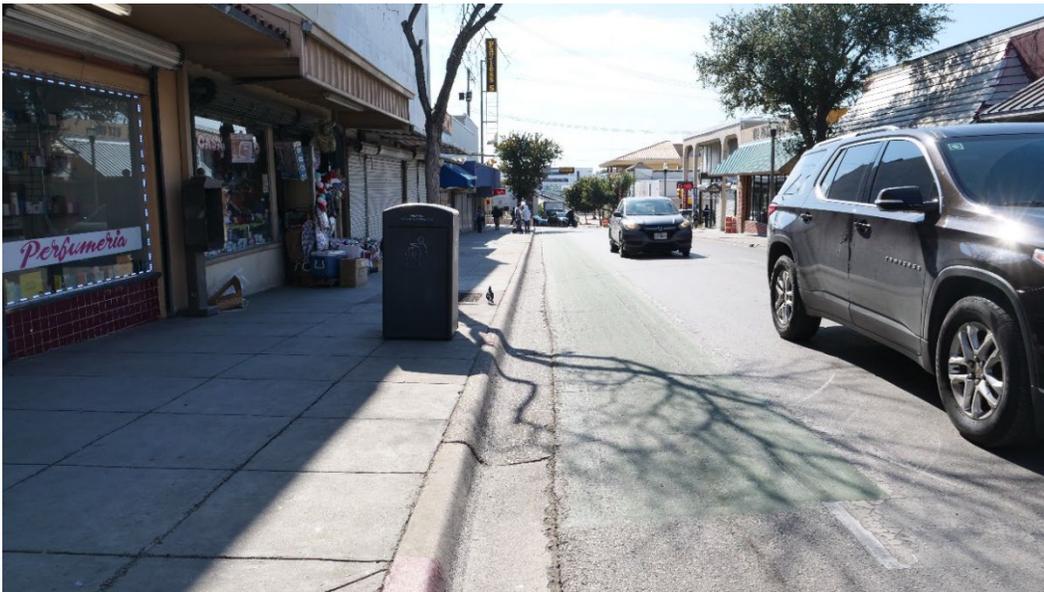
Figure 17 - Bike Lane on Convent Avenue

Convent Avenue has been identified as a priority corridor for bike infrastructure in Laredo, and there is an existing painted bike lane on the street. This bike lane should be vertically separated both to protect bicyclists and to slow vehicular traffic down by providing friction along the edge of the travelled way.

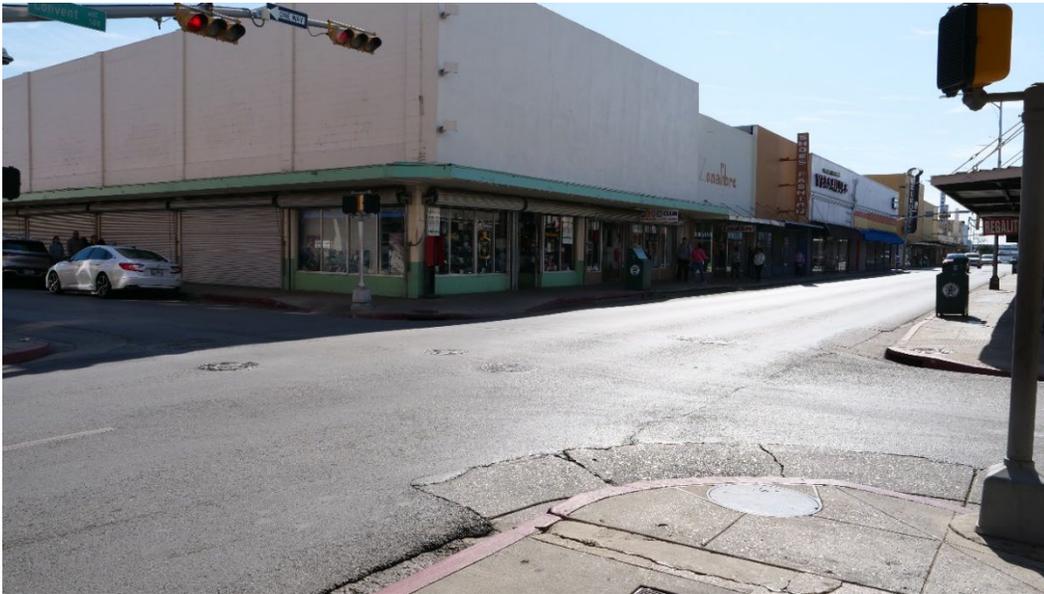
Figure 18 - Intersection of Convent Avenue and Lincoln Street with no crosswalks

- Leading Pedestrian Intervals at all intersections
- Refresh/install crosswalks and stop bars to high-visibility
- Install backplates with retroreflective borders on all signals
- Implement appropriately timed yellow change intervals
- Install curb extensions at all legs of intersections with adjacent parallel parking

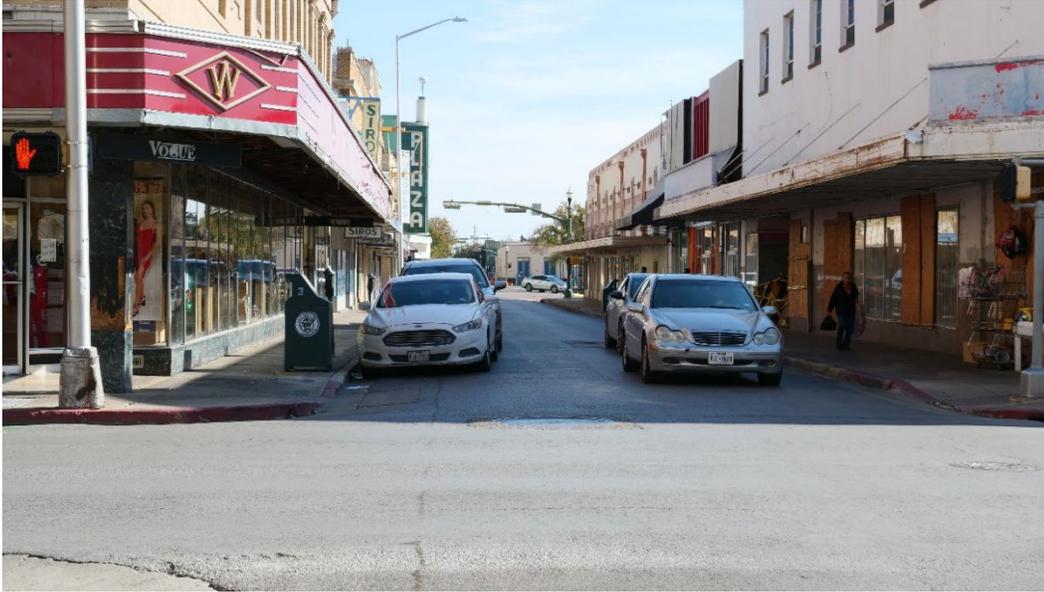
Figure 19 - Space for curb extension adjacent to parallel parking on Hidalgo Street

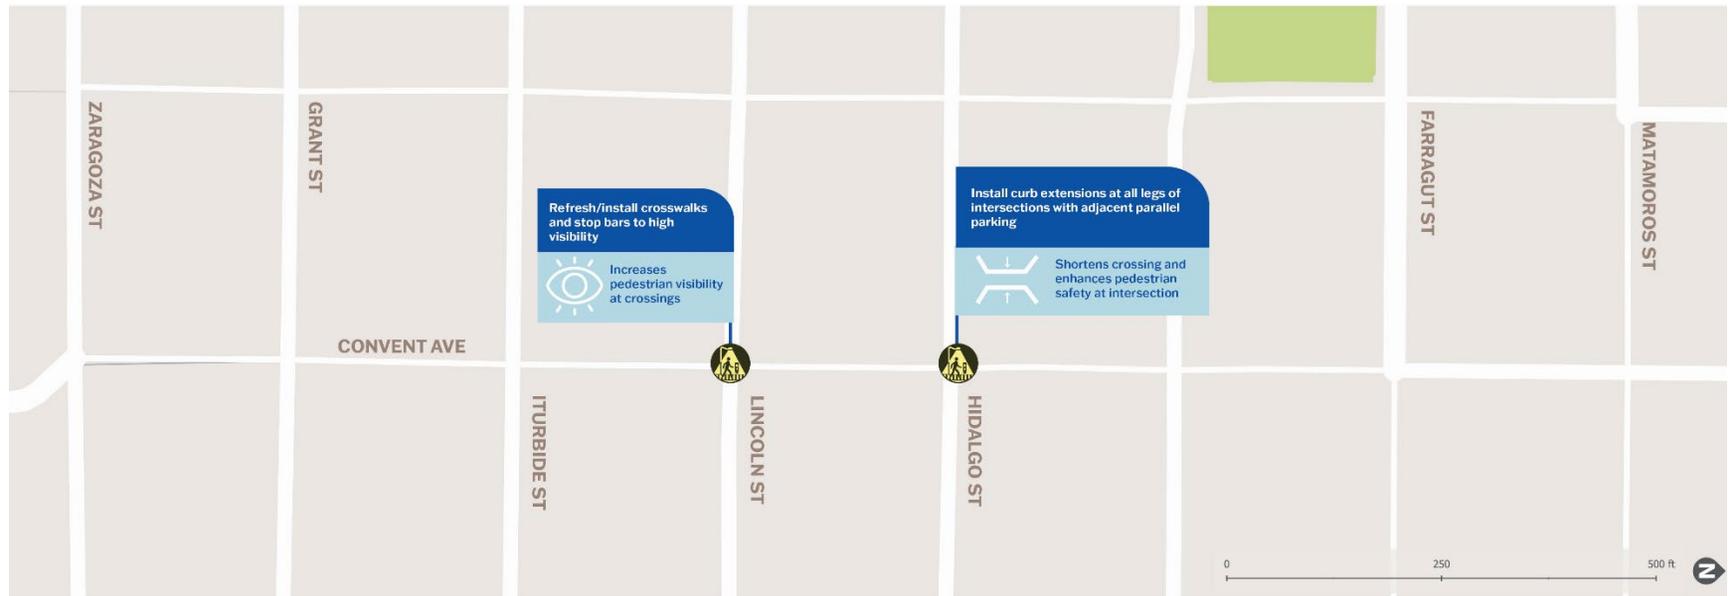
Figure 20 - Recommendations map of the Convent Avenue corridor

Countermeasure recommendations for the Convent Avenue corridor are summarized in Table 22 and Figure 20. Costs are based on TxDOT Bid Averages in fall of 2024 and project cost estimates from the 2025-2029 Laredo Capital Improvement Plan (CIP). Construction, engineering, and contingency are included in these costs. All assumptions are detailed in the Countermeasures Toolkit.

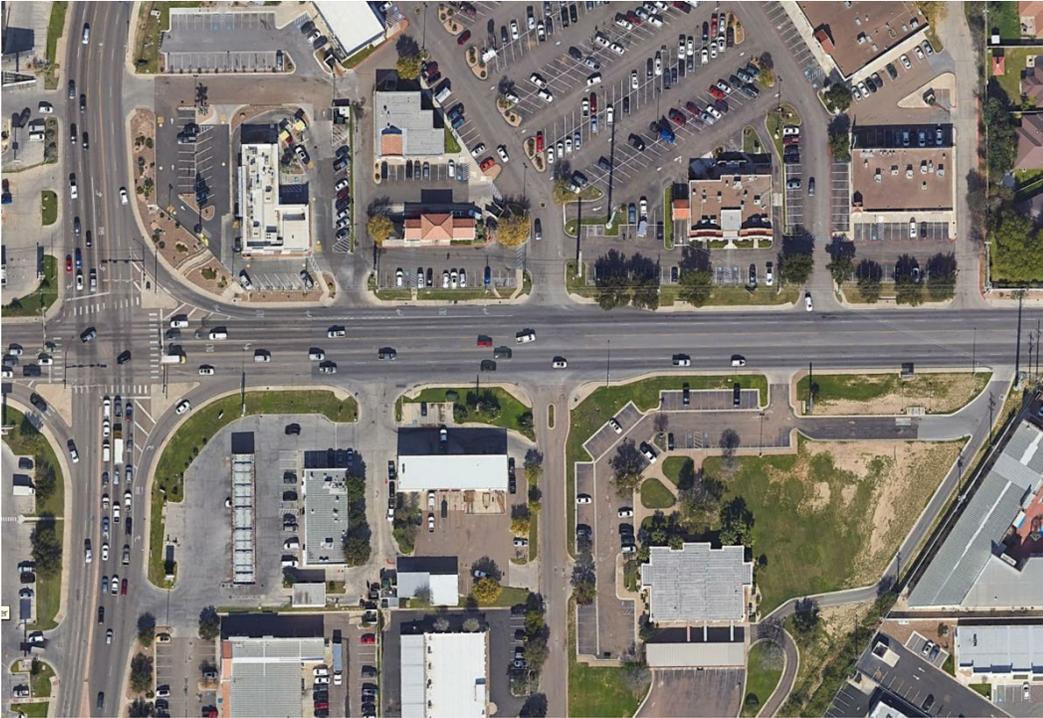
Figure 23 - High density of commercial driveways on Del Mar Boulevard

To reduce the number of rear-end and left-turn collisions along the Del Mar Boulevard corridor, steps must be taken to eliminate points of conflict along segments of the corridor. These conflicts are typically caused by drivers either slowing down within a travel lane to make a right turn into a driveway or taking a risky uncontrolled left turn from the center lane, especially when in intersection areas of influence. Countermeasure recommendations for the Del Mar Boulevard corridor include:

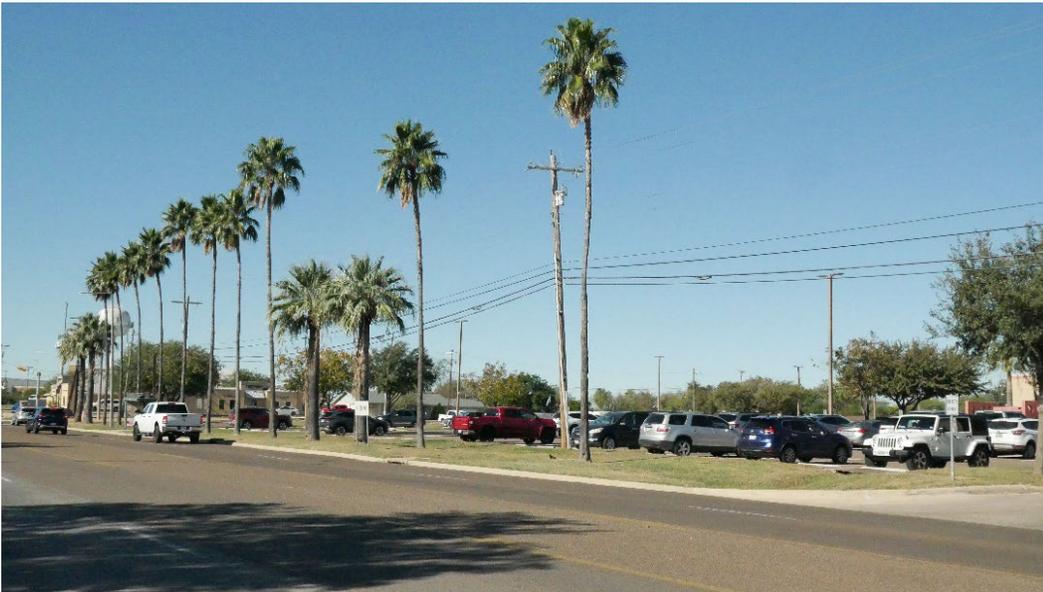
Figure 24 - Gap in narrow sidewalk across Del Mar Boulevard from United Middle School

- Consolidating access points
- Installing a hardened center line
- Widening and filling gaps in the sidewalk from Northview Drive to Martin Road

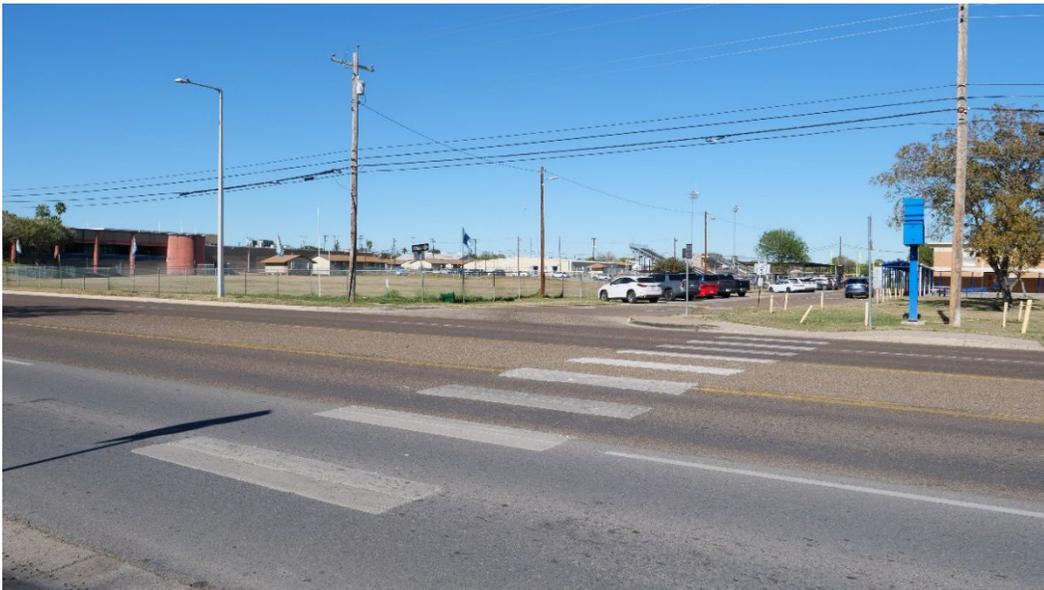
Figure 26 - Existing mid-block crossing at entrance to United Middle School 6th Grade campus

- Install pedestrian hybrid beacon
- Install median pedestrian refuge

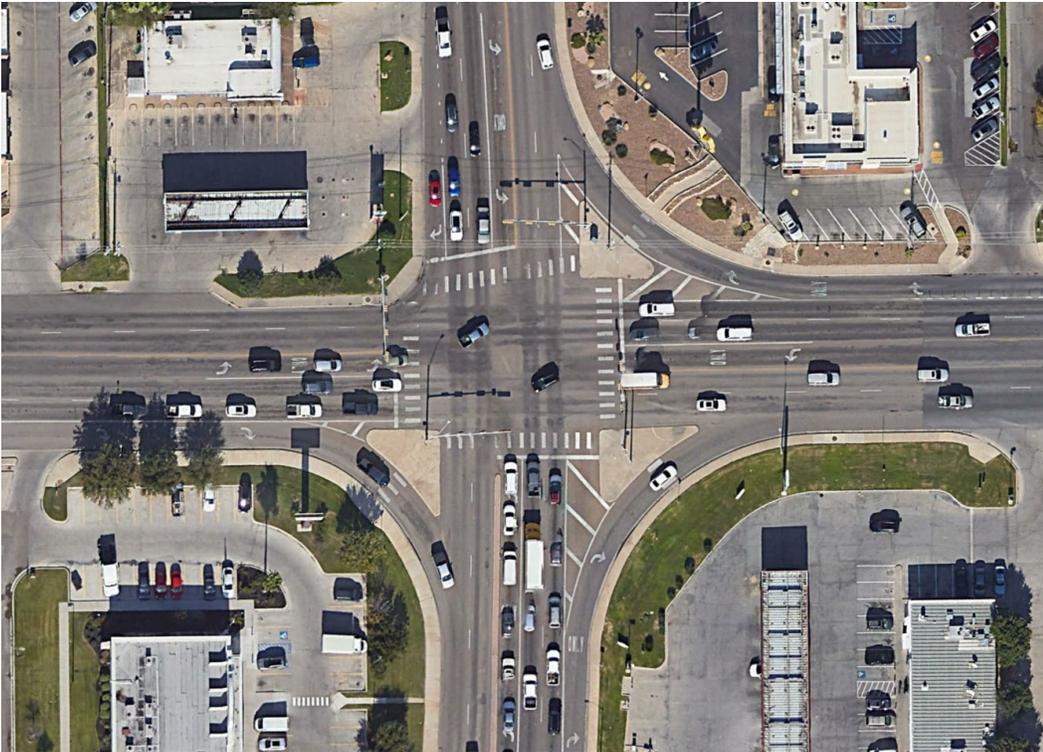
Figure 27 - Aerial of intersection of Del Mar Boulevard with McPherson Road

The McPherson Road intersection has by far the most crashes associated with it of all the intersections along the Del Mar Boulevard corridor. Del Mar Boulevard and McPherson Road are both high traffic volume urban arterials, and their intersection anchors a large shopping center. There are many shopping center driveways in close proximity to the intersection, creating many conflict points where inattentive drivers may have difficulty judging the safety of certain maneuvers. The following countermeasures are recommended at this intersection:

- Add lane line extensions for left turns
- Stripe the acceleration lanes
- Install advanced signal warnings
- Remove permissive left/flashing yellow left phase
- Realign crosswalks with channelization island curb cuts

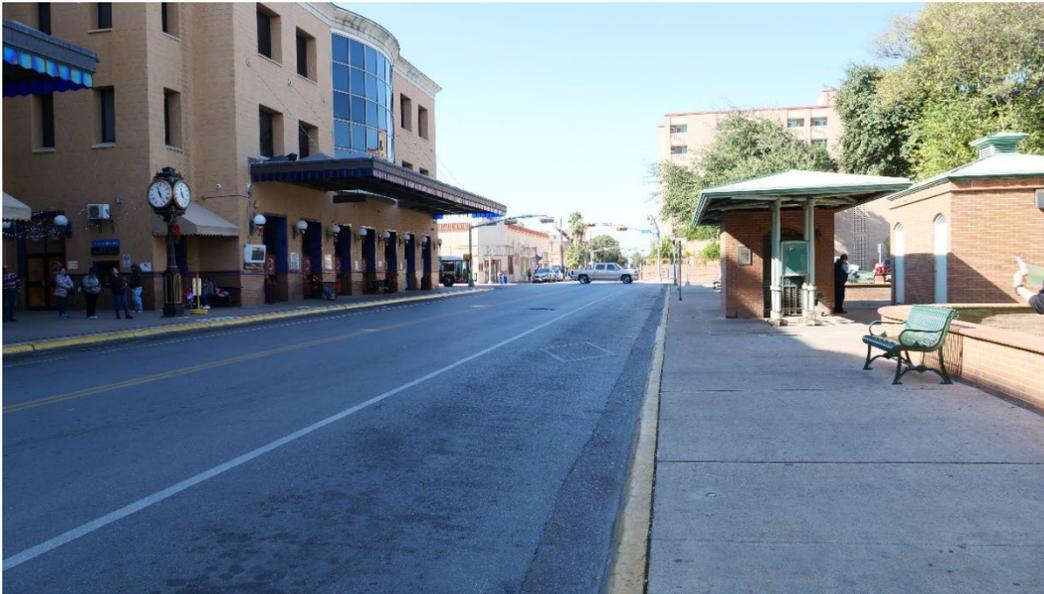
Most crashes along the Farragut Street corridor happened in intersection areas of influence so most of the general safety countermeasure recommendations for the corridor will be for intersections. However, there is an opportunity for a mid-block crossing connecting the El Metro Transit Center pedestrian entrance to Jarvis Plaza. To protect pedestrians who may wish to cross from the transit center to the park, this crossing should feature:

Figure 32 - Entrance of El Metro Transit Center across from Jarvis Plaza

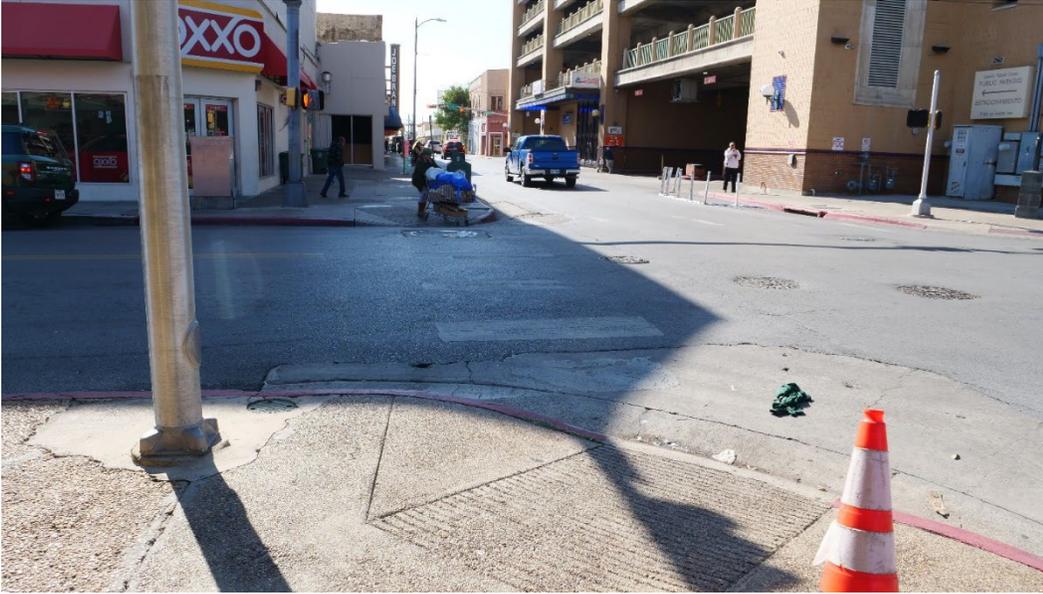
At the time of review, the pedestrian signal head on the northeast corner of the intersection of Salinas Avenue and Farragut Road appeared to have been removed and the other pedestrian signals had been wrapped and not operational. Full functionality must be restored to these pedestrian signals.

Figure 33 - A pedestrian signal appears to have been removed from the NE corner of Salinas Ave and Farragut St

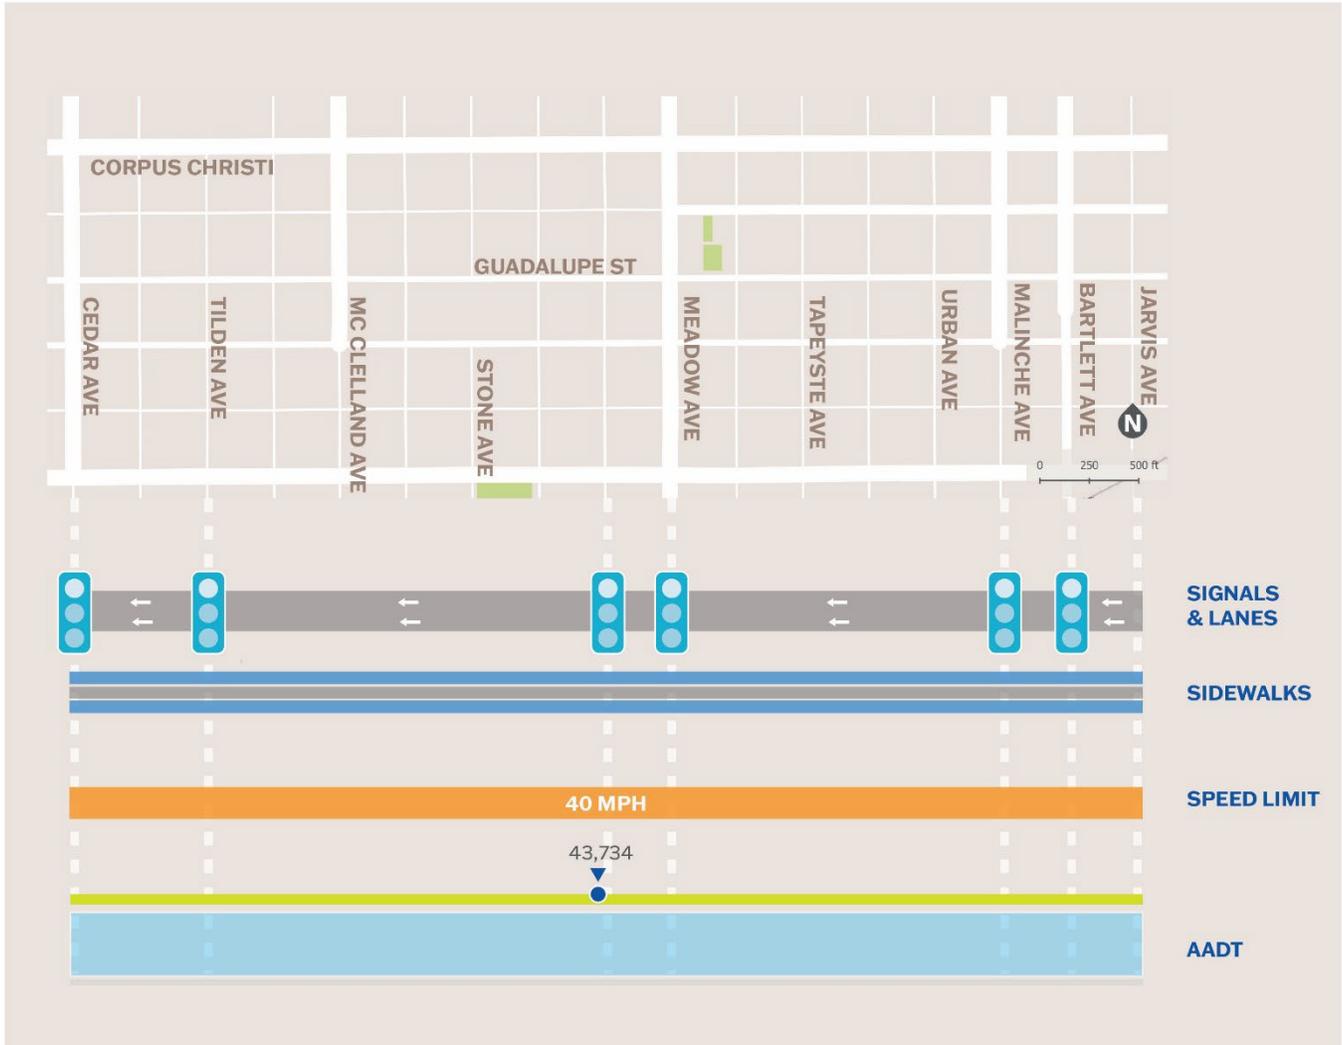
Figure 37 - Guadalupe Street multimodal features

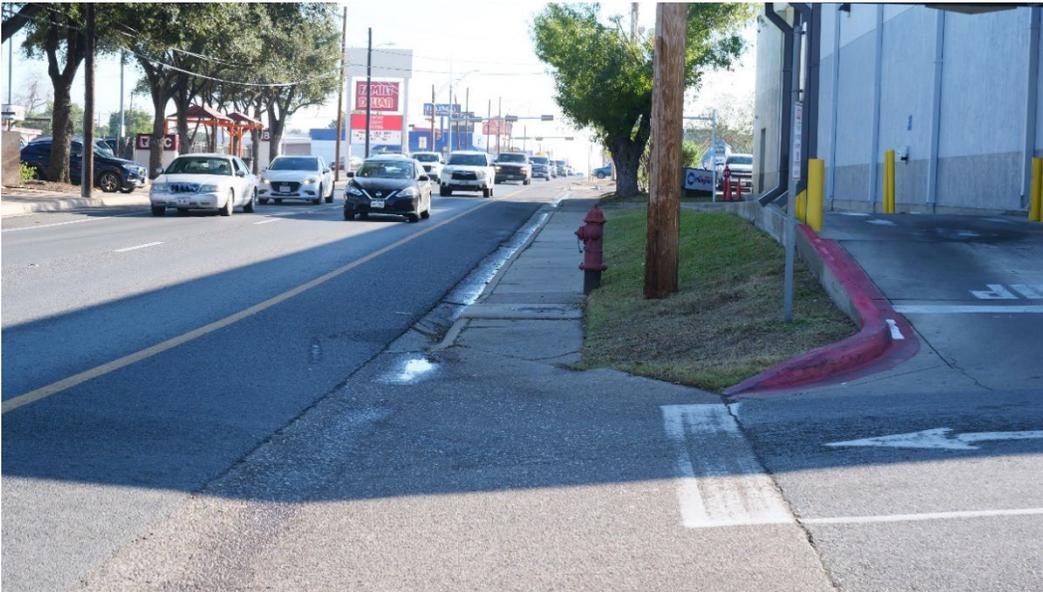
Figure 40 - Wide shoulders on Guadalupe Street

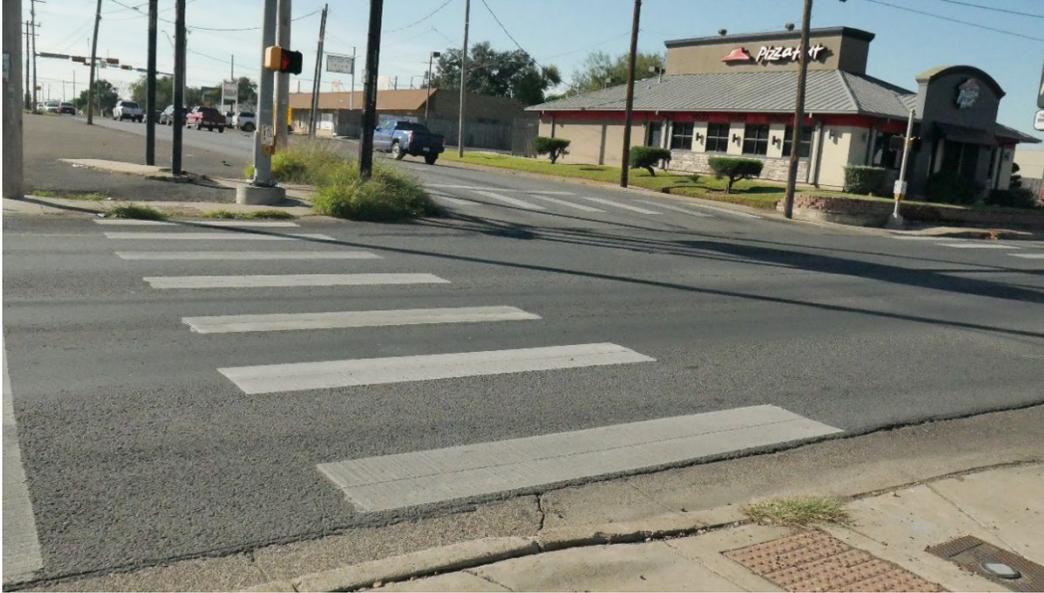
Figure 41 - Typical signalized Intersection on Guadalupe Street (Meadow Avenue)

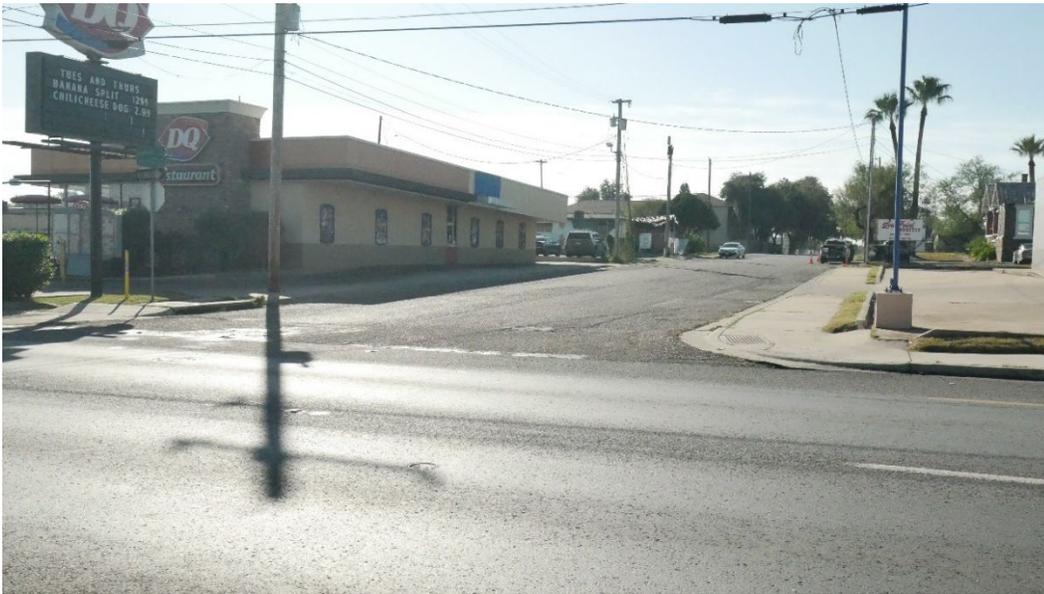
Figure 42 - Typical unsignalized intersection on Guadalupe Street (Mendiola Avenue)

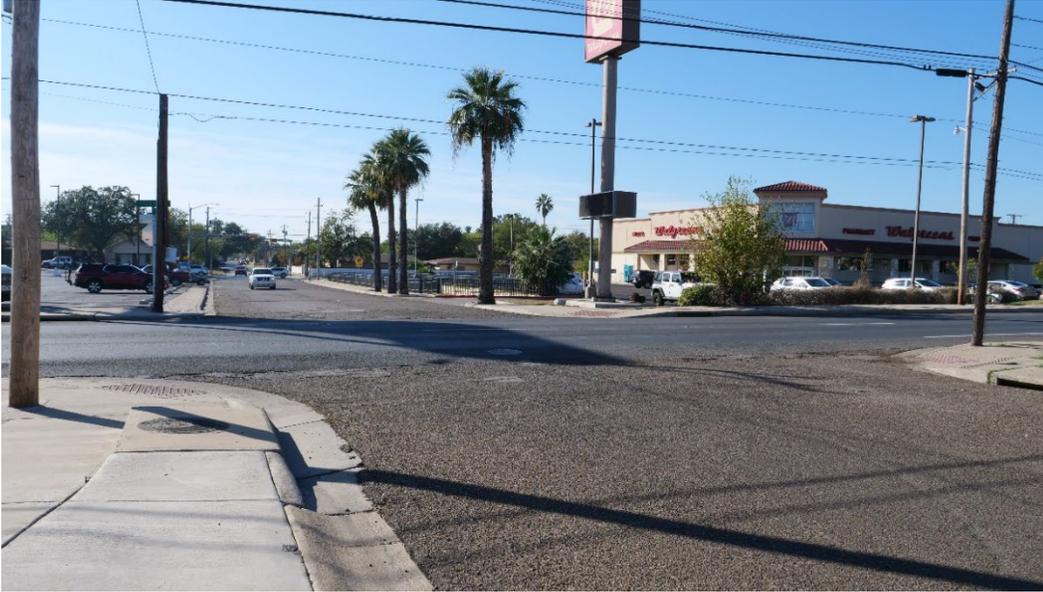
Between Seymour Avenue and Tilden Avenue, there is a 2,000-foot stretch of Guadalupe Street which does not have an opportunity for pedestrian crossings. The intersection of Guadalupe Street and McPherson Avenue should be fully signalized to close the gap in the pedestrian network and match the signal on the Chihuahua Street and McPherson Avenue intersection to the south.

Figure 43 - Intersection of Guadalupe Street and McPherson Avenue looking south

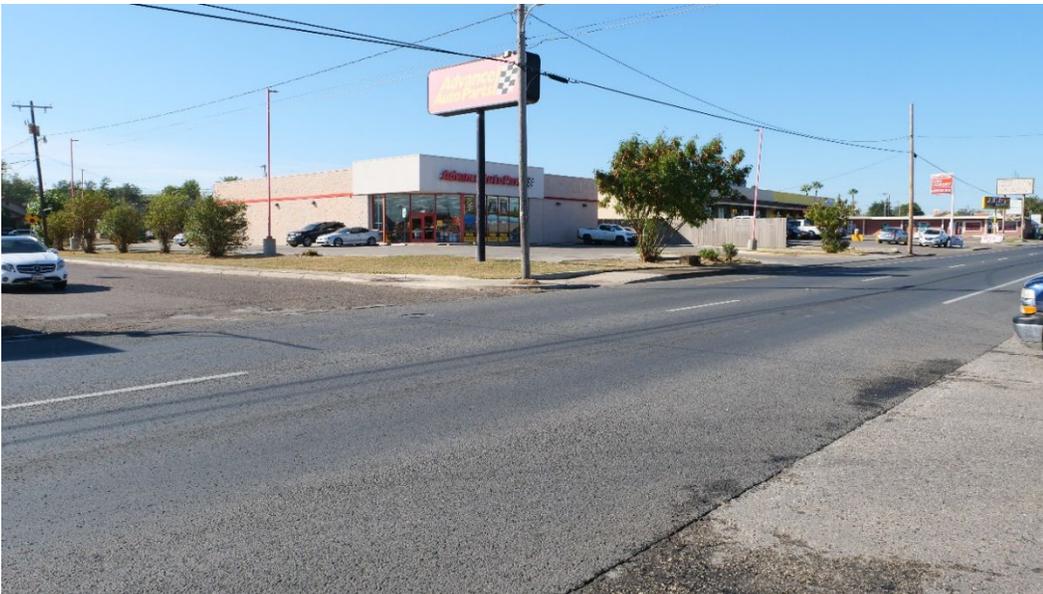
Between Meadow Avenue and Malinche Avenue, there is a 1,600-foot stretch of Guadalupe Street which does not have an opportunity for pedestrian crossings. A pedestrian hybrid beacon should be installed at the east leg of the intersection of Buena Vista Avenue and Guadalupe Street to close the gap in the pedestrian network.

Figure 44 - Intersection of Guadalupe Street and Buena Vista Avenue

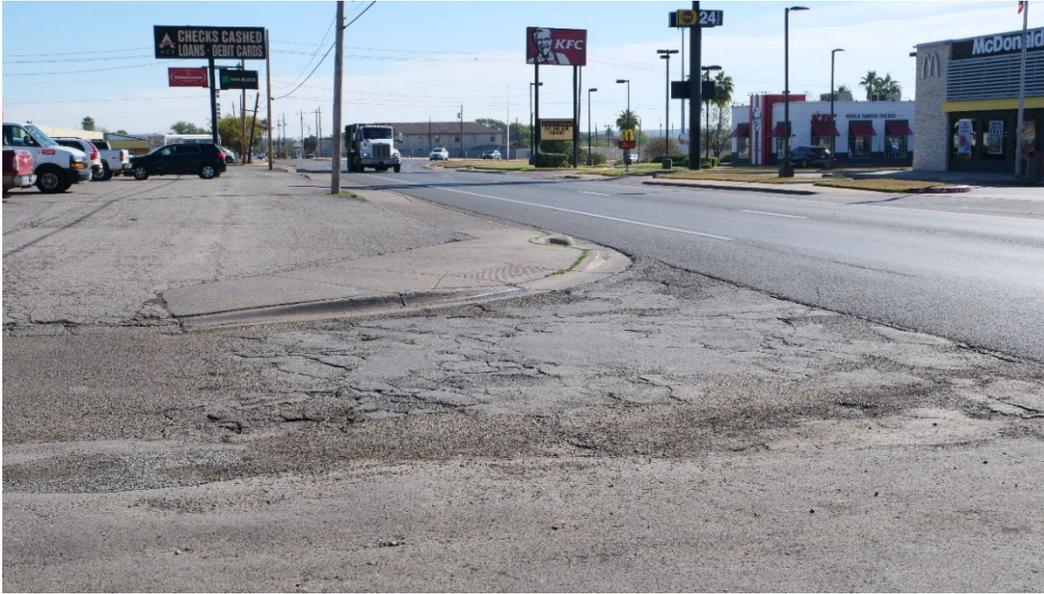
- Intersection control beacon to alert through traffic to the intersection
- Intersection advance warning sign

Figure 45 - Approach to North Jarvis Street intersection

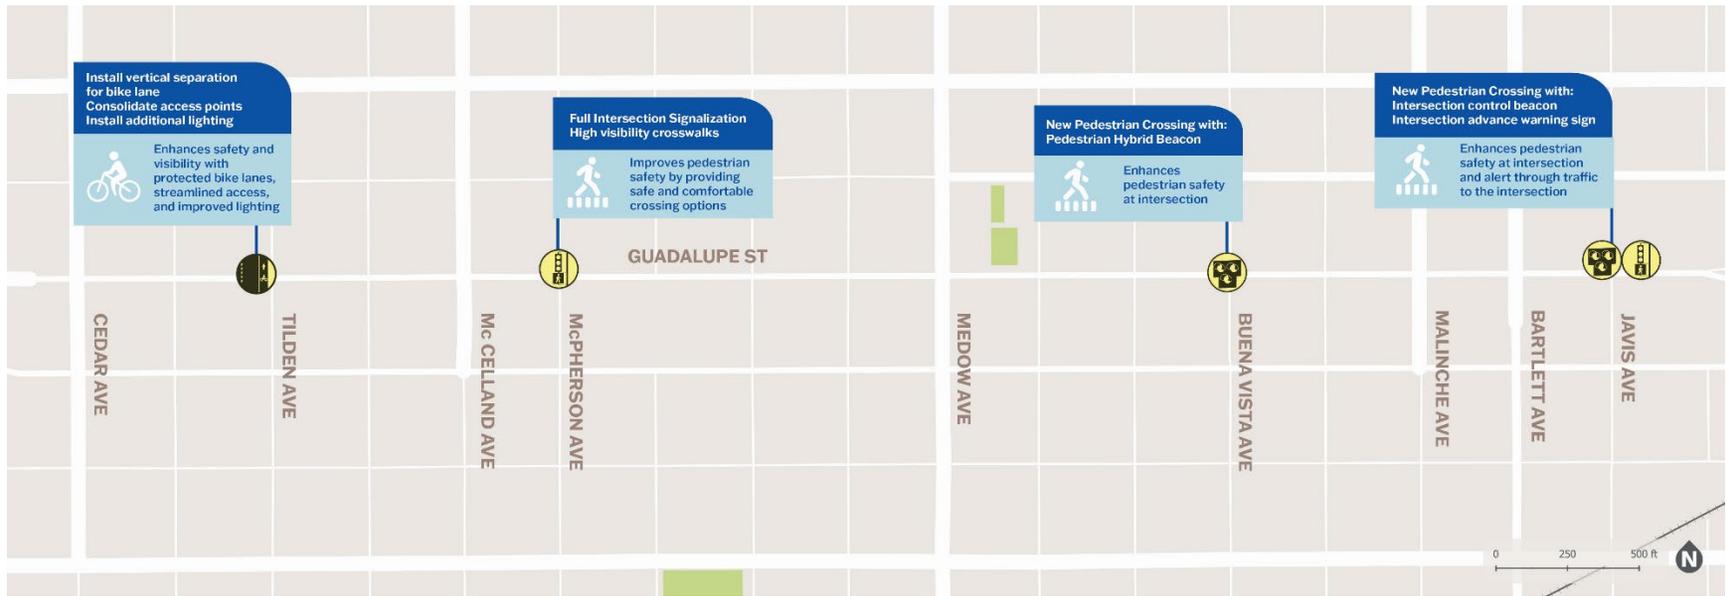
Figure 46 - Countermeasures map of the Guadalupe Street corridor

Countermeasure recommendations for the Guadalupe Street corridor are summarized in Table 49 and Figure 46. Costs are based on TxDOT Bid Averages in fall of 2024 and project cost estimates from the 2025-2029 Laredo Capital Improvement Plan (CIP). Construction, engineering, and contingency are included in these costs. All assumptions are detailed in the Countermeasures Toolkit.

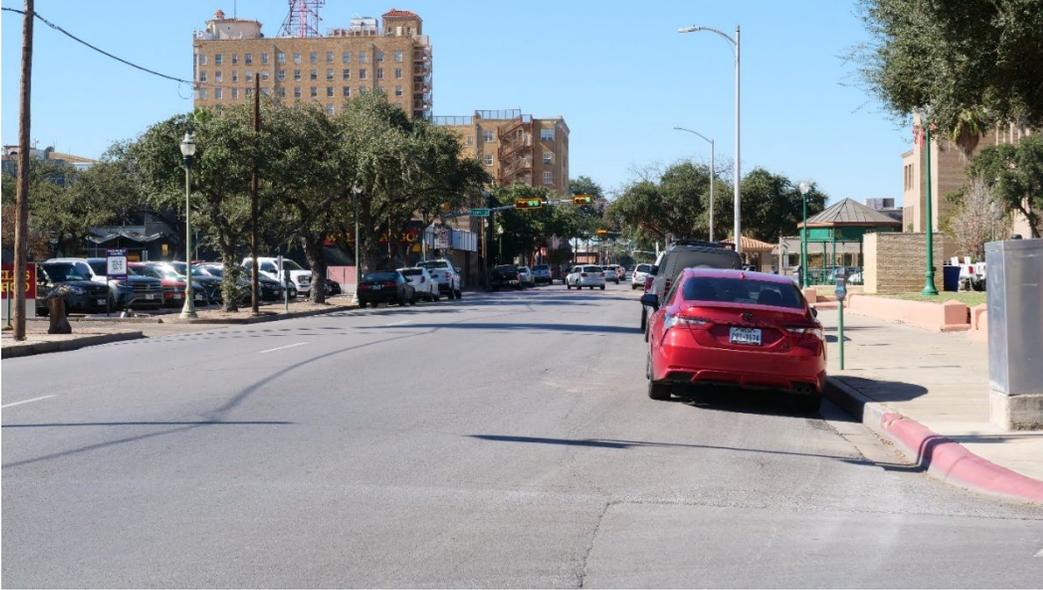
Along the entire subject segment of Houston Street, there is enough space to accommodate two travel lanes and two parallel parking lanes. Seeing as Houston Street has been identified as an opportunity corridor in the TxDOT Laredo Bike Plan, this extra width should be leveraged to install a curb separated bicycle lane, which will narrow the pavement and cause more friction to drivers, who will therefore be encouraged to maintain safer speeds, as well as protect pedestrians and cyclists.

Figure 49 - Wide roadway cross section typical of the Houston Street corridor

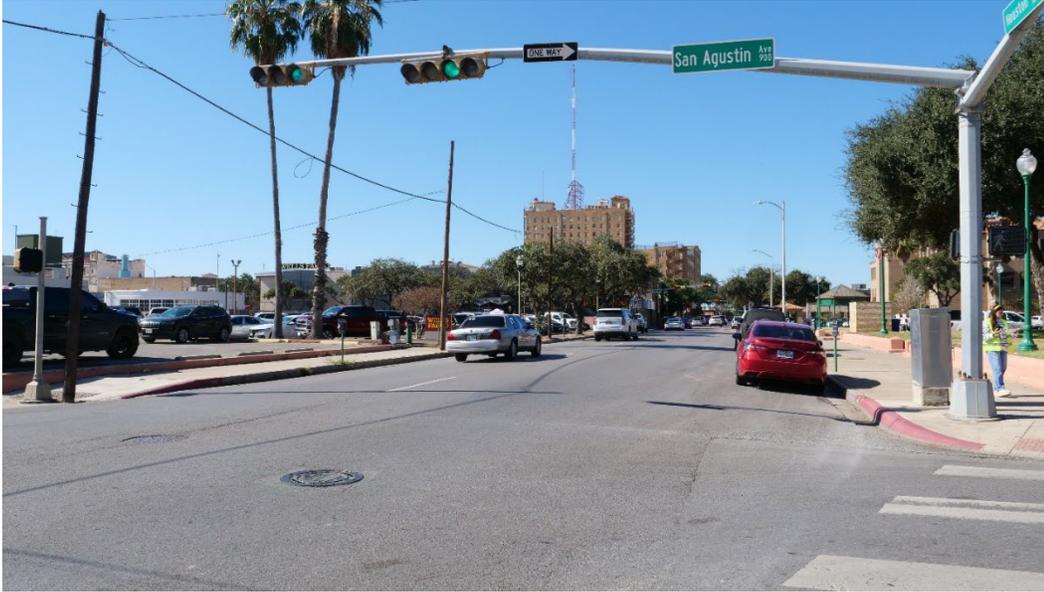
Figure 50 - Intersection of Houston Street and San Agustin Avenue with no pedestrian facilities on western leg

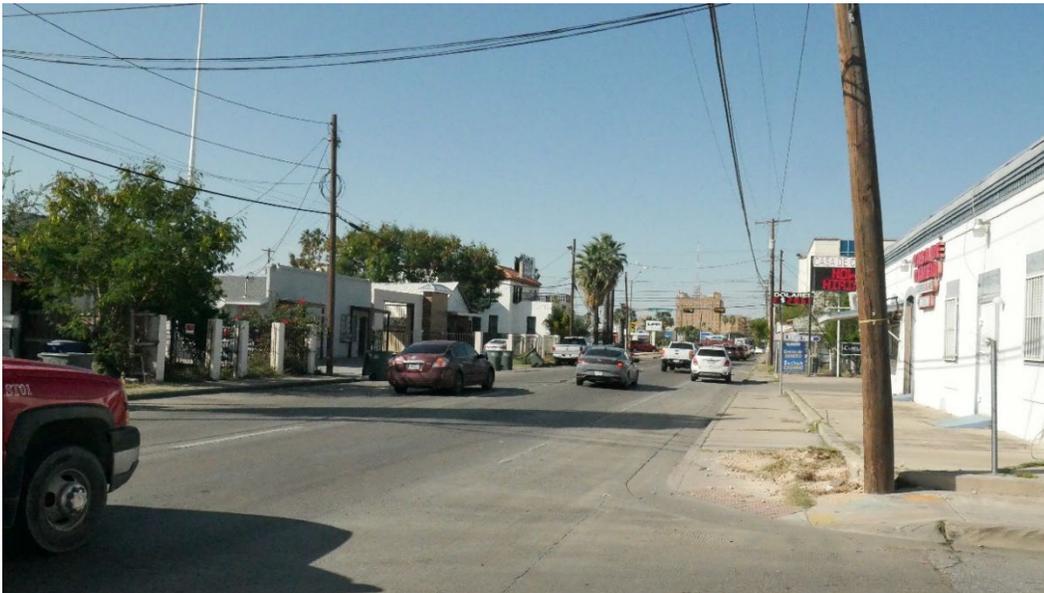
Advance signal warnings should be implemented before the San Eduardo Avenue because it is the first signal after a stretch of intersections without signalization.

Figure 51 - Approach to San Eduardo Avenue
