APPENDIX F

CAPITAL PLAN

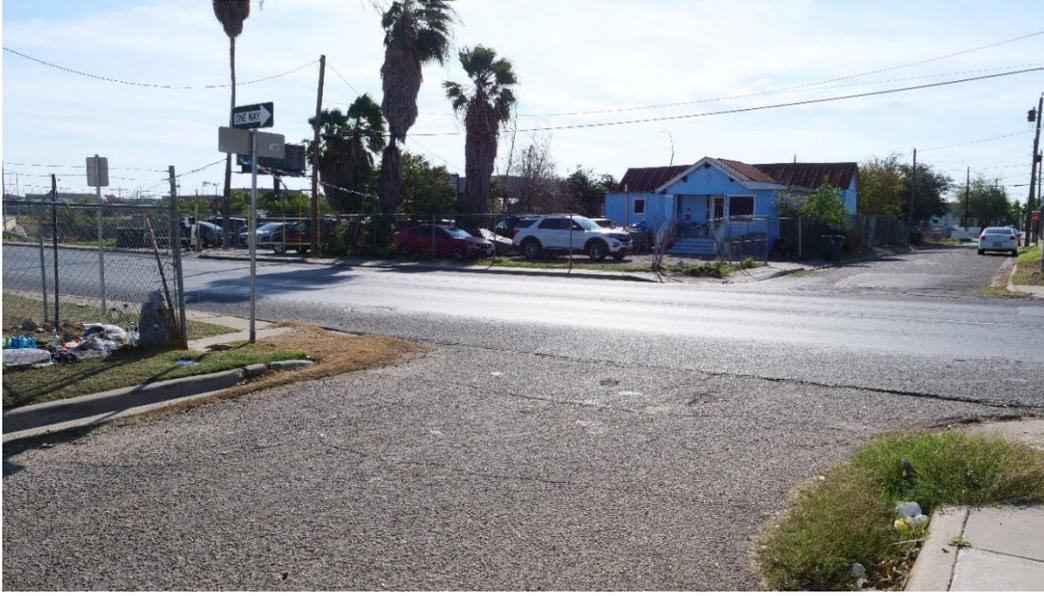
A pedestrian hybrid beacon and advance pedestrian warning should be installed in advance of the San Leonardo Avenue to serve Houston Park and the Zacate Creek linear park.

Figure 52 - Intersection of Houston Street and San Leonardo Avenue facing Houston Park

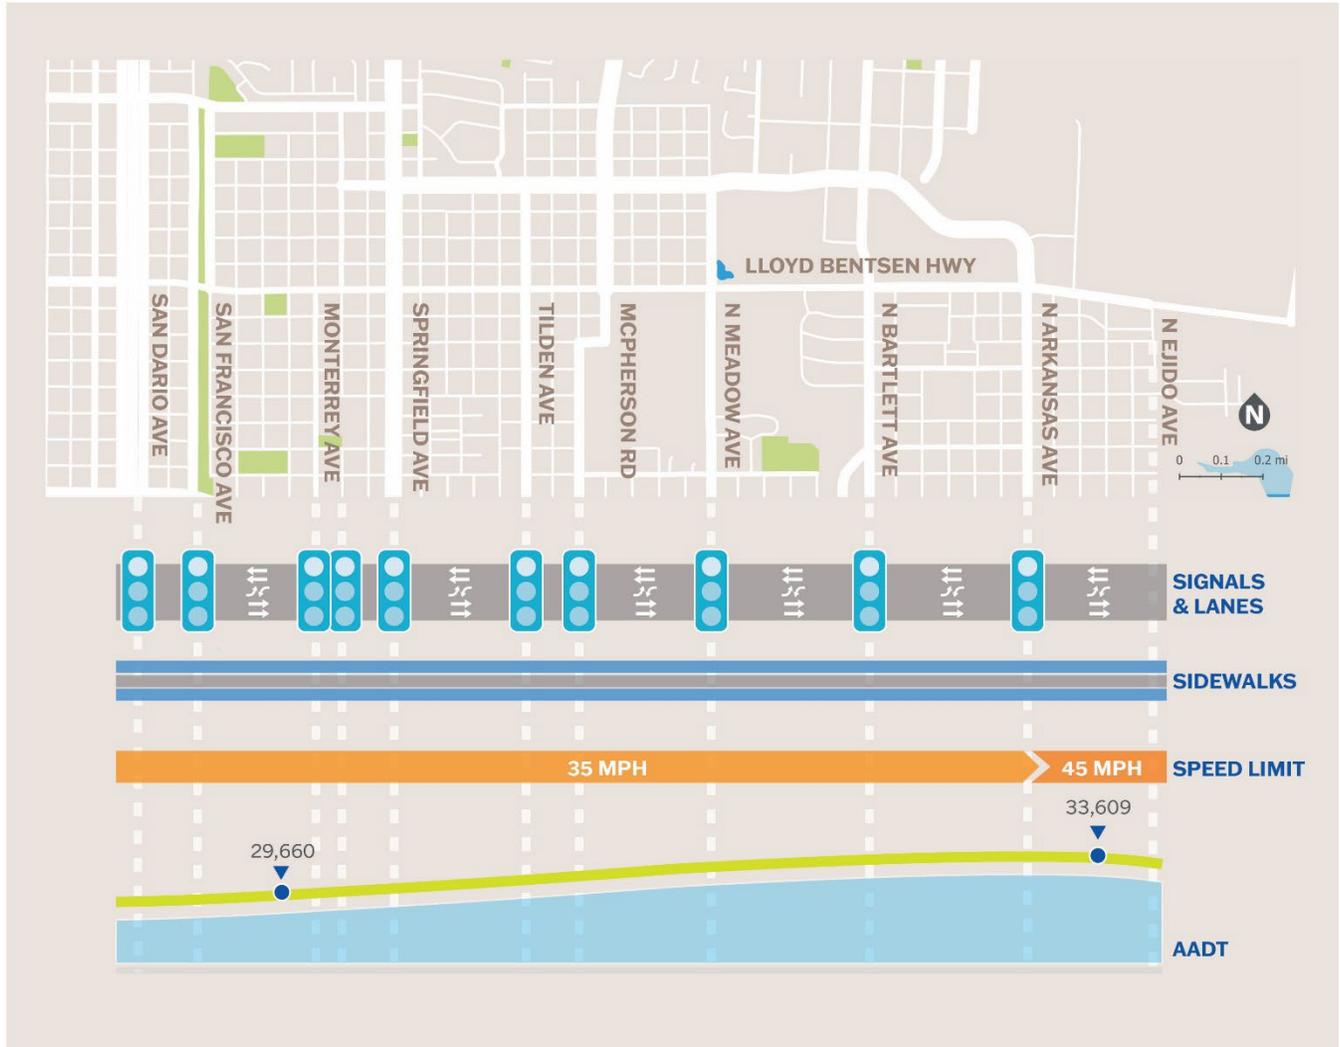
Figure 54 - Lloyd Bentsen Highway multimodal features

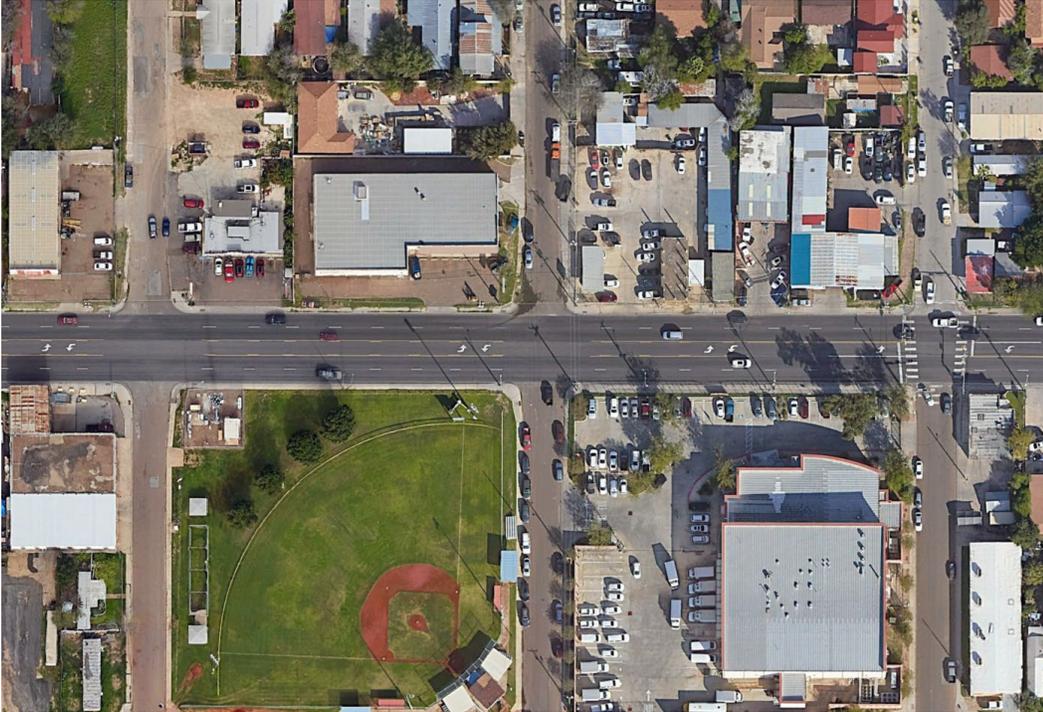
- Driveway consolidation and access management for commercial properties
- Implement a raised median or continue the hardened center line which currently exists between Buena Vista Avenue and Ejido Avenue
- Evaluating streetlights for adequate luminosity in areas where KSI crashes occurred at night

Figure 56 - High density of commercial access points and low density of pedestrian crossing opportunities

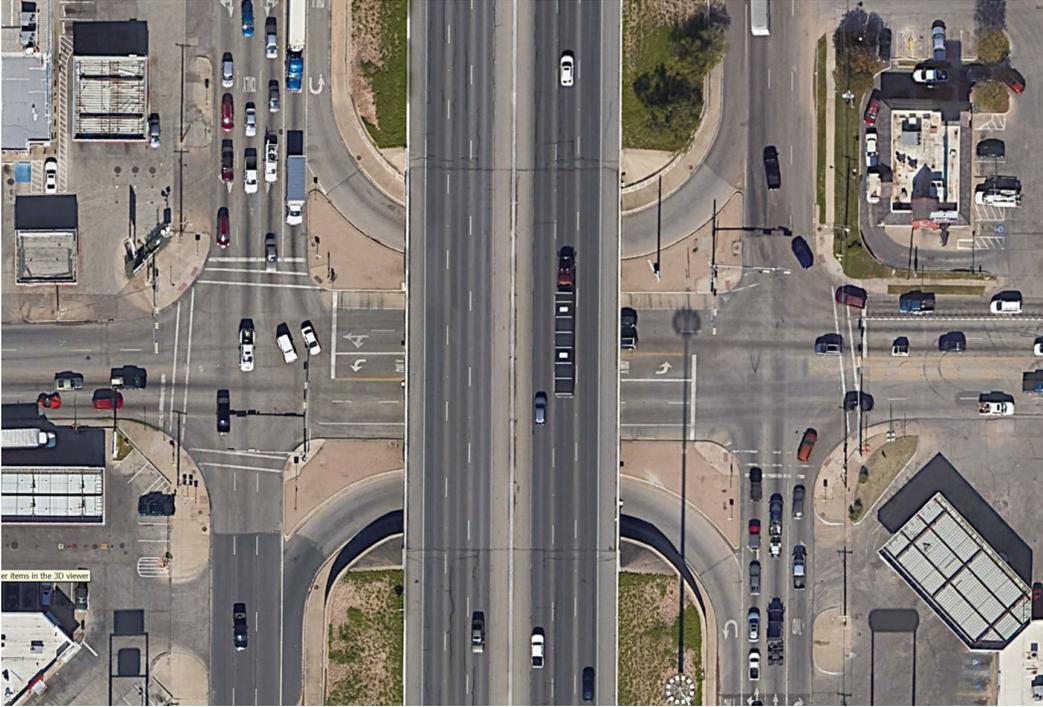
Figure 57 – Aerial view of interchange between Interstate 35 and Lloyd Bentsen Highway

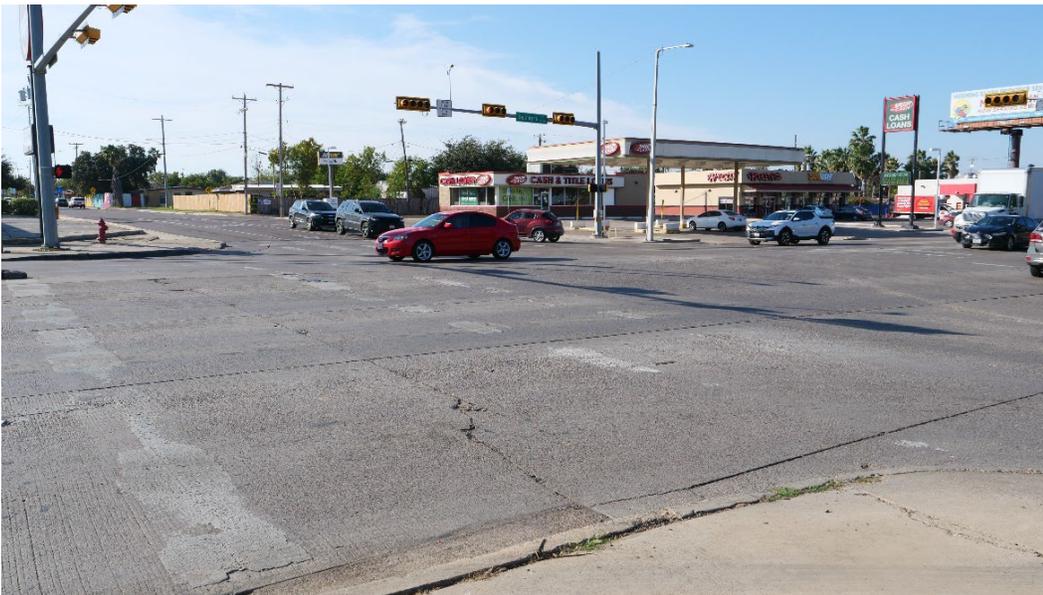
Figure 58 - Intersection of Lloyd Bentsen Highway and Bartlett Avenue

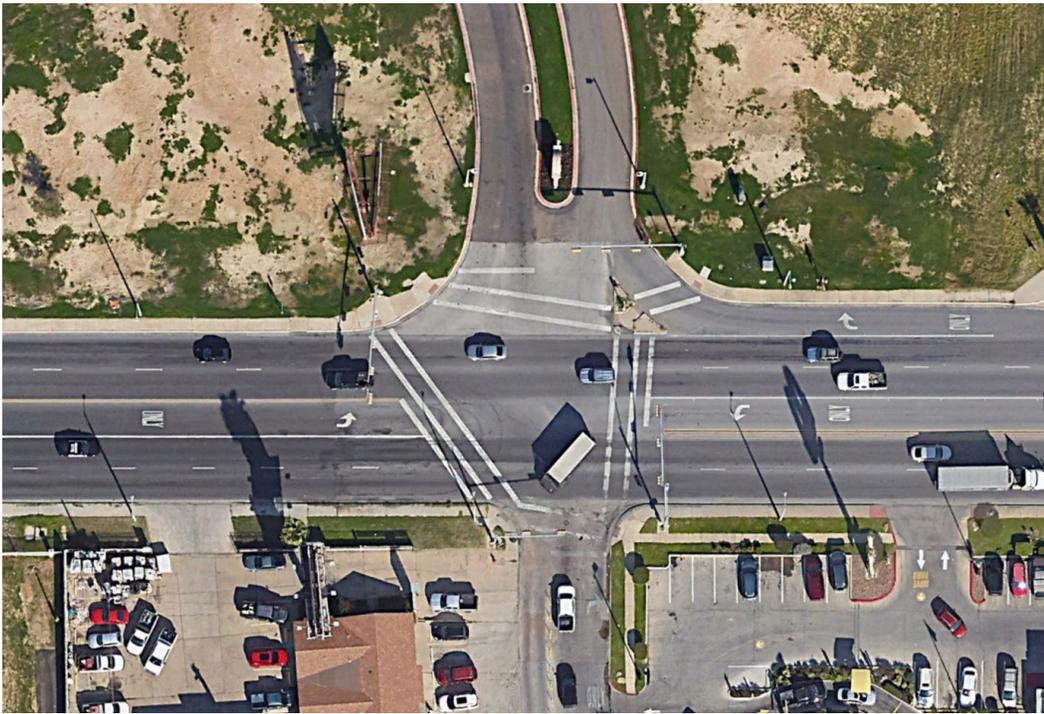
Buena Vista Avenue serves as an entrance to the Laredo Medical Center. Pedestrians are required to cross 100' of pavement, including a right-turn slip lane, and the lanes are misaligned from the lanes of Buena Vista Avenue across Lloyd Bentsen Highway. The intersection should be reconfigured to shorten the distance pedestrians are required to cross reduce vehicle speeds and driver confusion through the following countermeasures:

- Eliminate slip lane
- Advance median to provide pedestrian refuge

Figure 59 - Intersection of Lloyd Bentsen Highway and Buena Vista Avenue

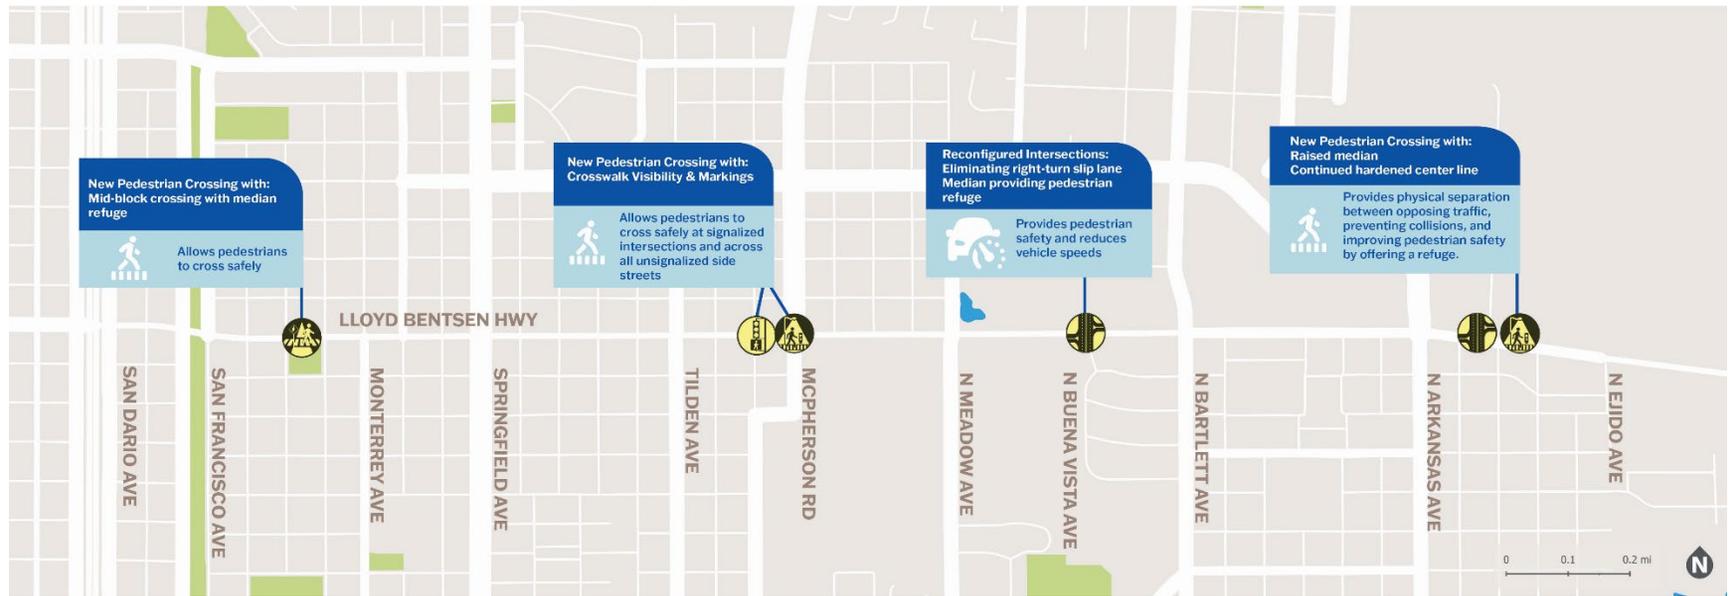
Figure 60 - Recommendations map of the Lloyd Bentsen Highway corridor

Countermeasure recommendations for the Lloyd Bentsen Highway corridor are summarized in Table 68 and Figure 60. Costs are based on TxDOT Bid Averages in fall of 2024 and project cost estimates from the 2025-2029 Laredo Capital Improvement Plan (CIP). Construction, engineering, and contingency are included in these costs. All assumptions are detailed in the Countermeasures Toolkit.

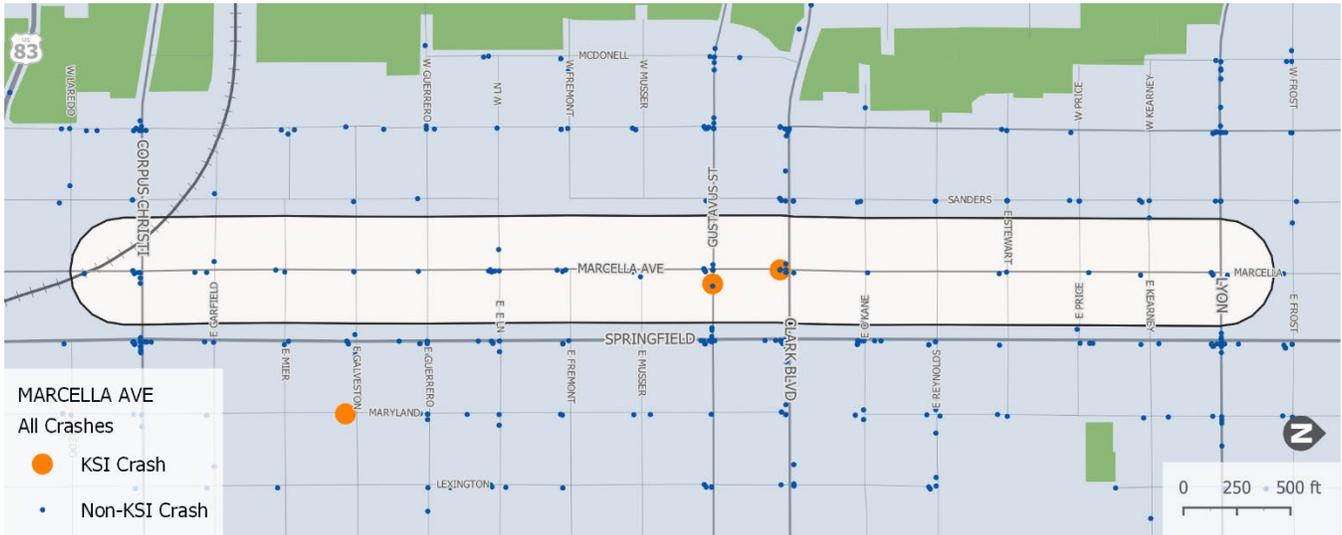
Figure 62 shows the spatial distribution of crashes in the Marcella Avenue corridor. It is apparent that most of the crashes occurred at intersections. The KSI crash shown on Gustavus Street was not included in this

corridor analysis. Gustavus Street and Clark Boulevard had the most crashes and are both characterized by stop control on Marcella Avenue with continuous flow of traffic on the cross streets. The only KSI crash recorded on the Marcella Avenue corridor occurred at the intersection with Clark Boulevard.

Figure 62 -Crash map of the Marcella Avenue corridor

Figure 62 -Crash map of the Marcella Avenue corridor 86

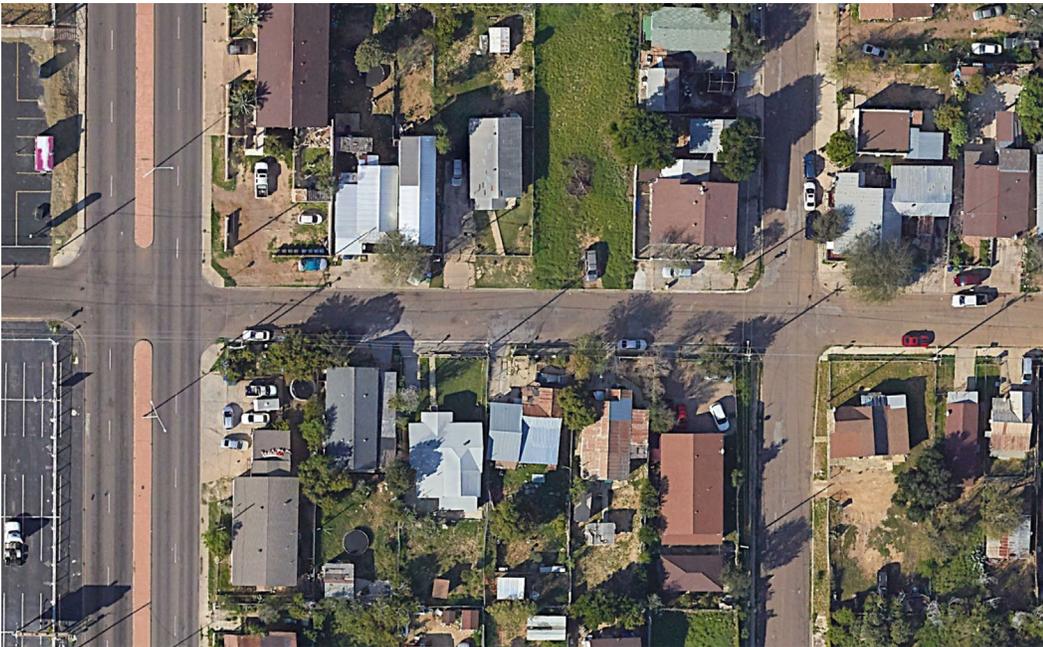
- Filling sidewalk gaps throughout the corridor
- Installing speed humps every block south of Clark Boulevard

Figure 63 - Example of sidewalk gaps on Marcella Avenue between Clark Boulevard and O'Kane Street

Figure 63 - Example of sidewalk gaps on Marcella Avenue between Clark Boulevard and O'Kane Street..... 88

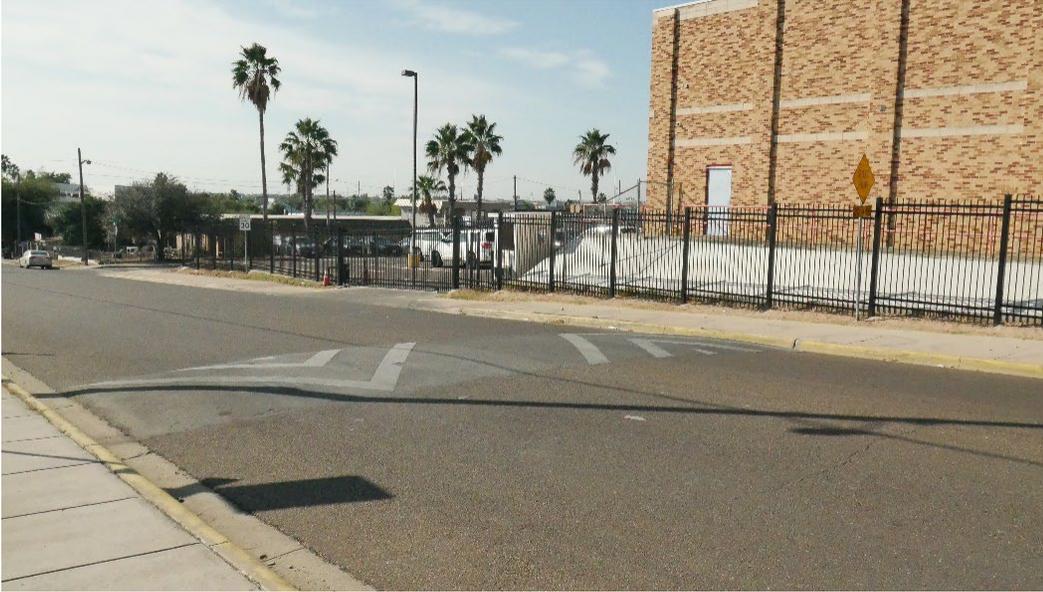
Figure 64 - Existing speed humps on Marcella Avenue adjacent to Memorial Middle School

Figure 64 - Existing speed humps on Marcella Avenue adjacent to Memorial Middle School..... 89

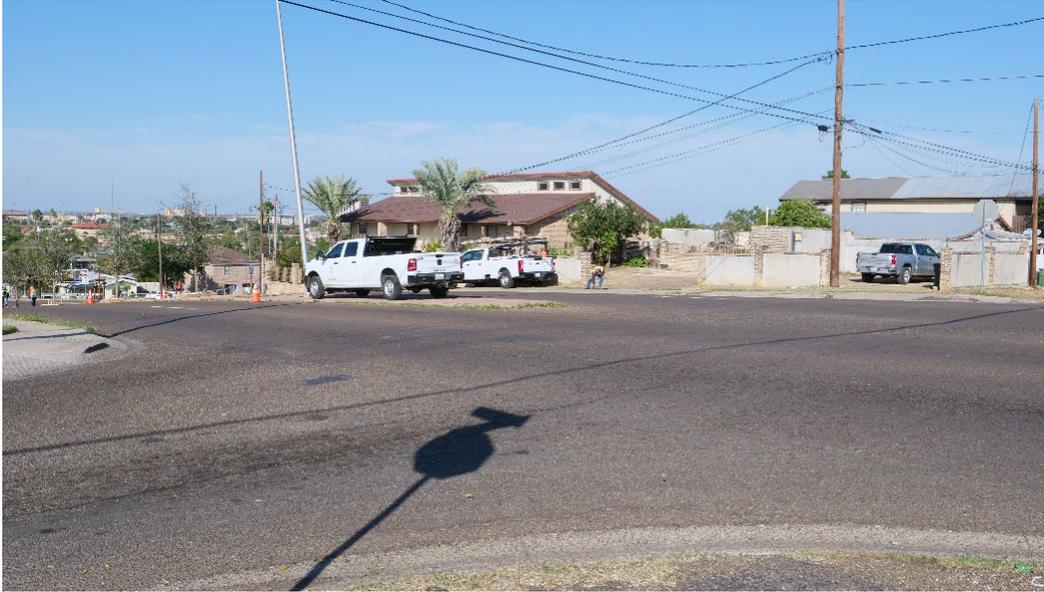
In the Marcella Avenue corridor, crashes happen primarily in intersections that are stop controlled along one street but not the other due to inattentiveness or failure to yield the right of way. Some countermeasures that can be implemented along the entire corridor to reduce these types of crashes include:

- Installing curb extensions at all side streets south of Clark Boulevard
- Installing/refreshing high-visibility crosswalks at signalized intersections, all-way stops, and major road crossings
- Neighborhood traffic circles at all intersections between O’Kane Street and Kearney Street
- Advance stop and signal warning signs

Figure 65 - Intersection of Marcella Avenue and Clark Boulevard

Figure 65 - Intersection of Marcella Avenue and Clark Boulevard..... 90

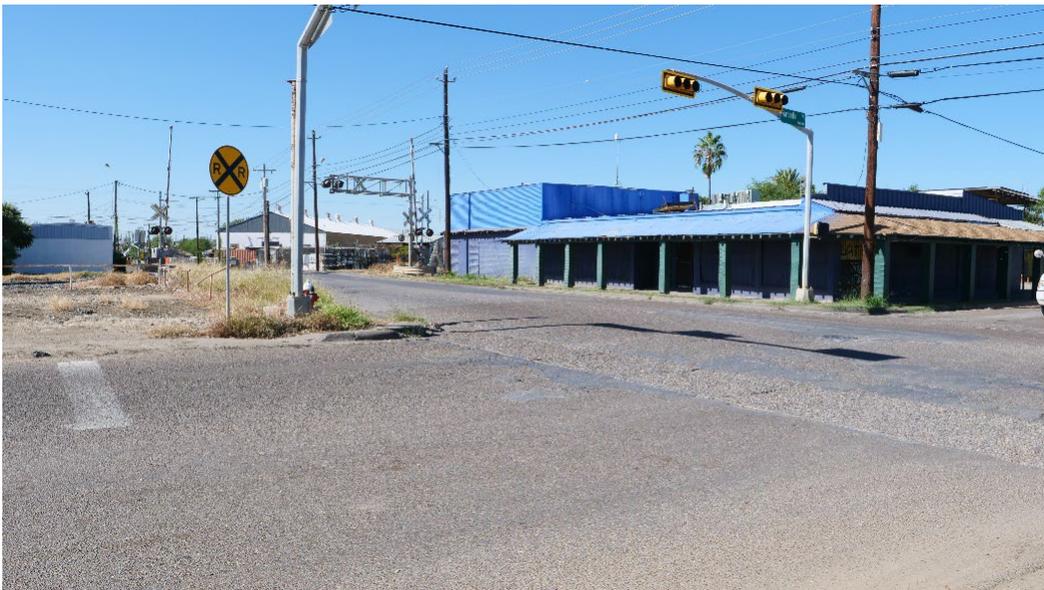
The Corpus Christi Street intersection is the only one along the studied segment of Marcella Avenue that is signalized. To improve safety at this intersection, the following countermeasures are recommended:

- Install pedestrian signalization
- Install ADA curb ramps on all corners

Figure 66 - Intersection of Marcella Avenue and Corpus Christi Street

Figure 66 - Intersection of Marcella Avenue and Corpus Christi Street..... 90

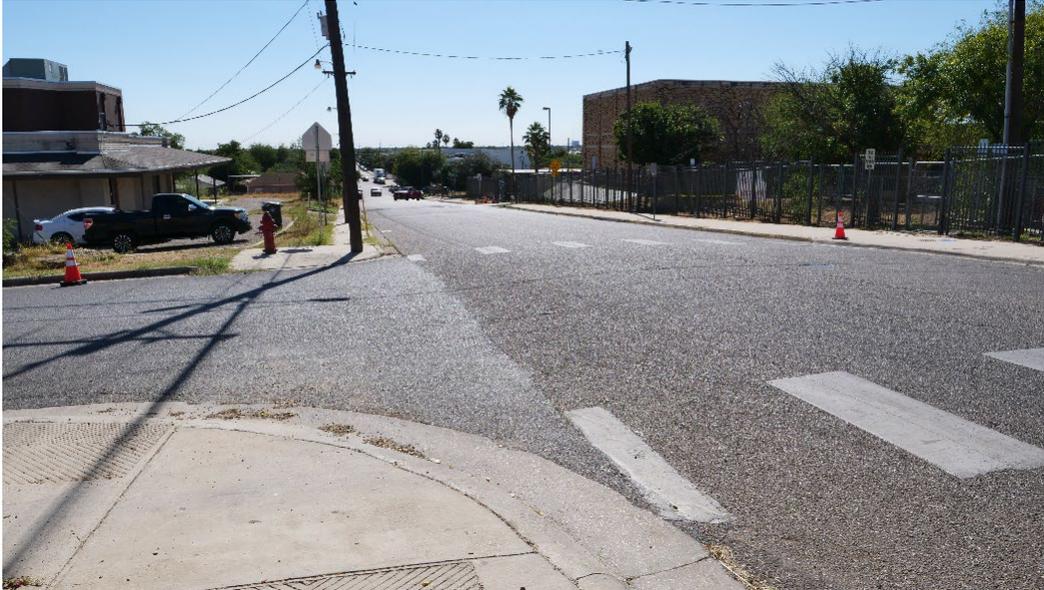
The Fremont Street intersection serves the main entrance to Memorial Middle School and should be made safer for students who are walking to school. Recommended countermeasures include:

- Installing raised crosswalks
- Installing a pedestrian hybrid beacon

Figure 67 - Intersection of Marcella Avenue and Fremont Street

Figure 67 - Intersection of Marcella Avenue and Fremont Street 91

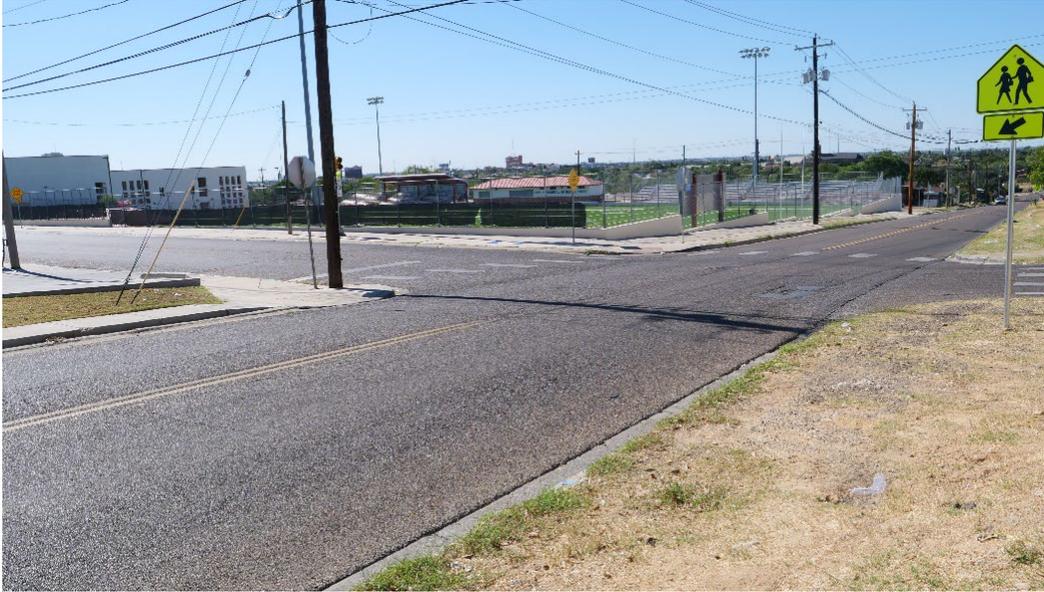
The Gustavus Street intersection experiences the most crashes of all the intersections along the corridor and is adjacent to Memorial Middle School. Many of the crashes in the intersection were due to drivers not yielding the right of way at the stop signs facing Marcella Avenue. It is recommended that the intersection be fully signalized to address driver inattention and to provide pedestrians with dedicated times to cross the street.

Figure 68 - Intersection of Marcella Avenue and Gustavus Street

Figure 68 - Intersection of Marcella Avenue and Gustavus Street 92

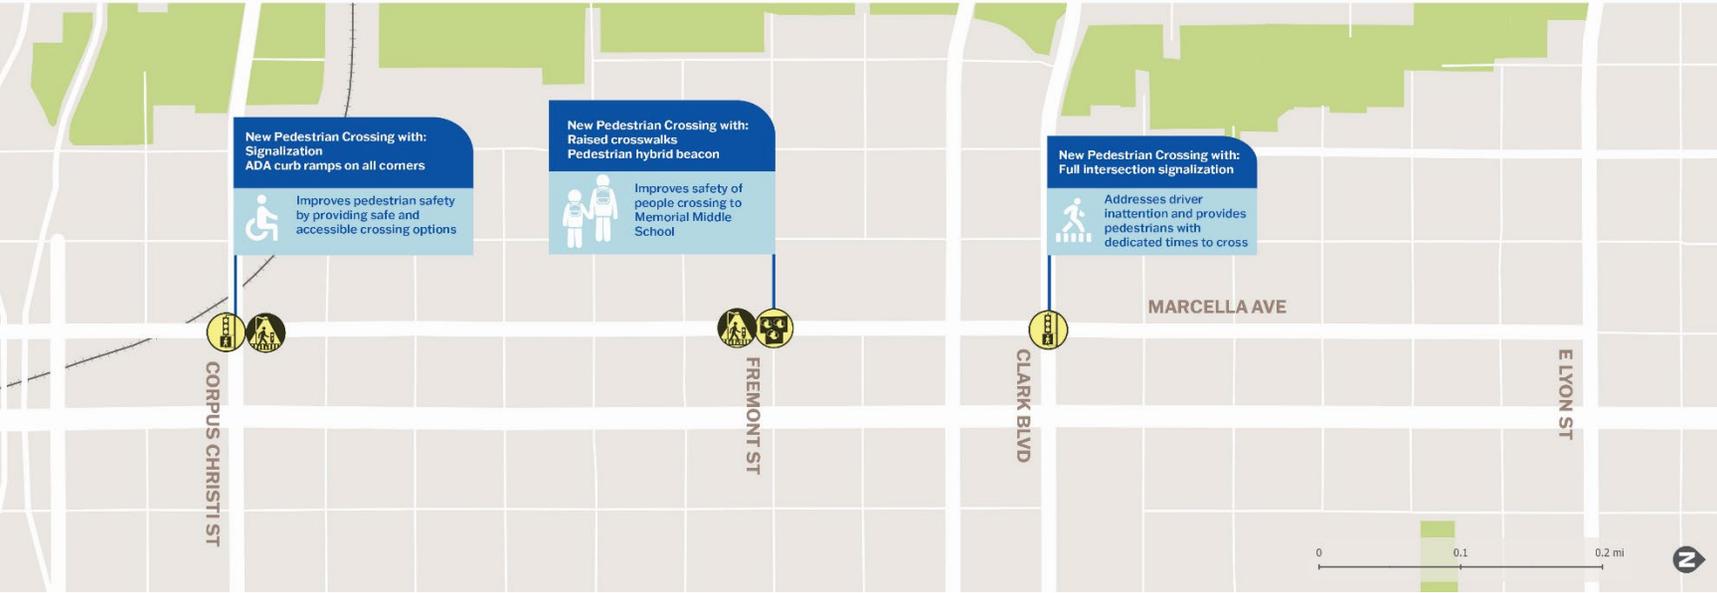
Figure 69 - Recommendations map of the Marcella Avenue corridor

Figure 69 - Recommendations map of the Marcella Avenue corridor 94

Countermeasure recommendations for the Marcella Avenue corridor are summarized in Table 77 and Figure 69. Costs are based on TxDOT Bid Averages in fall of 2024 and project cost estimates from the 2025-2029 Laredo Capital Improvement Plan (CIP). Construction, engineering, and contingency are included in these costs. All assumptions are detailed in the Countermeasures Toolkit.

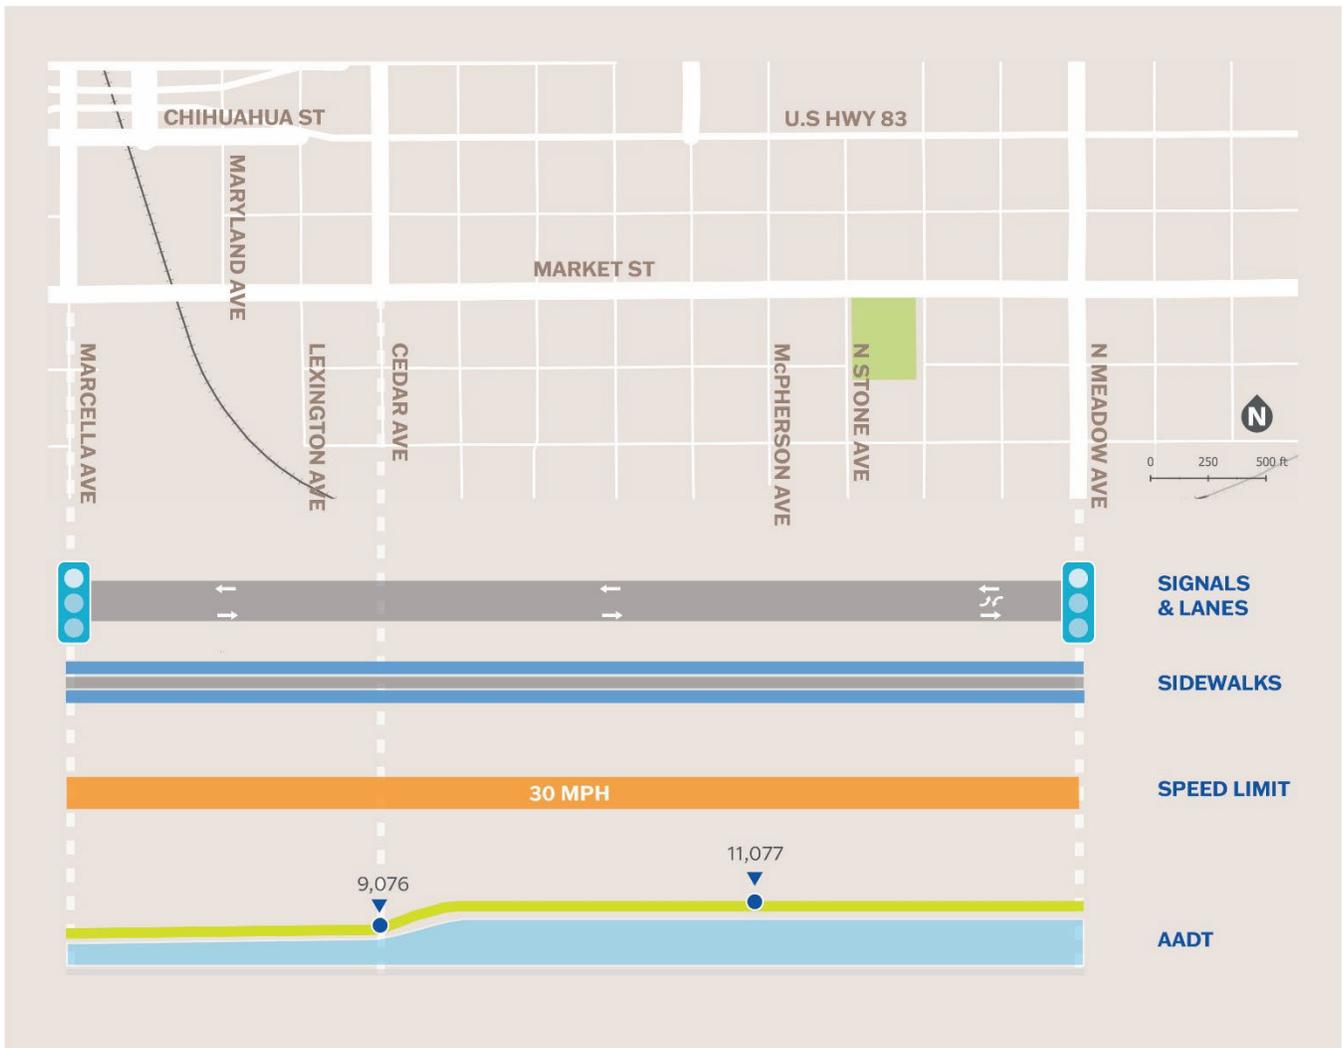
Figure 70 - Market Street multimodal roadway features

Figure 70 - Market Street multimodal roadway features..... 96

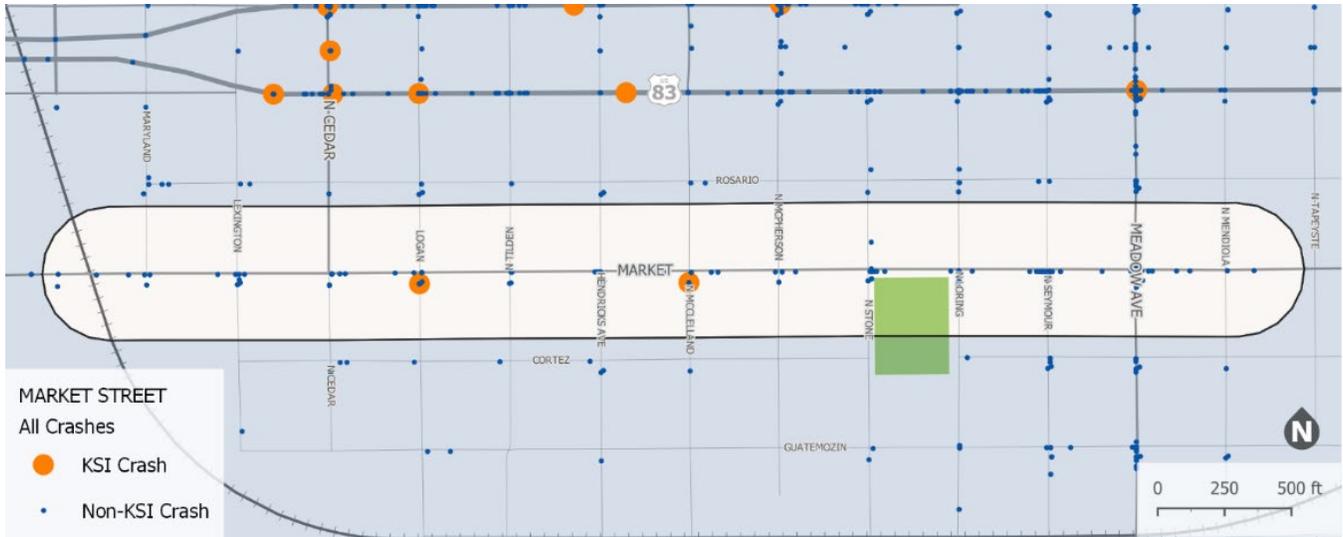
Figure 71 and Table 80 shows the spatial distribution of crashes in the Market Street corridor. Most of the crashes, including both KSI crashes, occurred at intersections. Among the top intersections, only the Meadow Avenue intersection is signalized, while all others are non-signalized. Notably, the two KSI crashes occurred at the Logan and McClelland intersections, both of which are non-signalized.

Figure 71 - Crash map of the Market Street corridor

Figure 71 - Crash map of the Market Street corridor..... 97

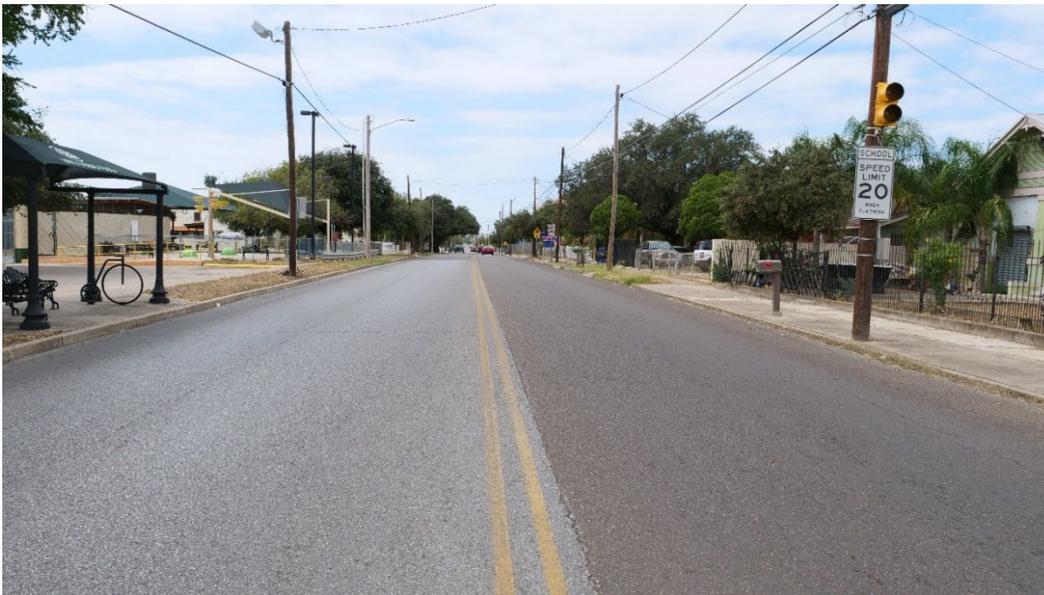
The analyzed segment of Market Street has a consistent width of 39 feet while having only two lanes of traffic for its majority. Wide lanes provide little friction for drivers, who will feel more comfortable going a faster speed as a result, putting pedestrians and bikers at risk. Some of this extra width can be converted to bike and pedestrian facilities to improve comfort for those outside of their vehicles. The following countermeasures are recommended for the mid-block segments of this corridor:

- Separated bike lanes
- Wider sidewalks
- Improved, pedestrian scale lighting

Figure 72 - Example of excessive width of Market Street in residential segment

Figure 72 - Example of excessive width of Market Street in residential segment 99

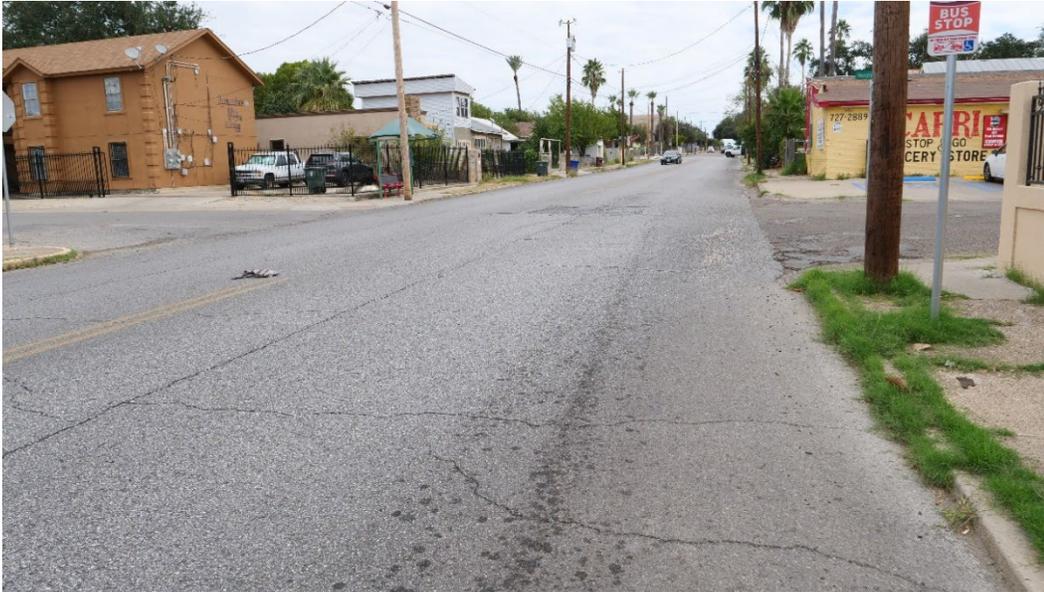
More than 90% of all crashes occurred at an intersection. Most of the intersections along this corridor are unsignalized and provide no markings delineating space for people outside of cars. Hights Elementary and the George Pappas Tennis Center attract pedestrians in the community, and ample infrastructure should be installed to make crossing Market Street safer. Recommended countermeasures include:

- Refresh intersection striping
- Curb bump-outs at all side streets
- LPIs at all signalized intersections

Figure 73 - Typical intersection in residential segment of Market Street

Figure 73 - Typical intersection in residential segment of Market Street..... 100

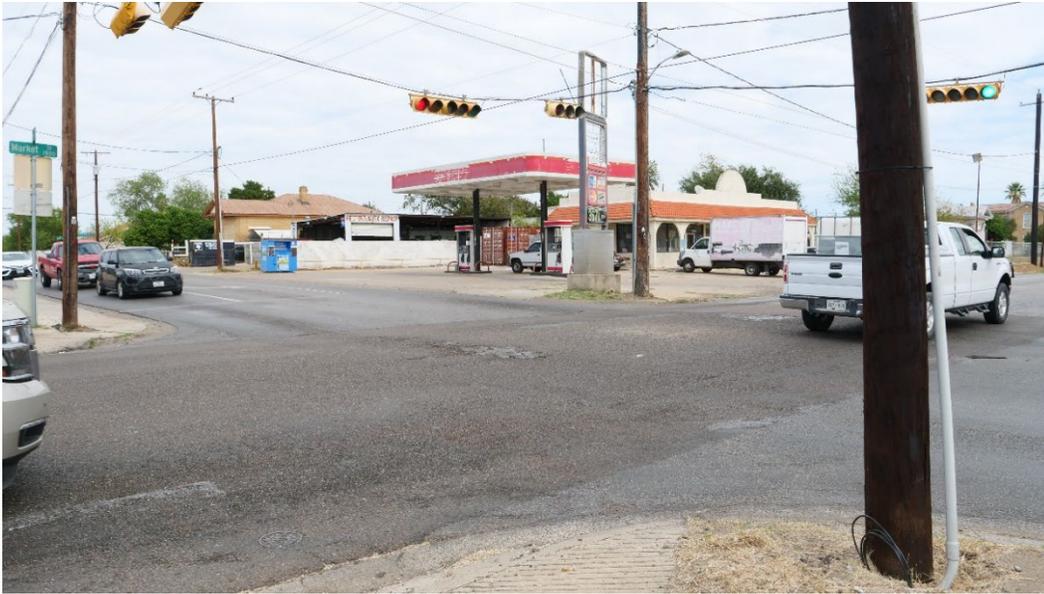
Along with Seymour Avenue, Meadow Avenue is a focal point for traffic crossing Market Street. Seymour Avenue appears to have received some improvements recently, and similar improvements should be implemented at Meadow Avenue, such as:

- Reflective backplates on Meadow Ave signals
- Pedestrian signalizations

Figure 74 - Intersection of Market Street and Meadow Avenue

Figure 74 - Intersection of Market Street and Meadow Avenue 101

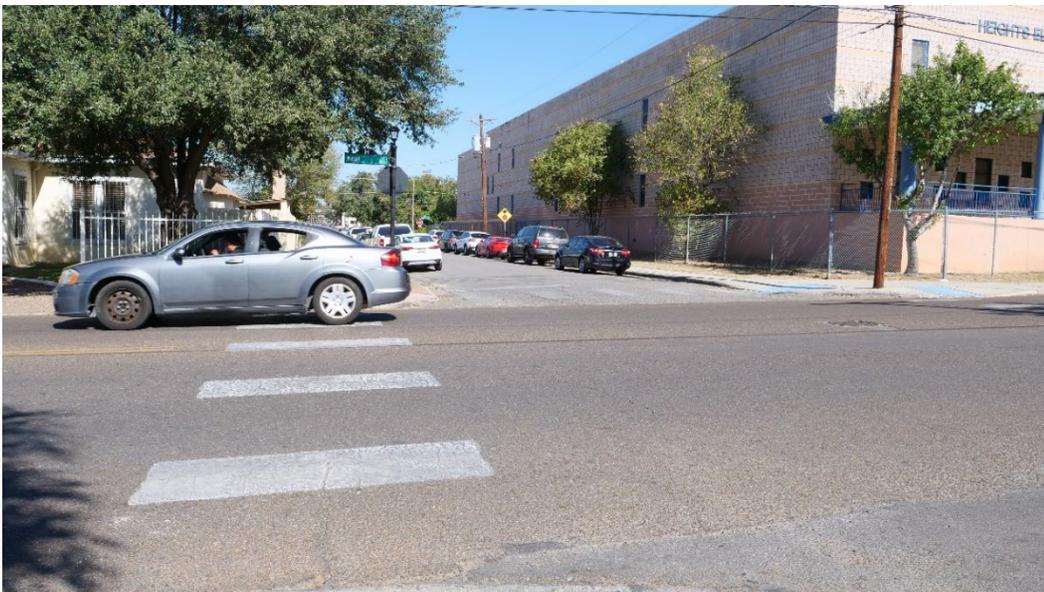
The McPherson Avenue intersection leads to the Heights Elementary School entrance and should be treated as a focal point for especially vulnerable pedestrian traffic. The following recommendations should be implemented to protect children walking to and from school:

- Pedestrian Hybrid Beacon
- Raised crossings
- Advanced stop signage

Figure 75 - Intersection of McPherson Avenue and Market Street

Figure 75 - Intersection of McPherson Avenue and Market Street..... 101

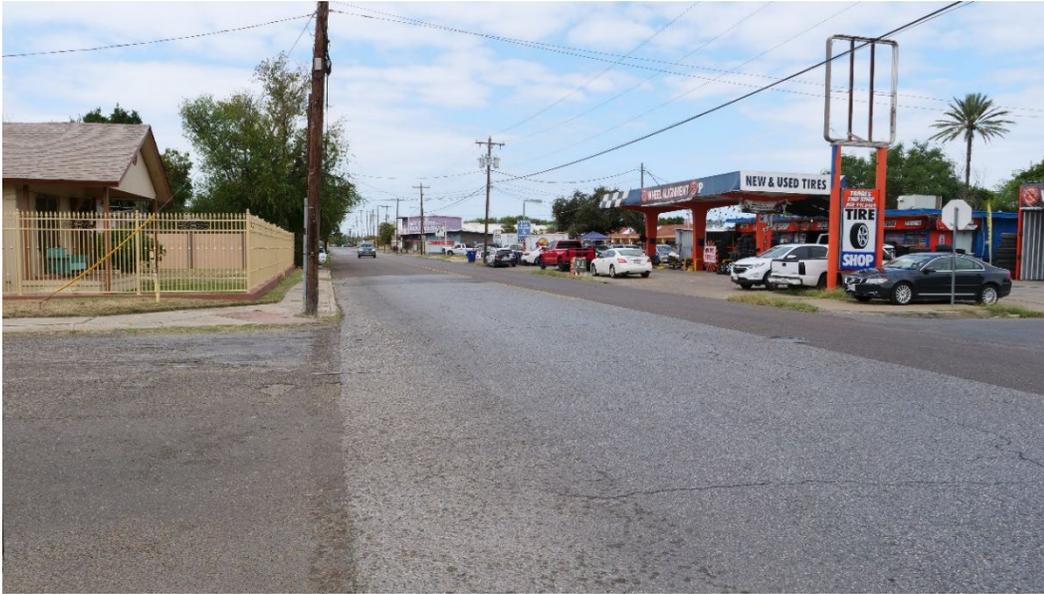
Cedar Avenue is located at the interface between residential and commercial areas of the neighborhood. As such, it should provide a safe and comfortable crossing option for people outside of cars and signal a change in neighborhood context to drivers. The following countermeasures should be implemented here:

- Pedestrian Hybrid Beacon
- High visibility crosswalk

Figure 76 - Intersection of Market Street and Cedar Avenue

Figure 76 - Intersection of Market Street and Cedar Avenue..... 102

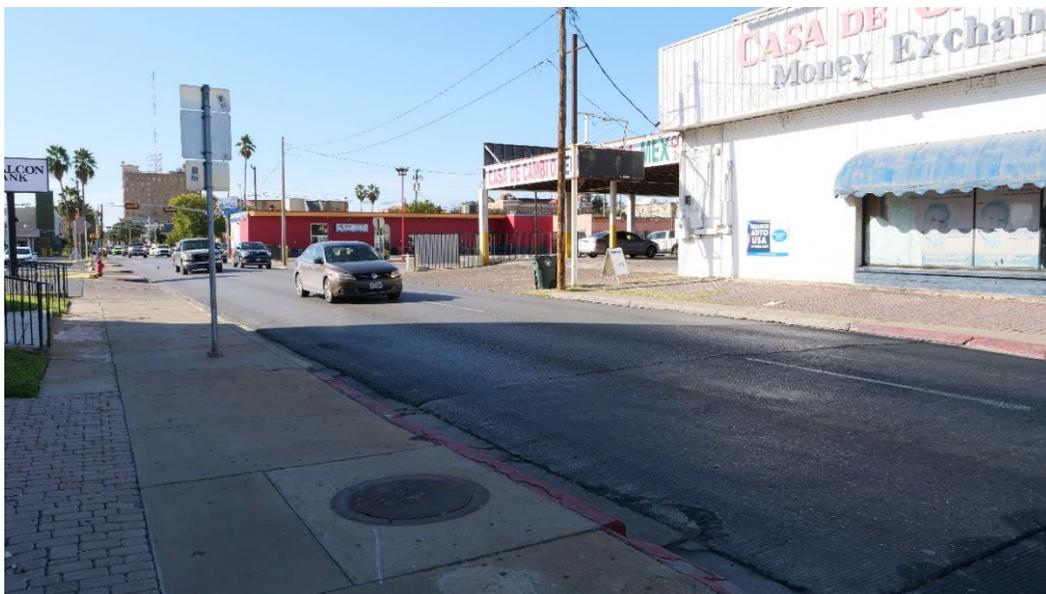
Matamoros Street has been identified as a corridor to proactively implement bicycle infrastructure in the TxDOT Laredo Bike Plan, and there is enough pavement width to install a bicycle lane, which will narrow the pavement and cause more friction to drivers, who will therefore be encouraged to maintain safer speeds, as well as protect pedestrians and cyclists.

Figure 80 - Typical width of Matamoros Street

Figure 80 - Typical width of Matamoros Street..... 108

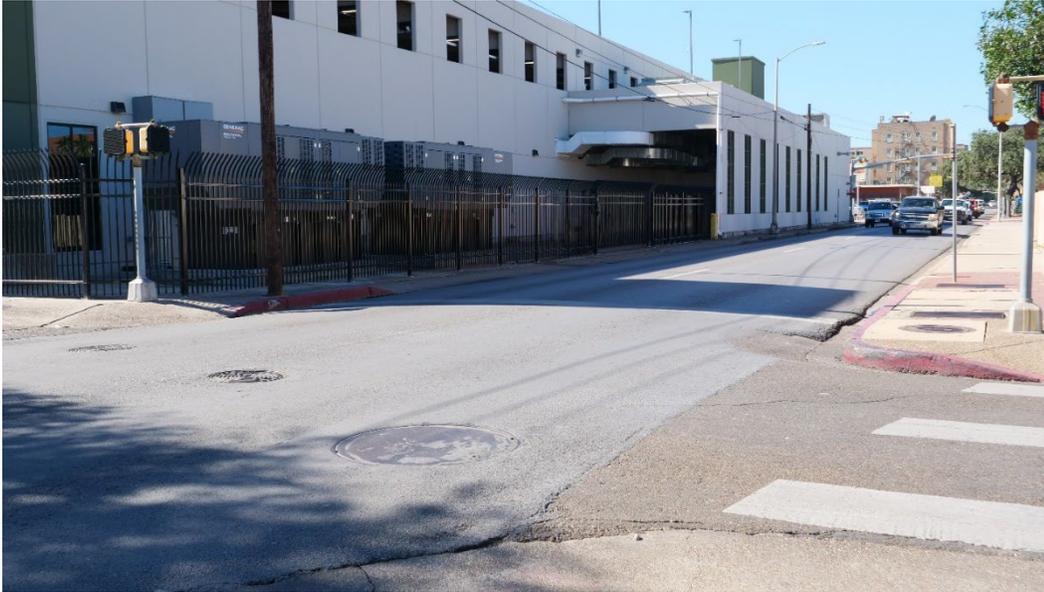
Most crashes along the Matamoros Street corridor occur in or near intersections, so it is important that improvements be made at each intersection to improve their safety. The following countermeasures are recommended for all applicable intersections along the corridor:

- Install and refresh high-visibility crosswalks at all signalized intersections
- Implement leading pedestrian intervals at all signalized intersections
- Install ADA compliant curb ramps

Figure 81 - Intersection of Matamoros Street and San Agustin Avenue

Figure 81 - Intersection of Matamoros Street and San Agustin Avenue..... 109

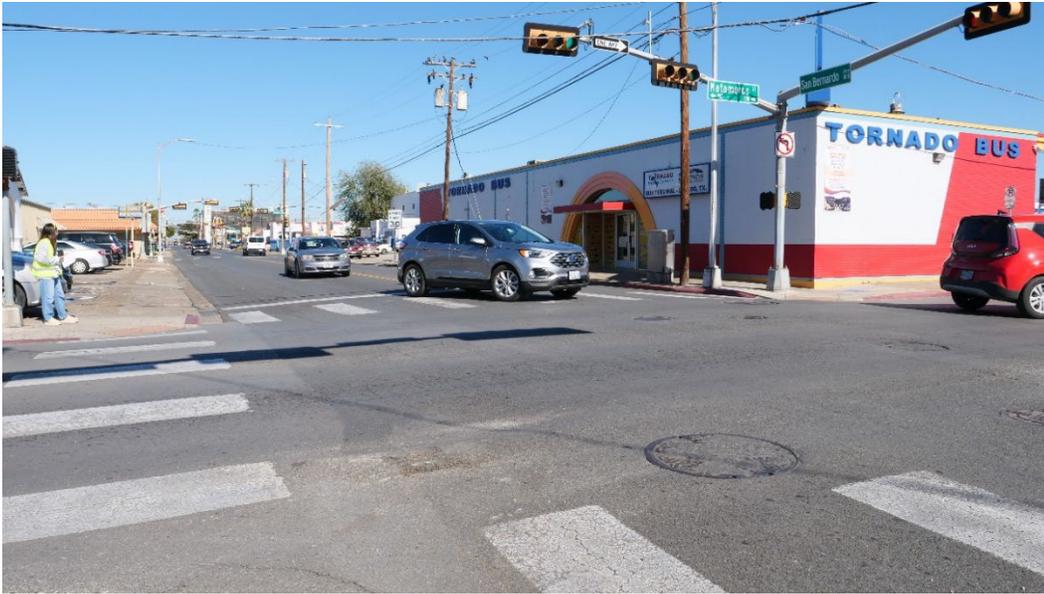
San Bernardo Avenue is a two-lane street with 36 feet of pavement width. Curb extensions should be implemented here to slow turning cars down and shorten the distance required to cross for pedestrians.

Figure 82 - Intersection of San Bernardo Avenue and Matamoros Street

Figure 82 - Intersection of San Bernardo Avenue and Matamoros Street 110

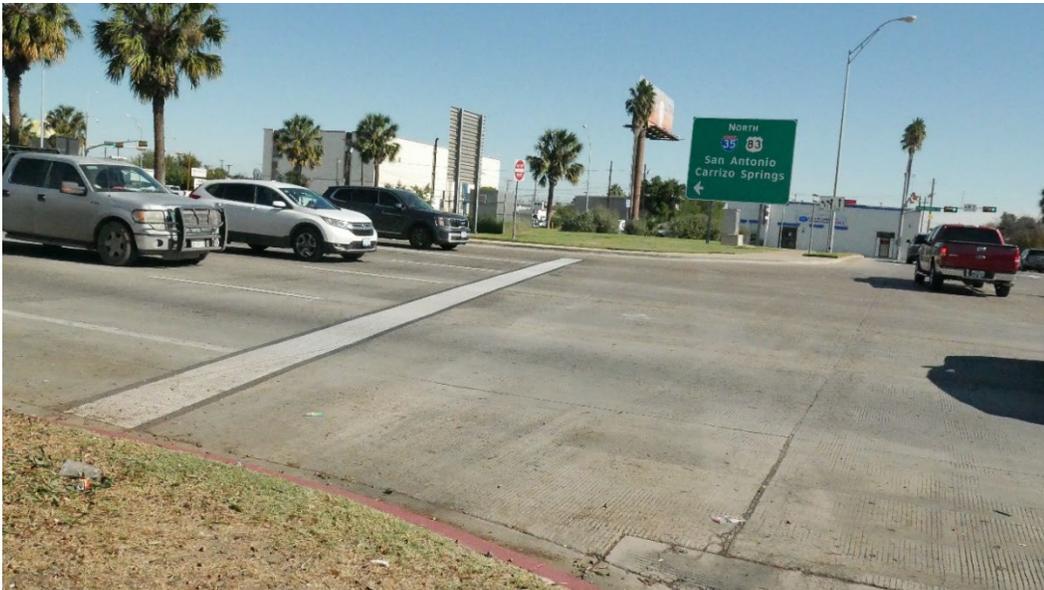
Santa Ursula Avenue serves as the terminus of IH-35 and has a wide cross section of four through lanes, a left turn lane, and a wide shoulder on the right side of the road. It also does not have a crosswalk on the north leg of the intersection. Countermeasure recommendations for the Santa Ursula Avenue intersection with Matamoros Street are:

- Install pedestrian signal heads addressing all legs of the intersection
- Install curb extensions in the left turn lane and shoulder of Santa Ursula Avenue and shift traffic accordingly

Figure 83 - Intersection of Santa Ursula Avenue and Matamoros Street

Figure 83 - Intersection of Santa Ursula Avenue and Matamoros Street..... 110
