APPENDIX F

CAPITAL PLAN

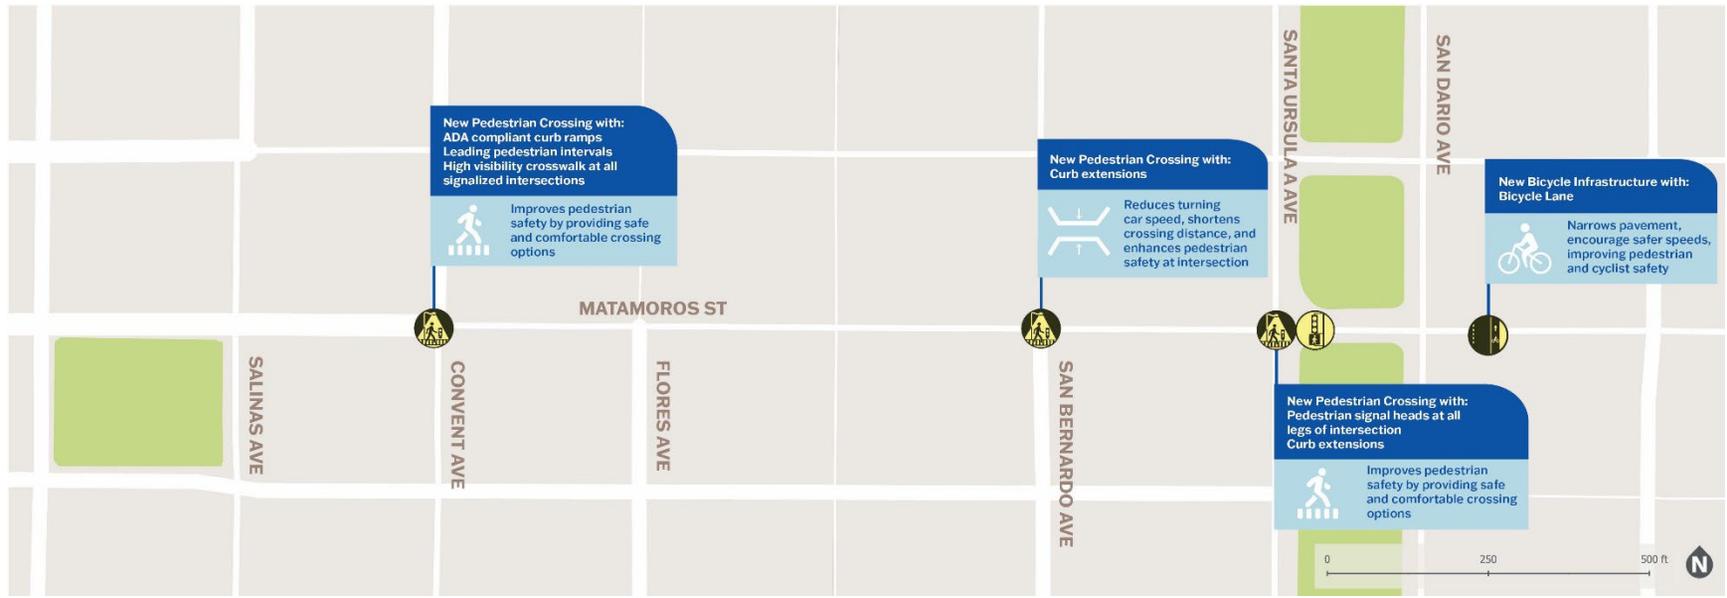
Figure 84 - Recommendations map of the Matamoros Street Corridor

Figure 84 - Recommendations map of the Matamoros Street Corridor 112

Countermeasure recommendations for the Matamoros Street corridor are summarized in Table 95 and Figure 84. Costs are based on TxDOT Bid Averages in fall of 2024 and project cost estimates from the 2025-2029 Laredo Capital Improvement Plan (CIP). Construction, engineering, and contingency are included in these costs. All assumptions are detailed in the Countermeasures Toolkit.

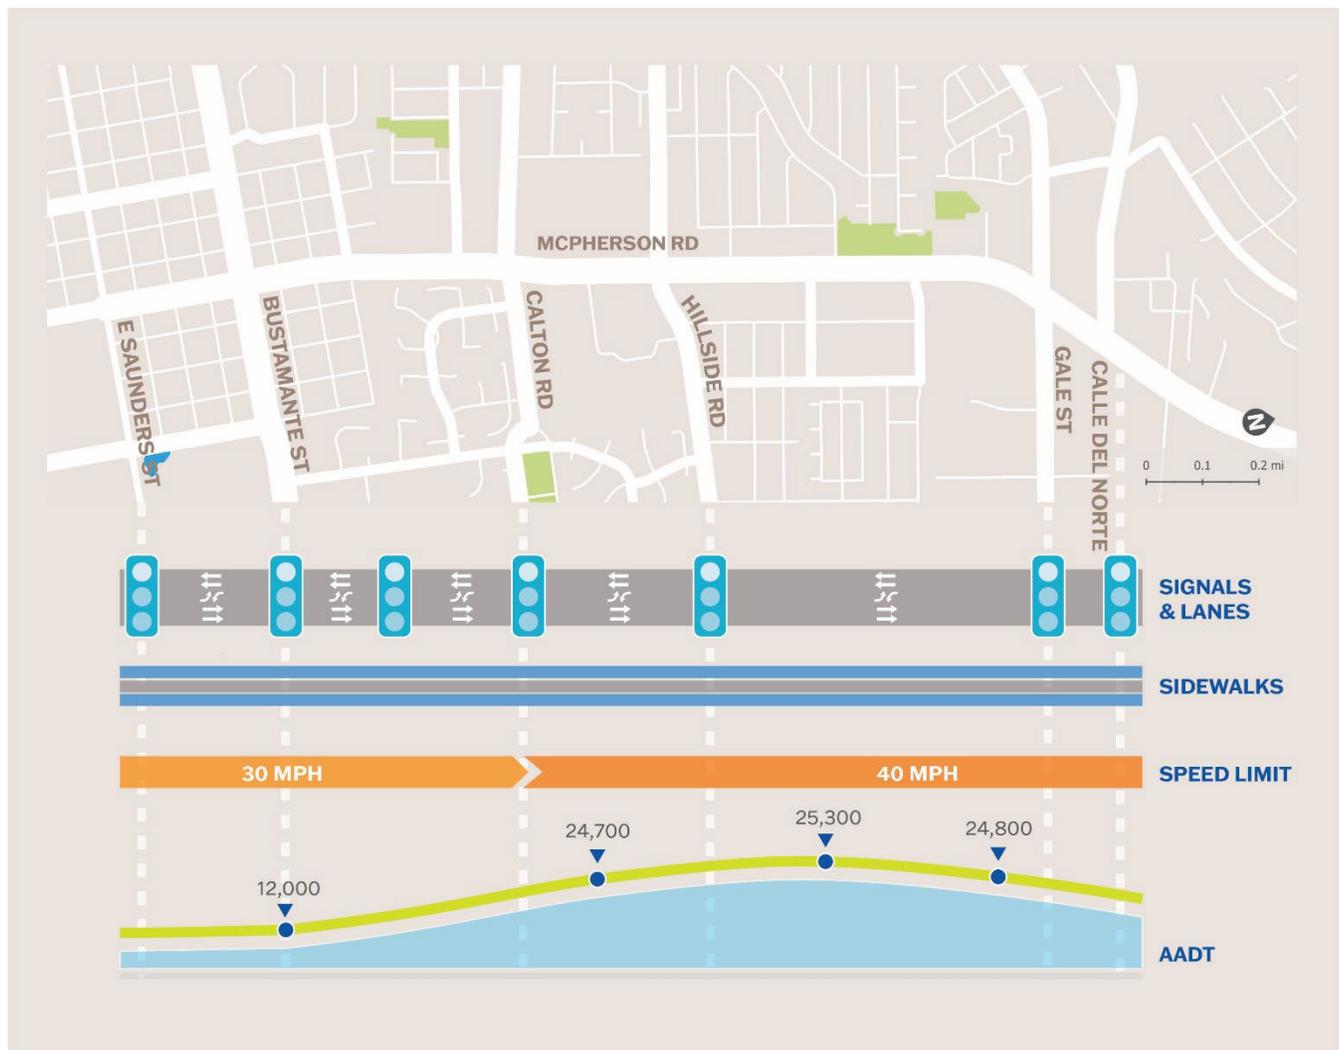
McPherson Road, running south to north between E Saunders St and Calle del Norte, is an urban principal arterial fronted by commercial uses such as strip malls, gas stations, restaurants, and auto mechanics. McPherson Road has four lanes with a two-way left turn lane for the entire length of the corridor from East Saunders Road to Calle del Norte, a stretch of 1.8 miles. The speed limit is 30 mph from East Saunders Road to East Calton Road and 40 mph from East Calton Road to Calle del Norte. The typical pavement width of McPherson Road is 82 feet and the right-of-way varies from 80 to 120 feet. AADT along this corridor varies from 12,000 in the south to 25,000 in the north, as shown in Figure 85.

Figure 85 - McPherson Road multimodal features

Figure 85 - McPherson Road multimodal features 114

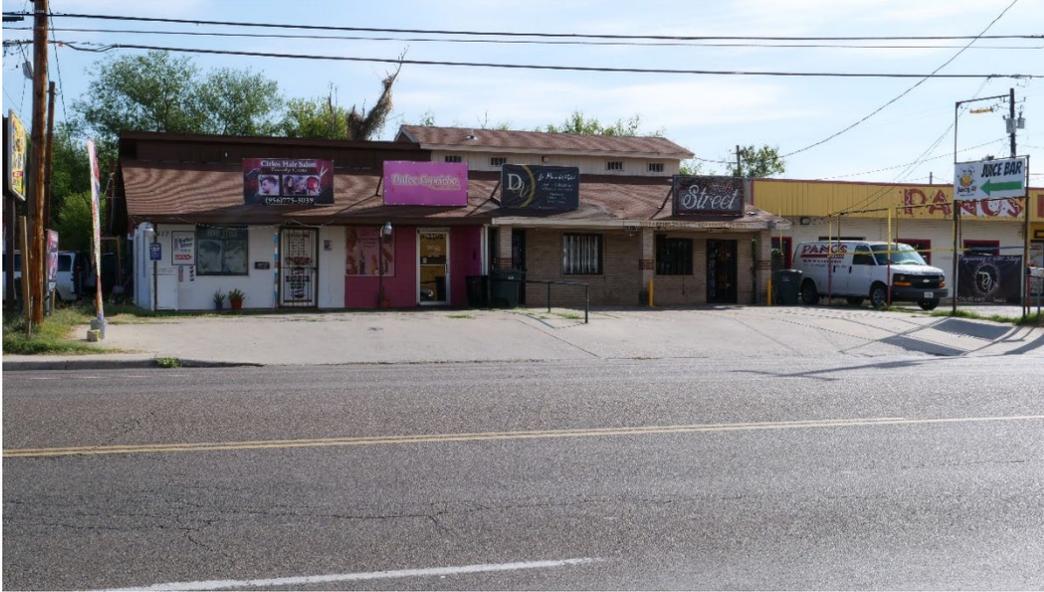
- Reevaluate speed limits along the corridor
- Install dynamic speed feedback signs to reduce speeding
- Convert the center two-way left turn lane (TWLTL) to a raised median
- Consolidate and minimize access points to reduce the occurrence of rear end, private drive, and backing collisions

Figure 87 - Businesses with parking lots backing onto McPherson Road

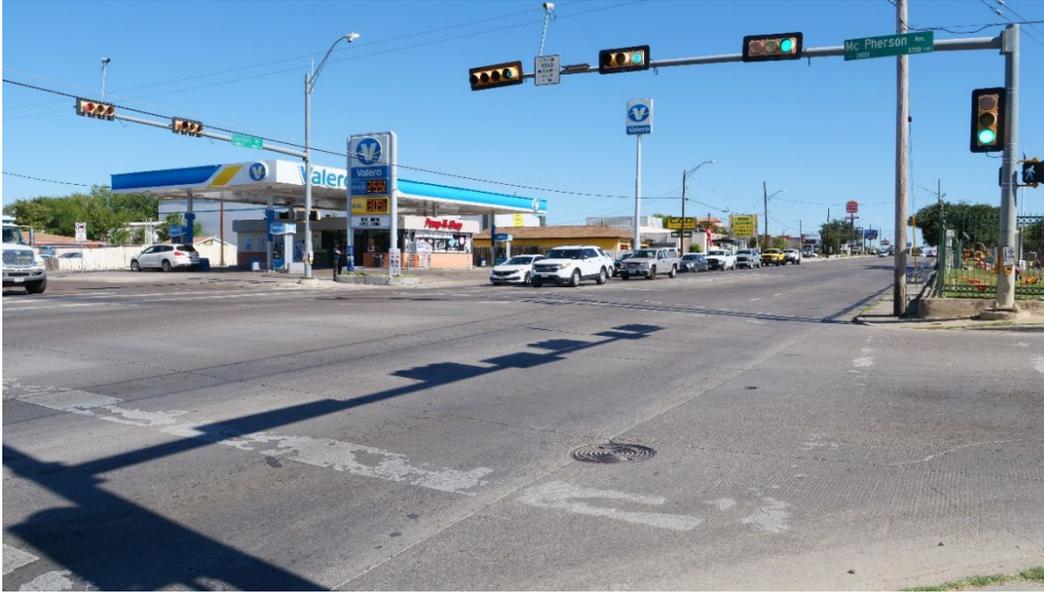
Figure 90 - Intersection of McPherson Road and East Saunders Road

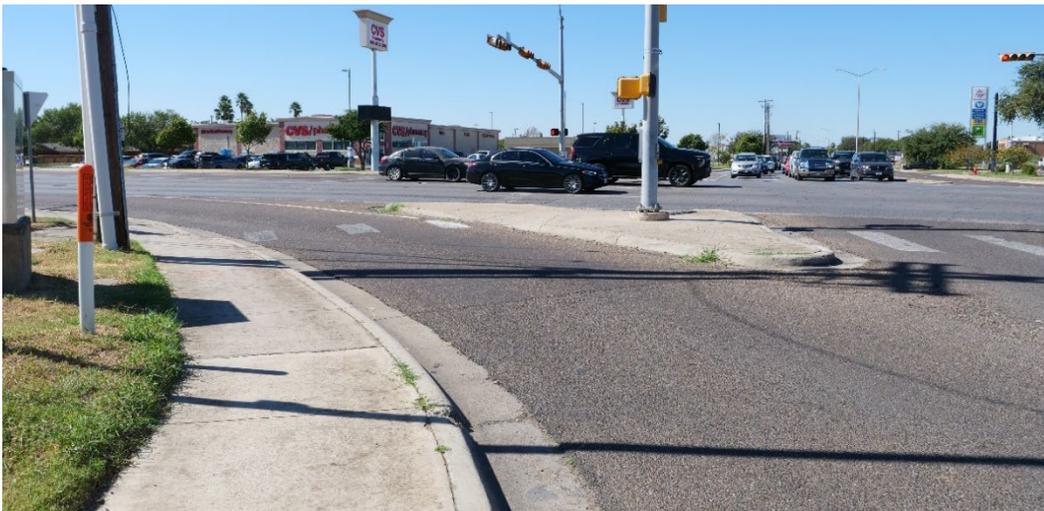
The East Calton Road intersection has faded high-visibility crosswalk markings and right-turn channelization, making for an uncomfortable pedestrian experience. The following countermeasures are recommended for the East Calton Road intersection:

- Refresh crosswalk striping.
- Install pedestrian refuges at the median of each leg of the intersection to minimize pedestrians' time spent in the travel lanes.
- Remove or modify right-turn channelization islands to increase pedestrian visibility for turning vehicles.
- Install advance yield pavement markings before crosswalks in the channelized right turn lane.

Figure 91 - Intersection of McPherson Road and East Calton Road

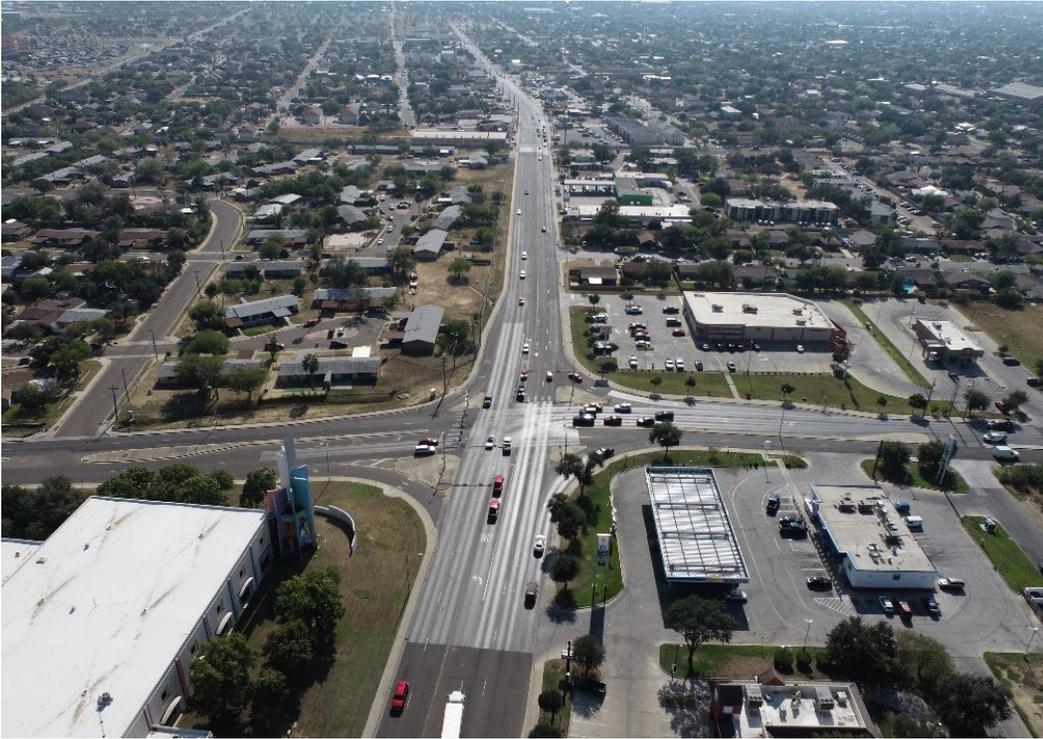
Figure 92 - Aerial view of the intersection of McPherson Road and East Calton Road

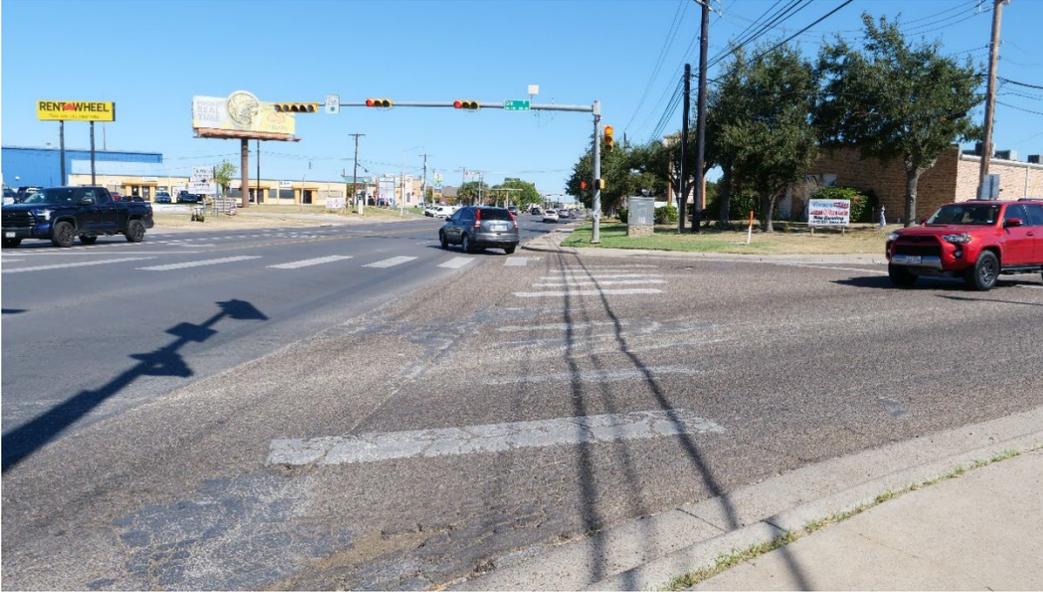
Gale Road and McPherson Road cross each other at a skewed angle. In its current configuration, the pedestrian crossings of the north and south legs of the intersection are not orthogonal to McPherson Road, making for a long distance needed to cross. The following countermeasures are recommended for the Gale Road intersection:

- Reconfigure the intersection to provide a pedestrian refuge when crossing McPherson.
- Bring the crossings to right angles to minimize time spent by pedestrians in the travel lanes.

Figure 93 - Intersection of McPherson Road and Gale Street

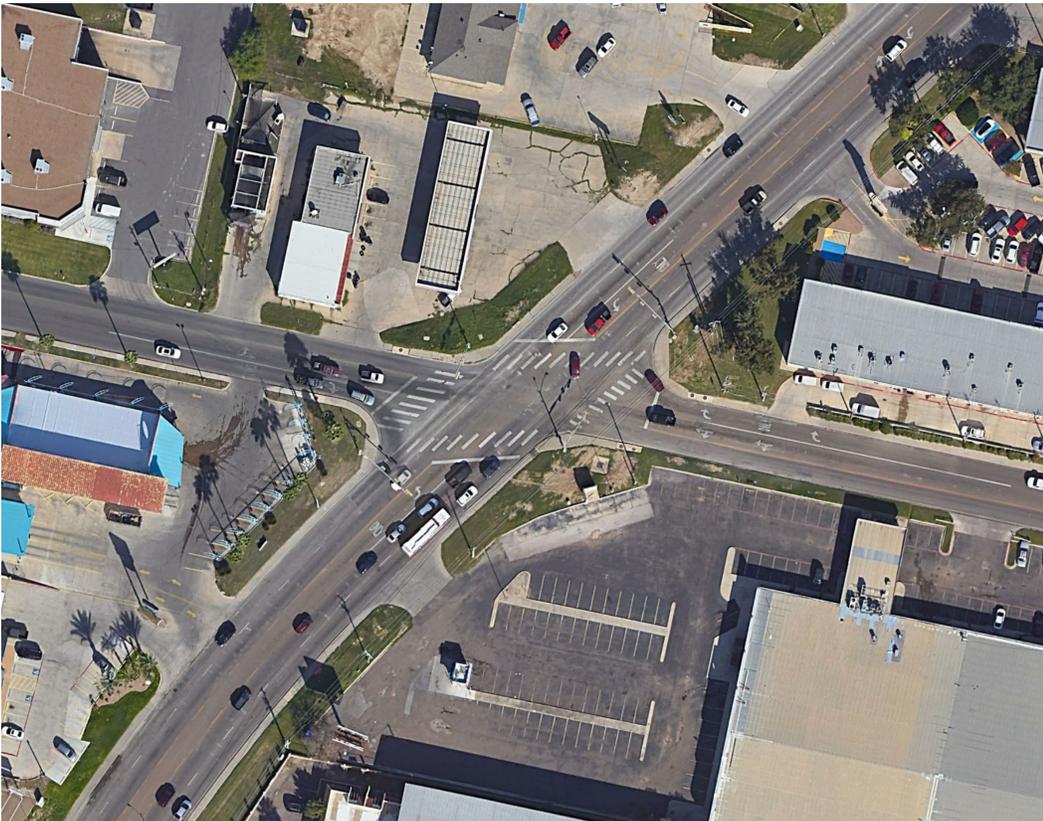
Figure 94 - Aerial view of McPherson Road and Gale Street

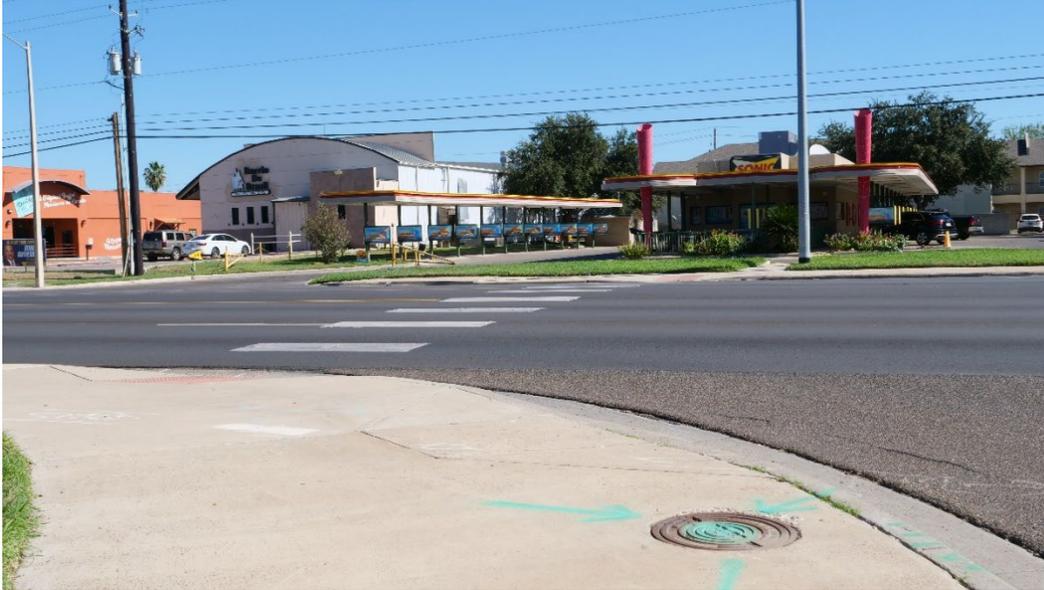
A high-visibility crosswalk and pedestrian refuge island were installed at the Wyoming Street intersection before 2015 and the pedestrian refuge was removed around 2018 prior to a KSI bicycle crash that occurred at this intersection. The crosswalk connects Blas Castaneda Park and the Hillside Terrace neighborhood –

which has no direct roadway connection to McPherson but does have a pedestrian connection by way of the park – to Newman Elementary School and the Alta Vista neighborhood. The spacing between the Hillside Road and Gale Street signalized intersections is nearly two thirds of a mile. It is recommended the Wyoming Street intersection be fully signalized, including pedestrian signals with leading pedestrian intervals.

Figure 95 - High-visibility crosswalk at Wyoming Street

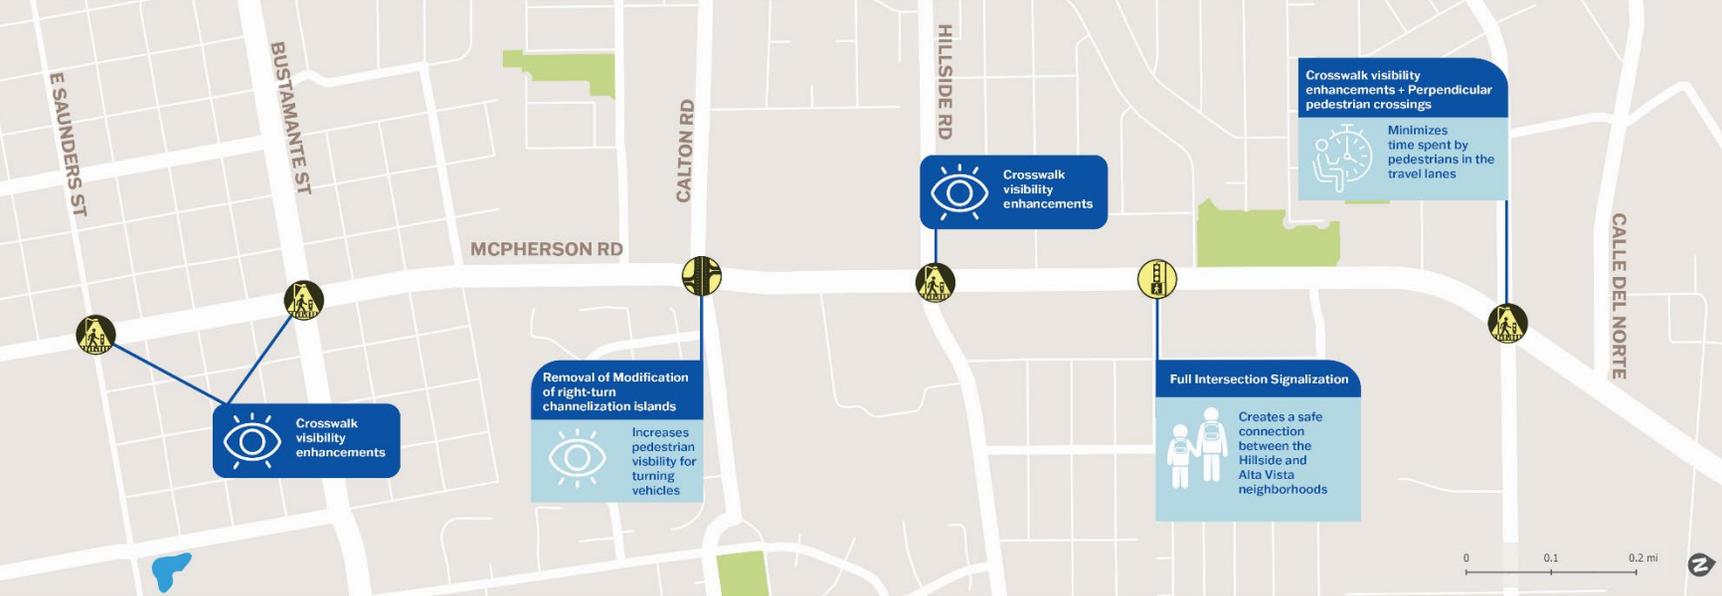
Countermeasure recommendations for the McPherson Road corridor are summarized in Table 104 and Figure 96. Costs are based on TxDOT Bid Averages in fall of 2024 and project cost estimates from the 2025-2029 Laredo Capital Improvement Plan (CIP). Construction, engineering, and contingency are included in these costs. All assumptions are detailed in the Countermeasures Toolkit.

Figure 96 - Recommendations map of the McPherson Road corridor

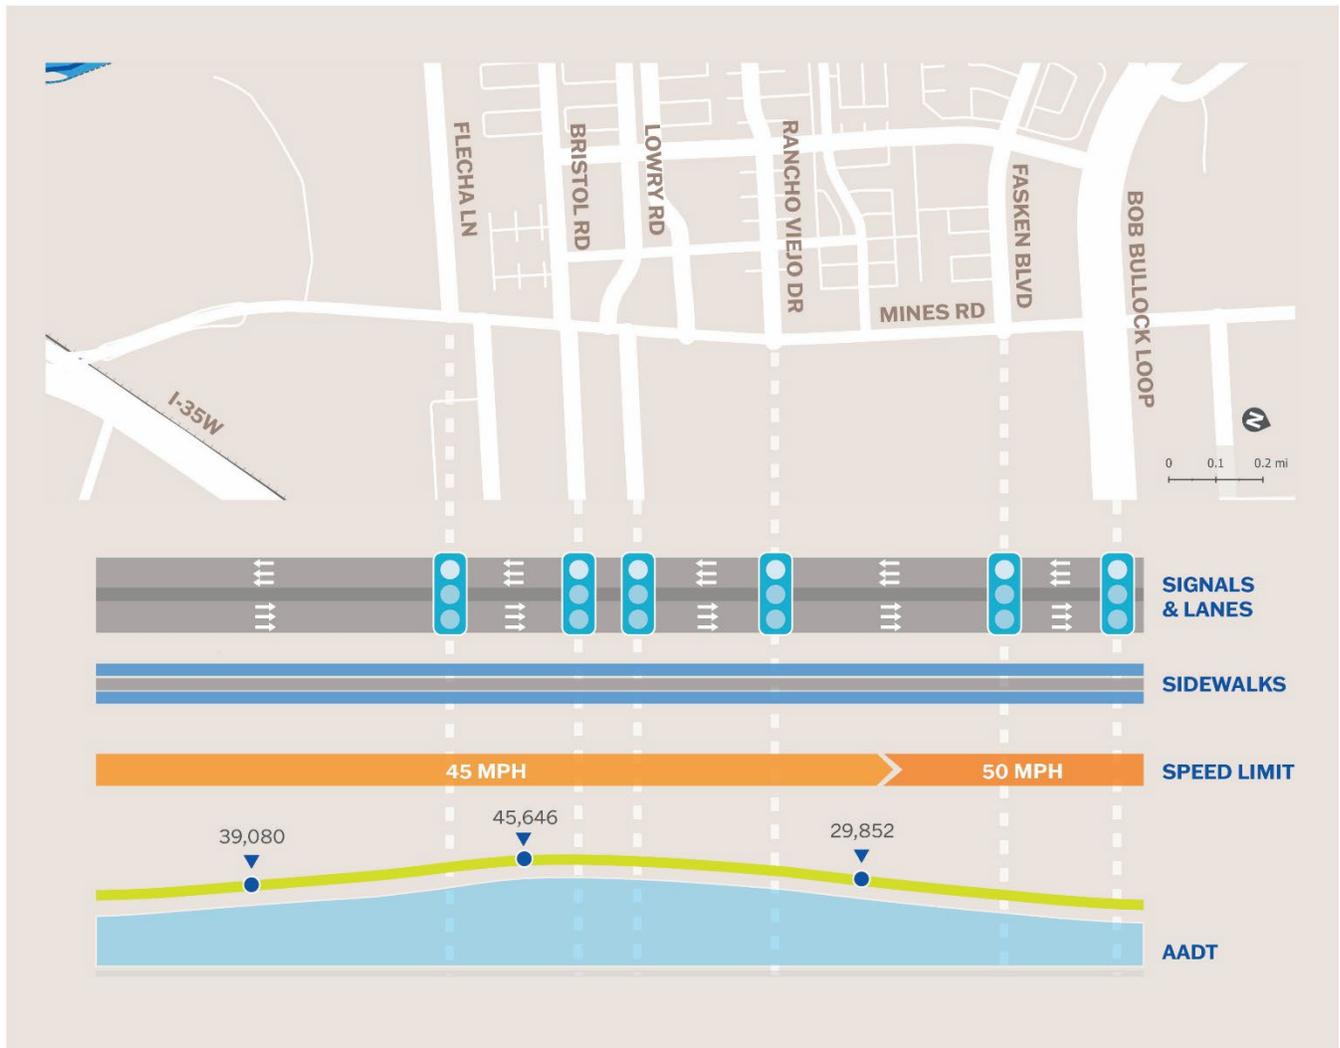
Figure 97 - Mines Road multimodal roadway features

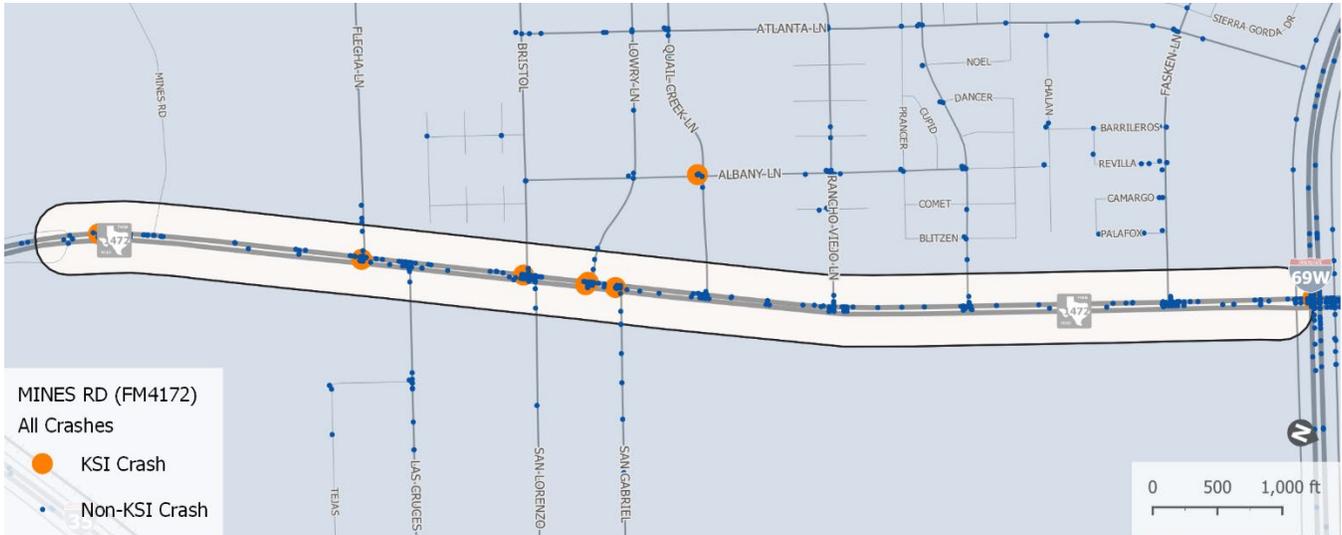
Table 107 and Figure 98 show the spatial distribution of crashes in the Mines Road corridor. The intersections with the most frequent crashes were those which served large industrial parks and had high truck traffic. Lowry Road was the intersection with the most KSI crashes, with two.

Figure 98 - Crash map of the Mines Road corridor

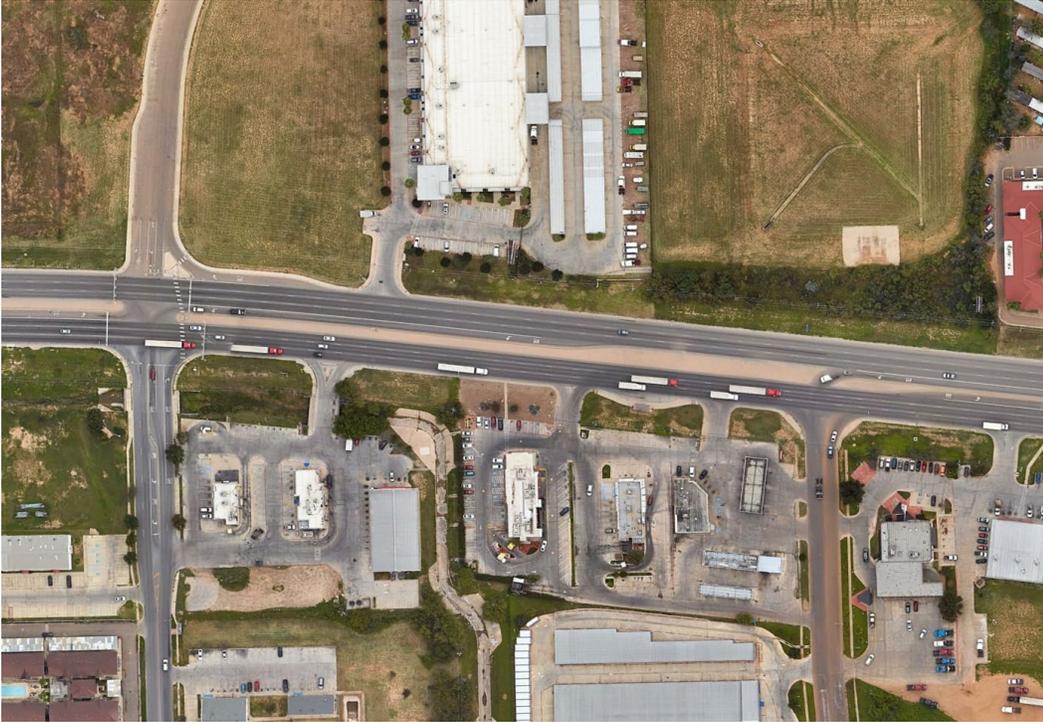
Figure 99 - High density of driveways between Rancho Viejo Drive and Quail Creek Road

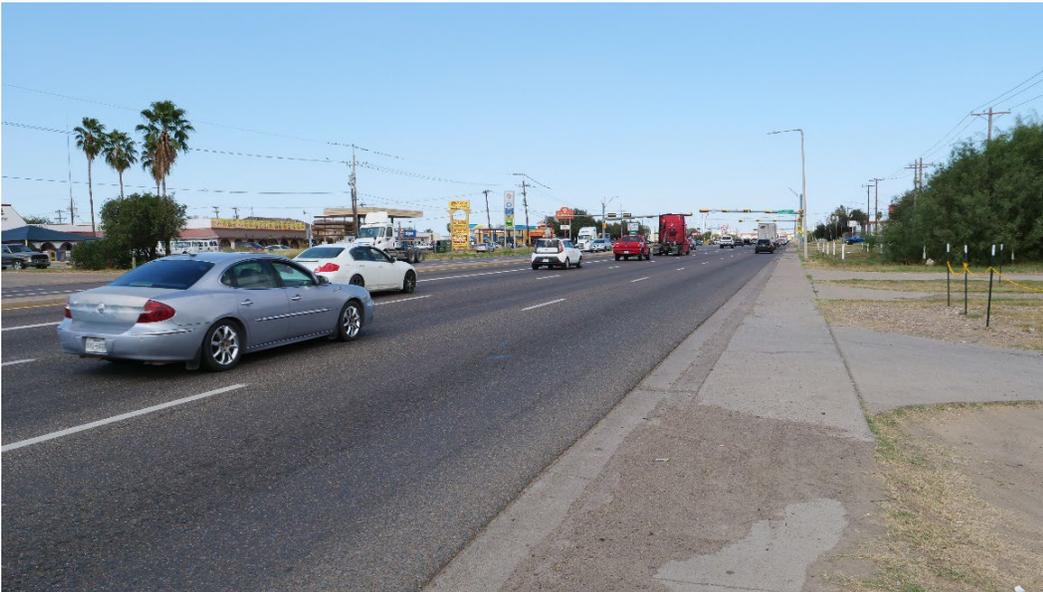
Wide grass buffers along both sides of Mines Road provide ample opportunities for the implementation of better bike and pedestrian infrastructure, which is called for in both the TxDOT Pedestrian Safety Action Plan and the TXDOT Laredo District Bike Plan. Within the roadway, steps must be taken to control driver speed and raise attentiveness. The following countermeasures are recommended for mid-block segments of the Mines Road corridor:

Figure 100 - Wide grass buffer behind sidewalk north of Big Bend Boulevard

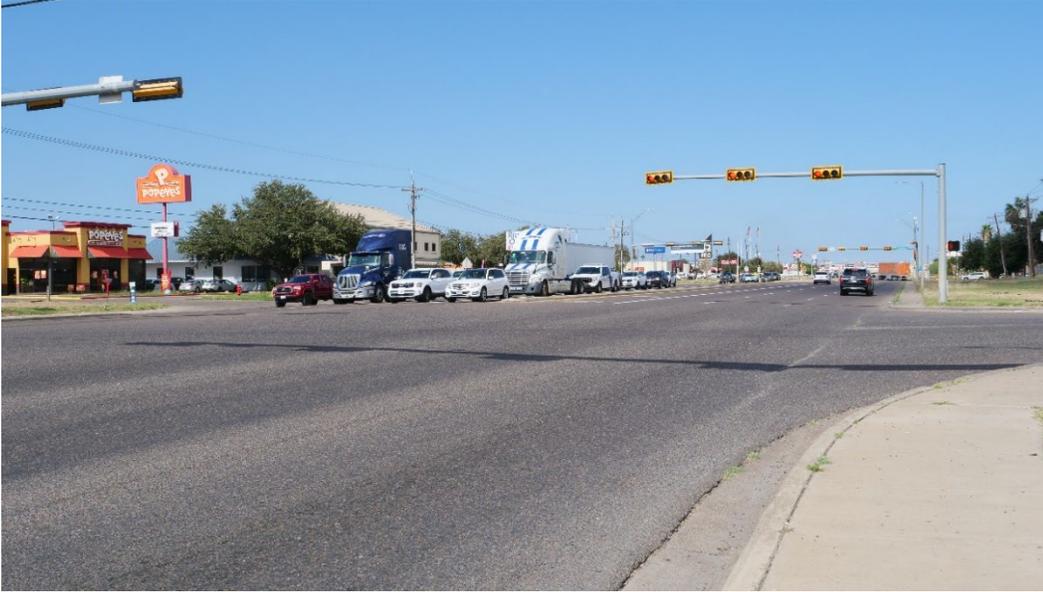
Figure 101 - Intersection of Mines Road with Bristol Road and San Lorenzo Drive

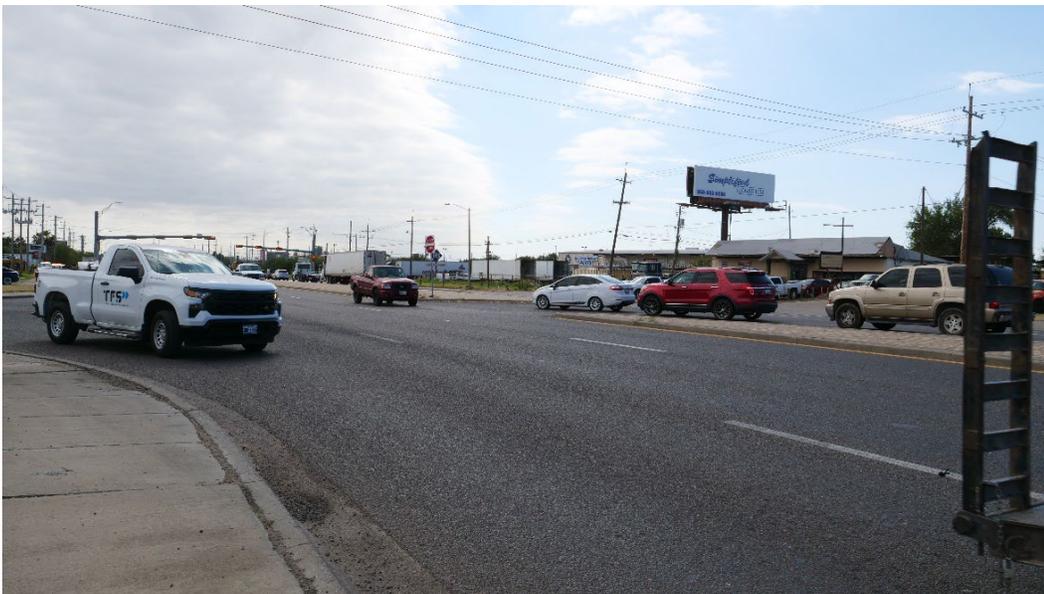
Figure 103 - View from left turn lane serving Las Cruces Drive looking at the Flecha Lane intersection

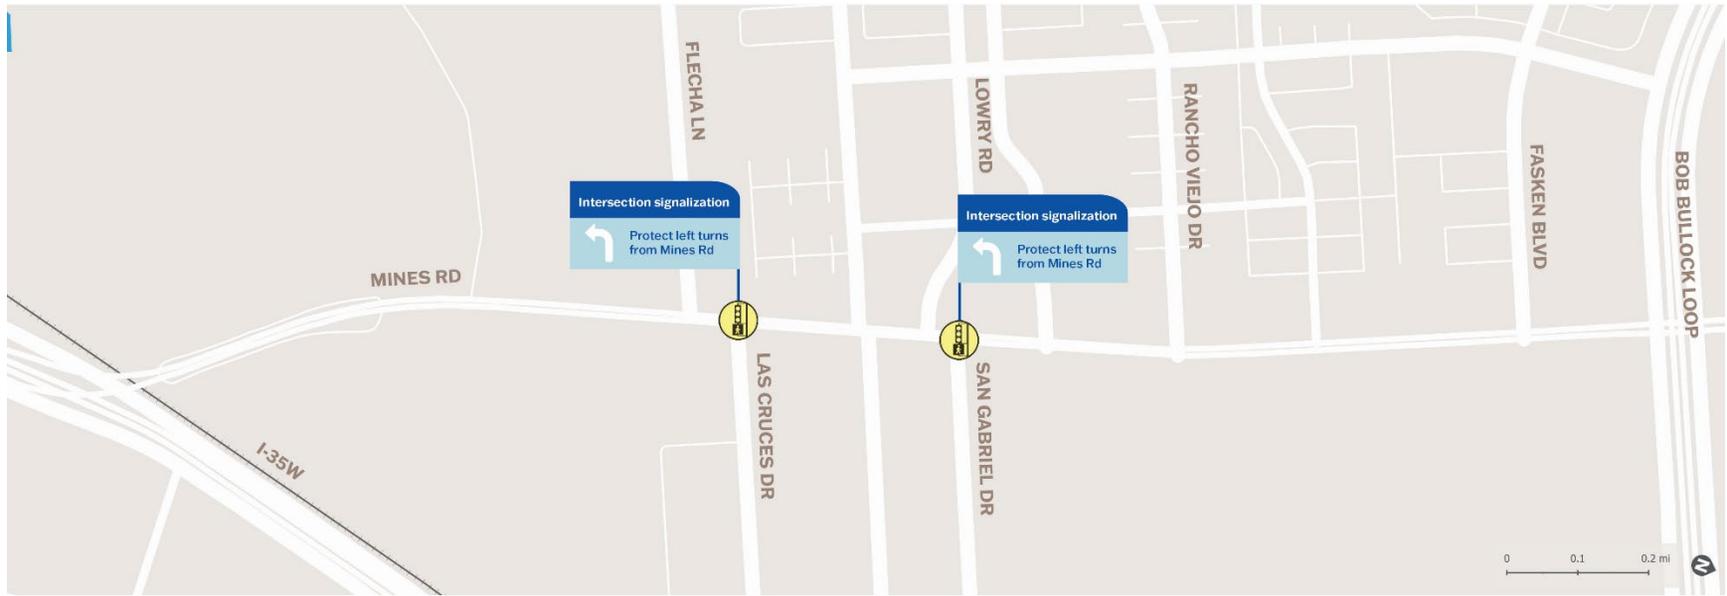
Figure 104 - Mines Road recommended countermeasures

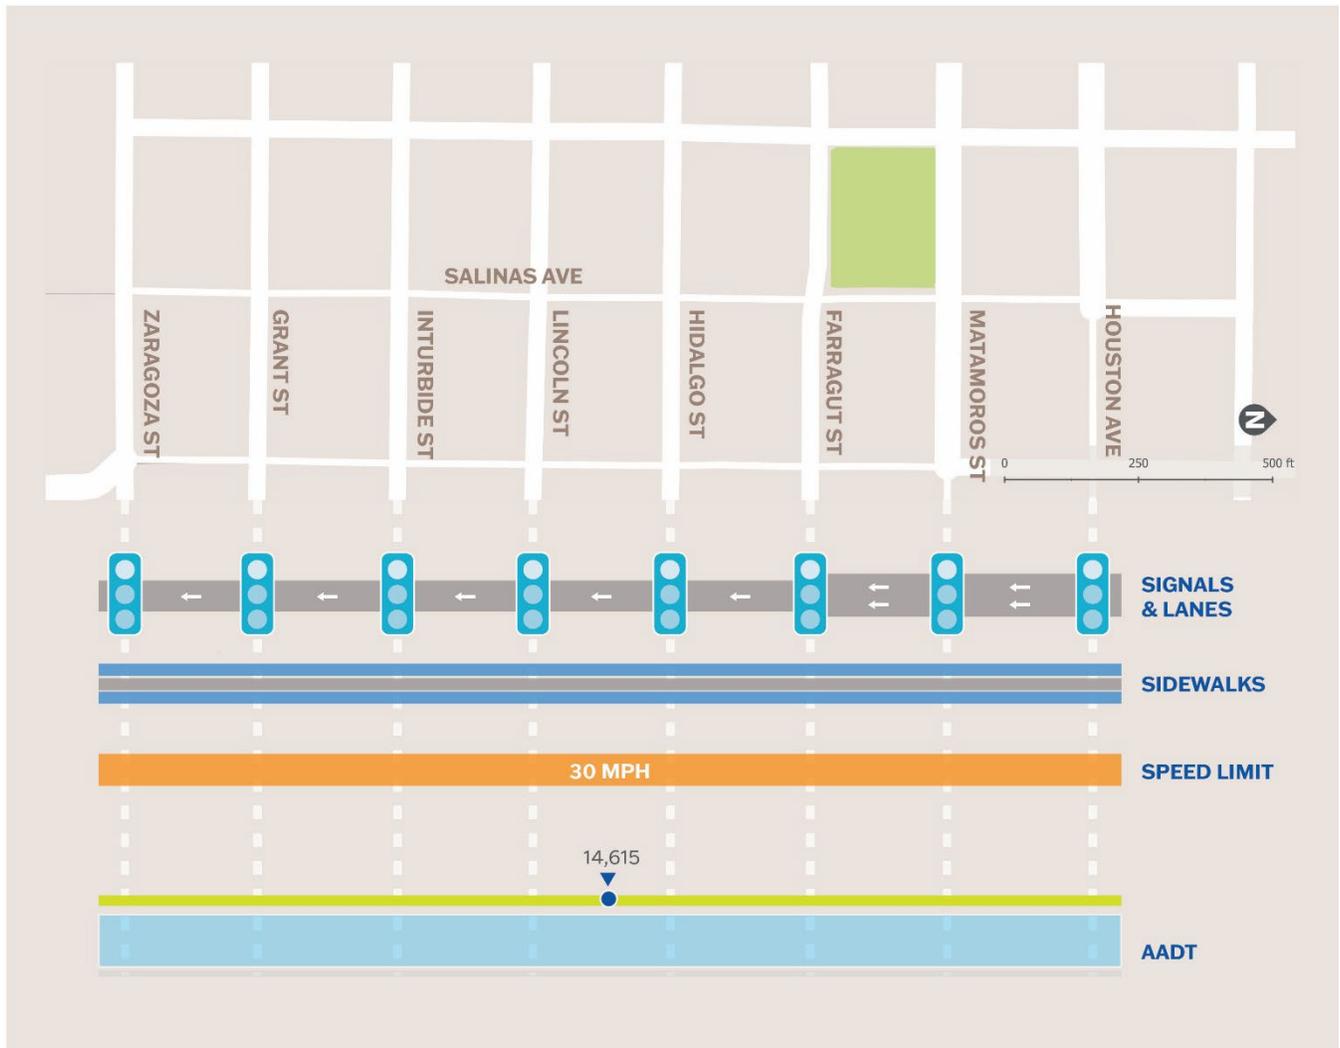
Figure 105 – Salinas Avenue multimodal roadway features

Salinas Avenue, running south to north from Zaragoza Street to Houston Street, is an urban principal arterial fronted by city center commercial uses. Salinas Avenue is a one-way city street with two lanes north of Farragut Street and one travel lane south of Farragut Street. It has street parking on both sides for the majority of the corridor length. Salinas Avenue handles all bus traffic accessing the El Metro Transit Center, which has an entrance off of Salinas Avenue just south of Farragut Street. The speed limit is 30 mph for the entire length of the analyzed corridor, as shown in Figure 105.

The typical pavement width of Salinas Ave is 28 to 40 feet and the typical right-of-way width is 55 feet. AADT along this corridor is 14,600, as shown in Figure 105.

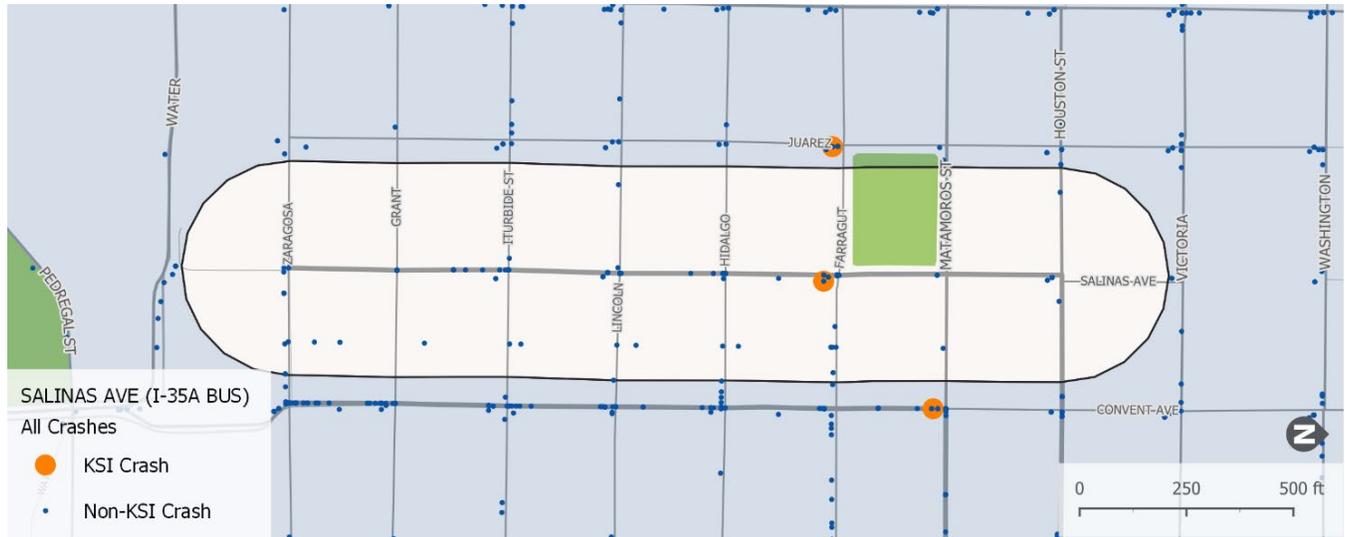
Figure 106 and Table 116 show the spatial distribution of crashes in the Salinas Avenue corridor. It is apparent that most of the crashes, including the KSI crash, occurred at intersections. Many of the crashes

occurred as a result of drivers trying to pass other cars near this intersection where parked cars reduce the width of the traveled way from two lanes to one. The only KSI crash recorded in the Salinas Avenue corridor occurred at the intersection with Farragut Street.

Figure 106 - Crash map of the Salinas Avenue corridor

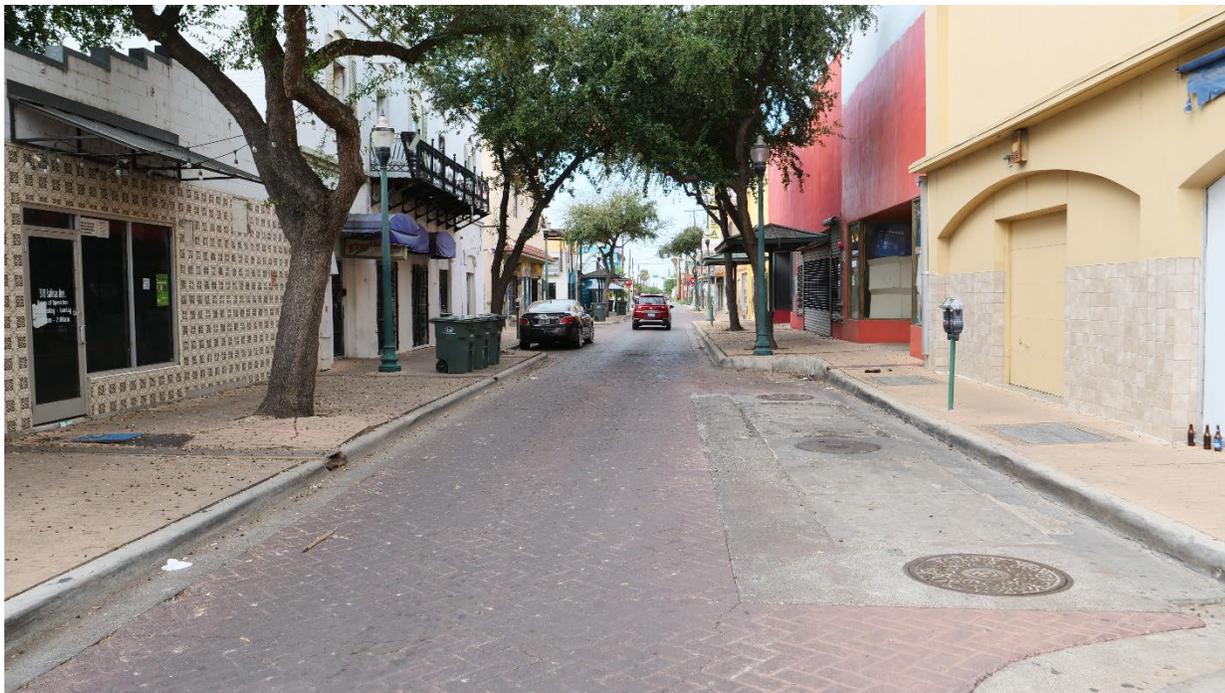
Salinas Avenue has been identified as a priority corridor for future bike infrastructure in Laredo, and there is a parallel bike lane with an opposite direction of travel on Convent Avenue. A vertically separated bike lane should be installed throughout the Salinas Avenue corridor to complete the one-way bike lane couplet. The bike lane feature will also serve to better delineate the travelled way where, at present, it is ambiguous as to whether there are one or two vehicular travel lanes in this corridor.

Figure 107 - Salinas Avenue with parking on both sides of street

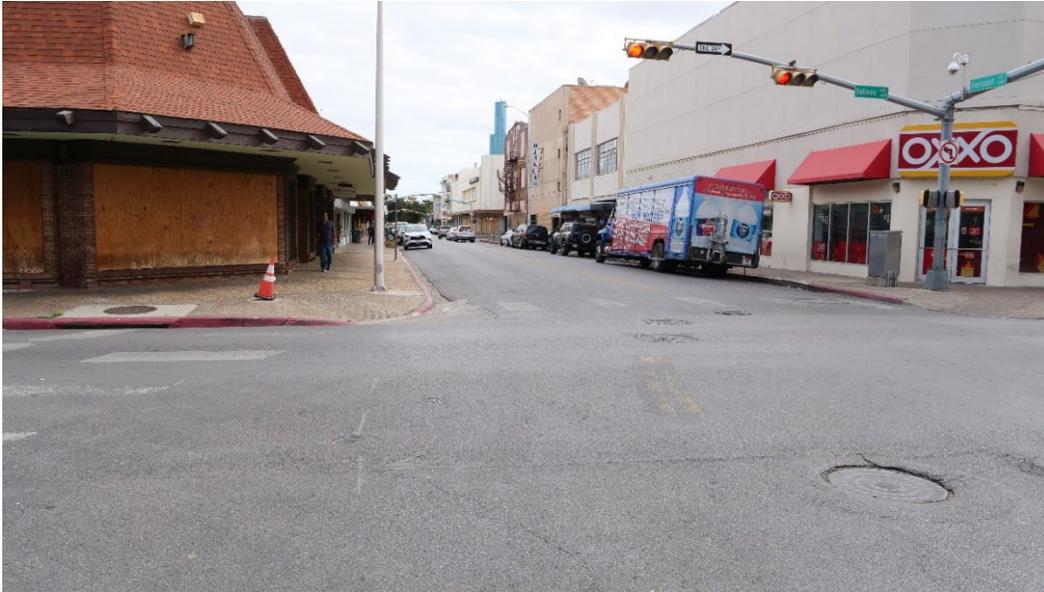
Figure 108 - Salinas Avenue intersection with Farragut Street

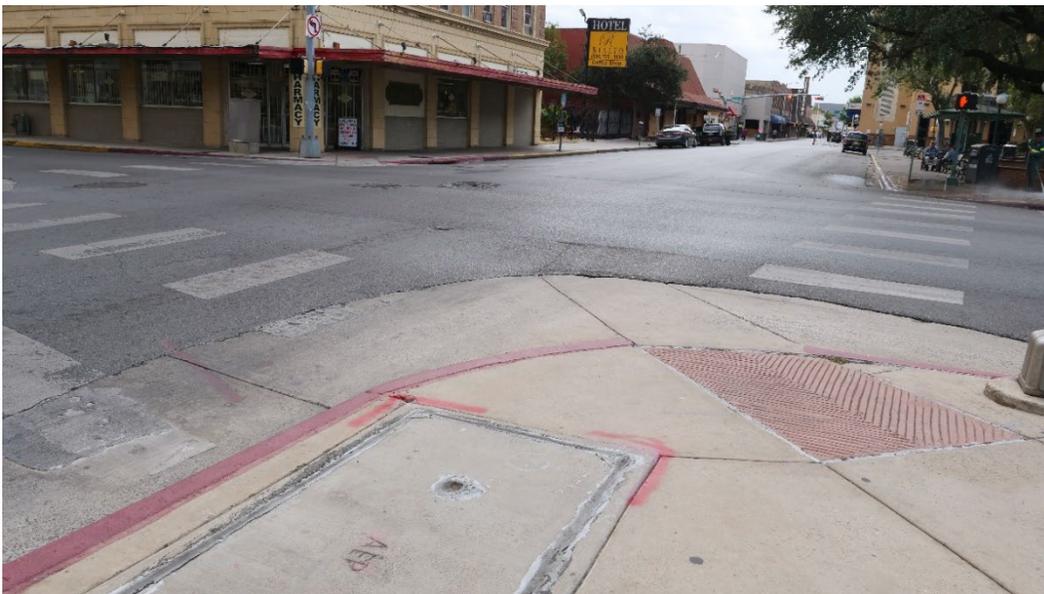
Figure 109 - Intersection of Salinas Avenue and Matamoros Street looking at Jarvis Plaza

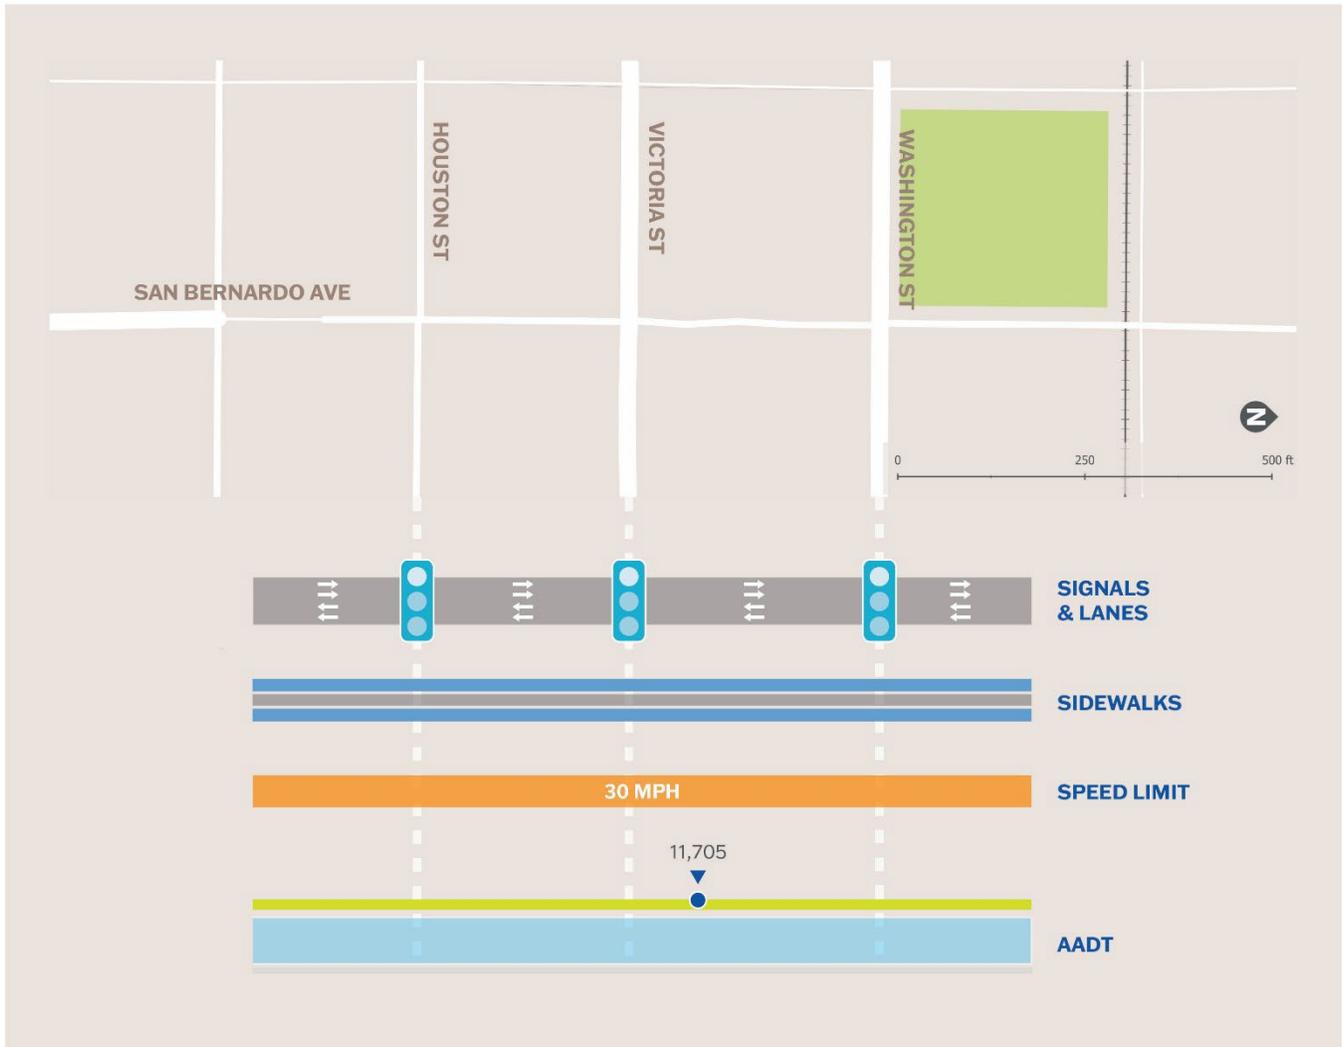
Figure 111 – San Bernardo Avenue multimodal features

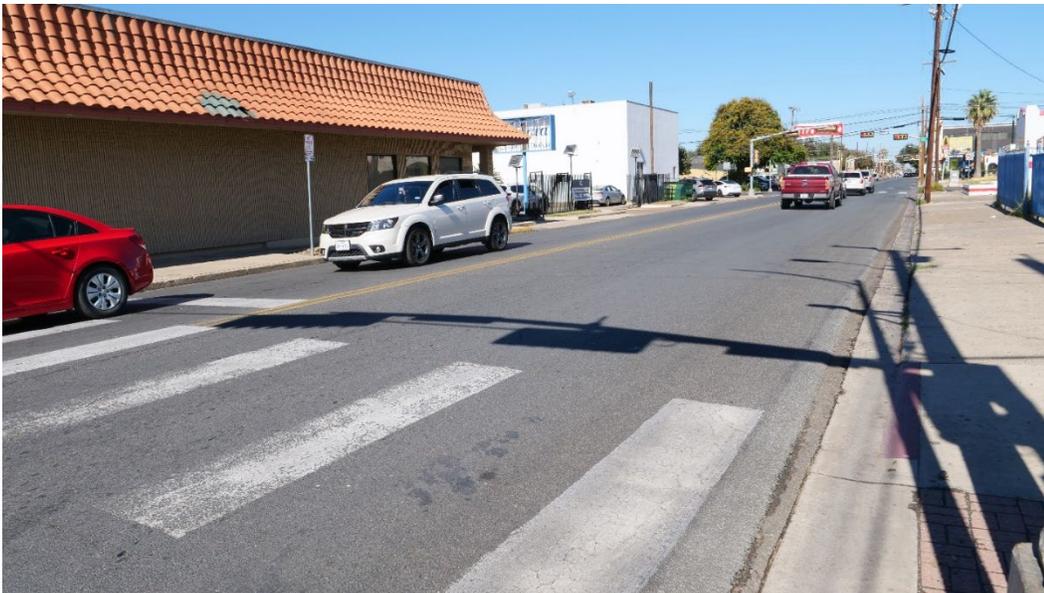
Washington street is a short corridor, but it has been identified as a high priority bicycle corridor and there is sufficient width available on both sides of the street to implement buffered bike lanes. With vertical separation, these bike lanes will designate space in the right-of-way to cyclists, protect pedestrians on the sidewalk, and provide friction to motorists, encouraging them to operate at safer speeds and pay more attention.

Figure 113 - View of San Bernardo Avenue showing wide pavement section

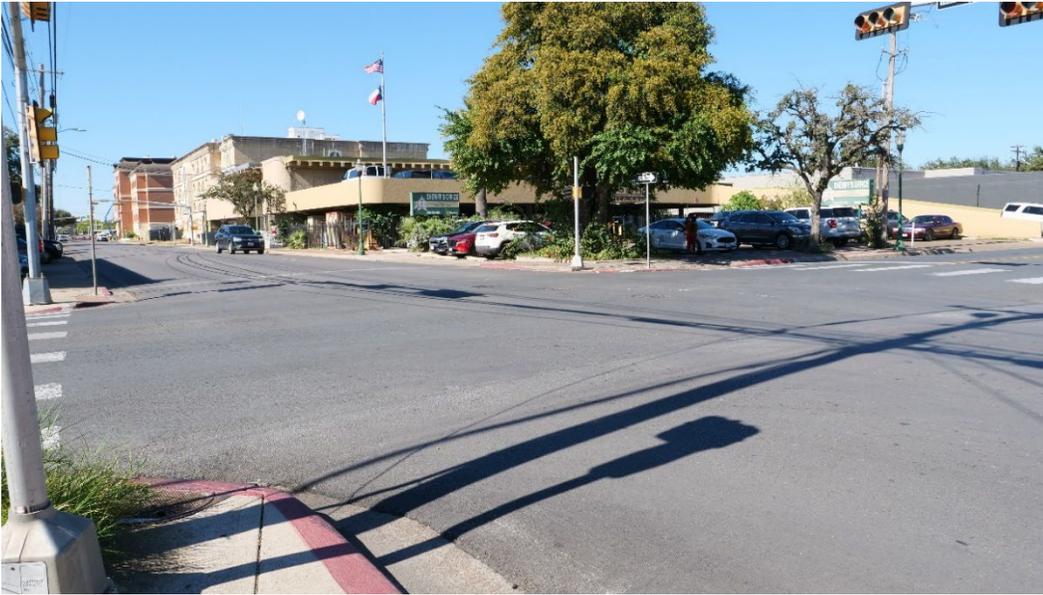
The intersections along San Bernardo Avenue feature several wide cross streets which encourage cars to go fast and require pedestrians to cross wide sections of traffic. Some intersection legs do not have crosswalks even when pedestrian signal heads are present. The following countermeasures are recommended at all intersections in this corridor:

Figure 114 - Two legs of intersection of San Bernardo Avenue and Victoria Street do not have crosswalks
