APPENDIX F

CAPITAL PLAN

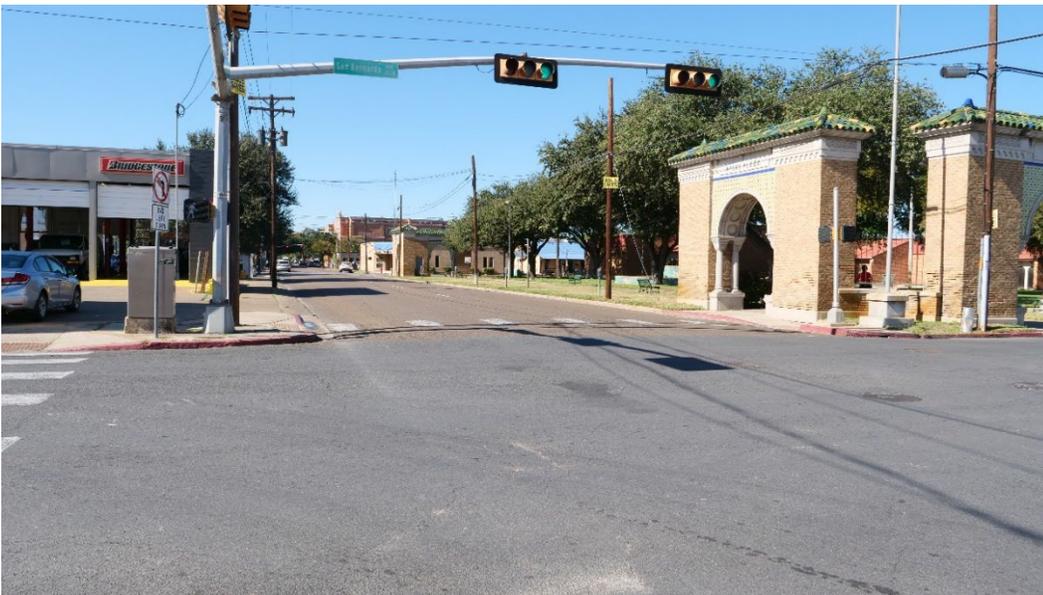
Figure 115 - Intersection of San Bernardo Avenue and Washington Street

Washington Street is a one-way street with two wide lanes. Its intersection with San Bernardo Avenue has the most crashes of the analyzed corridor. To slow traffic down, increase driver awareness, and shorten the roadway width that pedestrians need to cross, curb extensions should be installed on either sides of both of the Washington Street legs of the intersection.

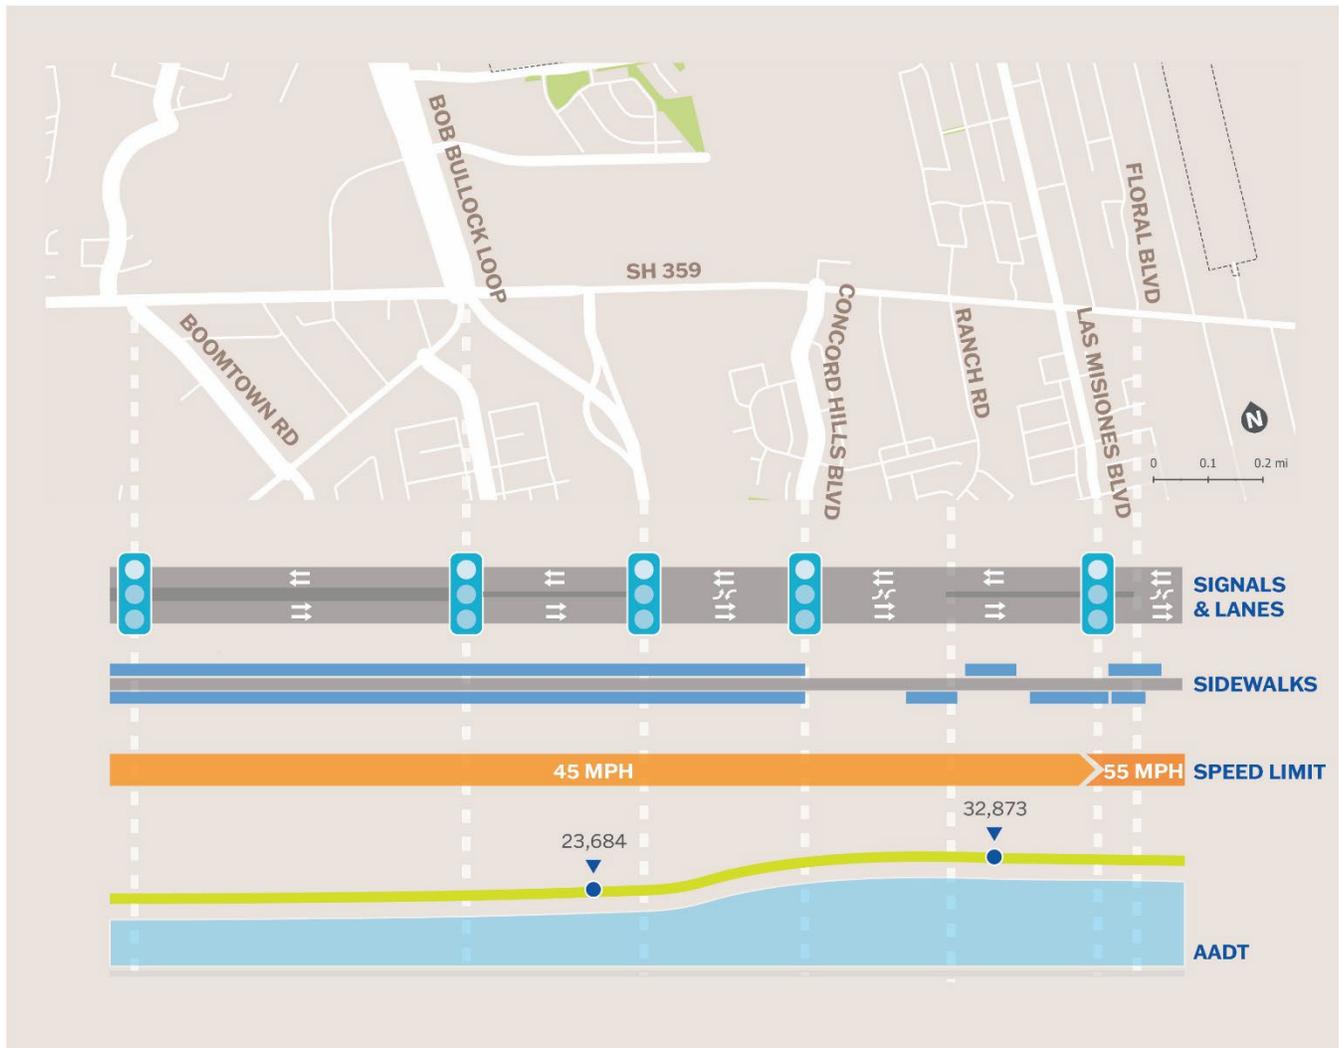
Figure 117 - SH 359 multimodal roadway features

Street Name	State Highway 359
Extents	Boomtown Road to Floral Boulevard
Length	1.8 miles
Roadway Jurisdiction	TxDOT
Functional Class	Principal Arterial

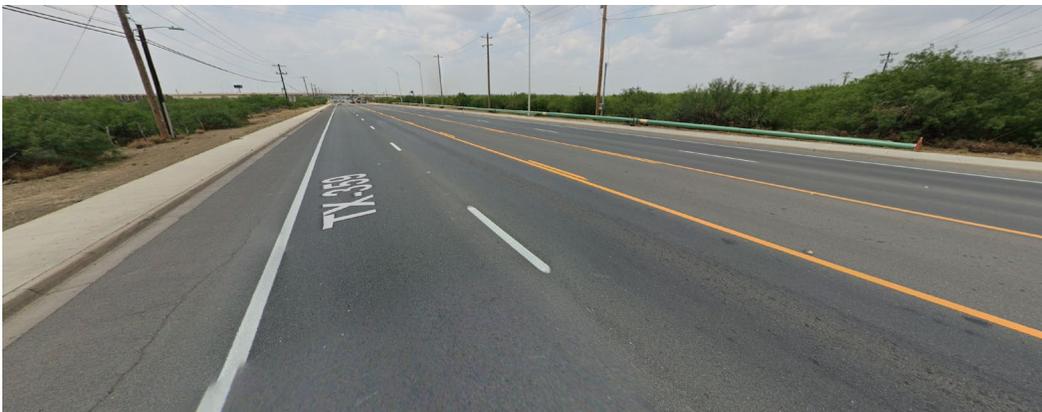
Figure 119: SH359 Corridor

Most crashes in the SH 359 corridor were caused by speeding or driver inattentiveness, and measures should be taken to reduce those types of crashes. The high number of crashes which occurred in the dark also indicated that visibility at night needs to be improved. A majority of the road in this segment has a paved shoulder between the edge of the outer lane and the curb, which provides drivers with large margins for error and encourages them to drive too quickly. The following countermeasures should be applied along mid-block segments of the corridor:

- Install additional corridor lighting
- Provide continuous sidewalks
- Raised median where there is none currently
- Install vertical separation to convert existing paved shoulder into protected bike lane

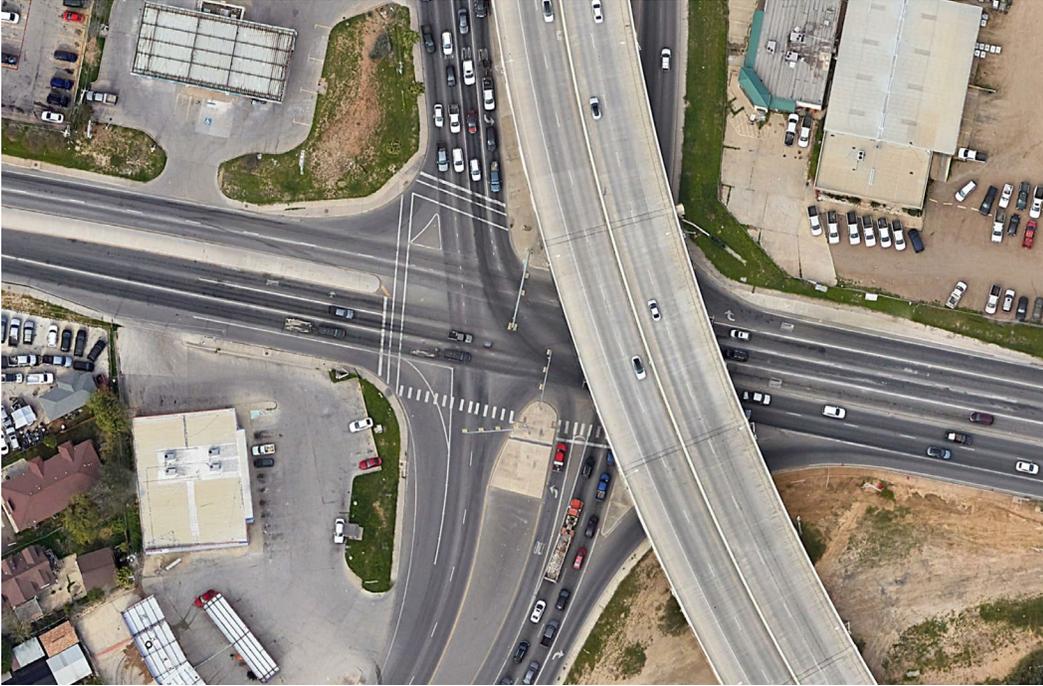
Figure 121 - Aerial view of interchange between Bob Bullock Loop and SH 359

The interchange between Bob Bullock Loop and SH 359 where access ramps are located to the north and the southern leg changes names to Jaime Zapata Memorial Highway presents a wide area of asphalt for pedestrians to cross. Existing right turn channelizations are achieved with striping, but no hardscape. Installing raised truck-mountable concrete aprons at these slip lanes will encourage drivers to slow down when taking right turns and provide pedestrians with a refuge as they cross the road.

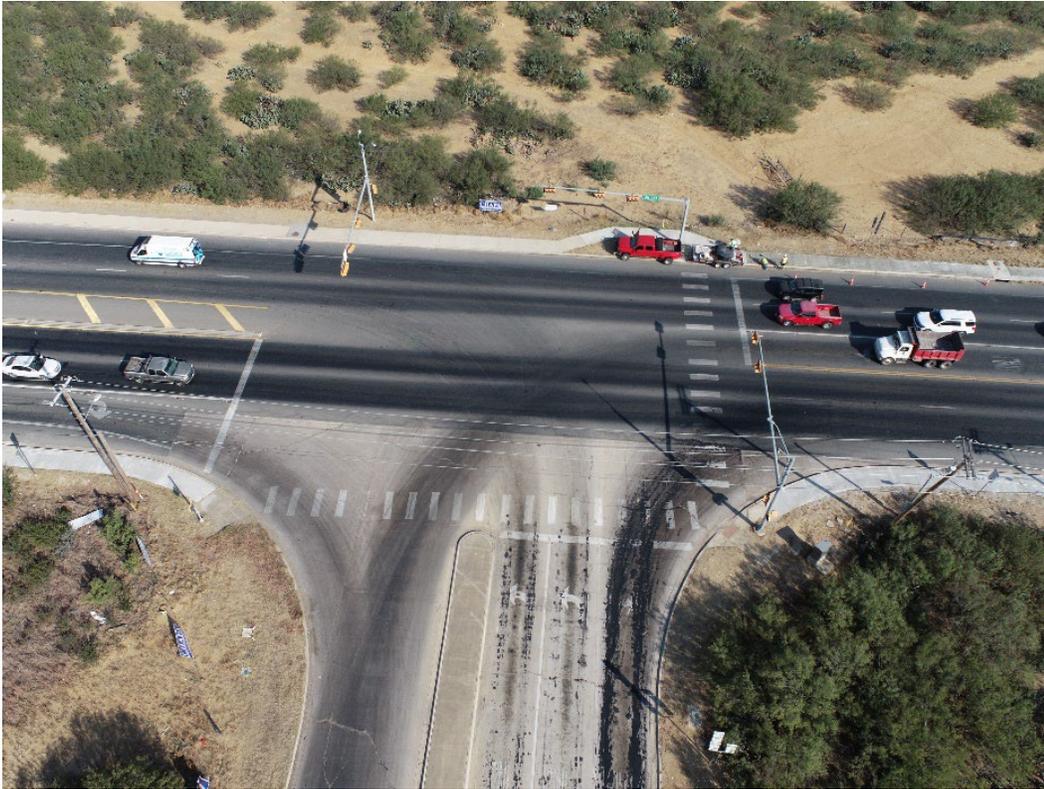
Figure 122 - Aerial view of the intersection of SH 359 and Cuatro Vientos Boulevard

Existing medians provide opportunities to install pedestrian refuges on the west and south legs of the Cuatro Vientos Boulevard intersection. This will complement the existing upgraded sidewalks that pass through the area and cause drivers to take turns more slowly and safely.

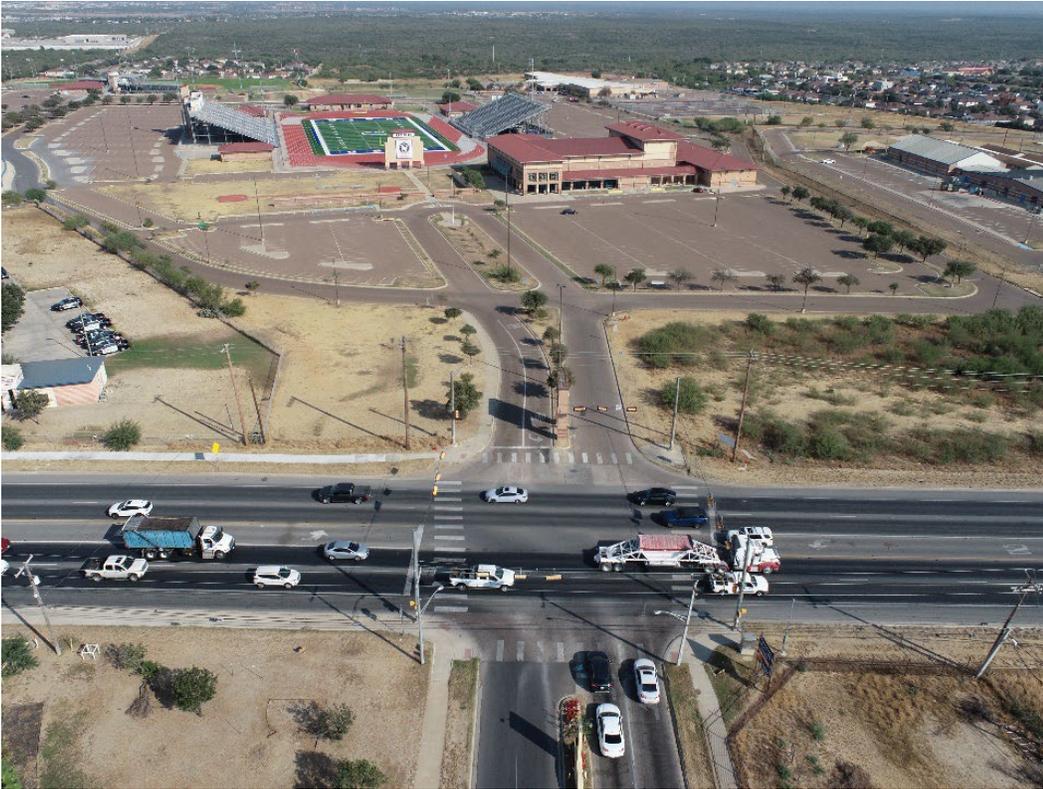
Figure 123 - Intersection of Concord Hills Boulevard and SH 359

Concord Hills Boulevard had the most KSI crashes associated with pedestrians than any other intersection in the corridor. Pedestrian visibility may be improved by extending the existing medians on the side street approaches to provide pedestrian refuges.

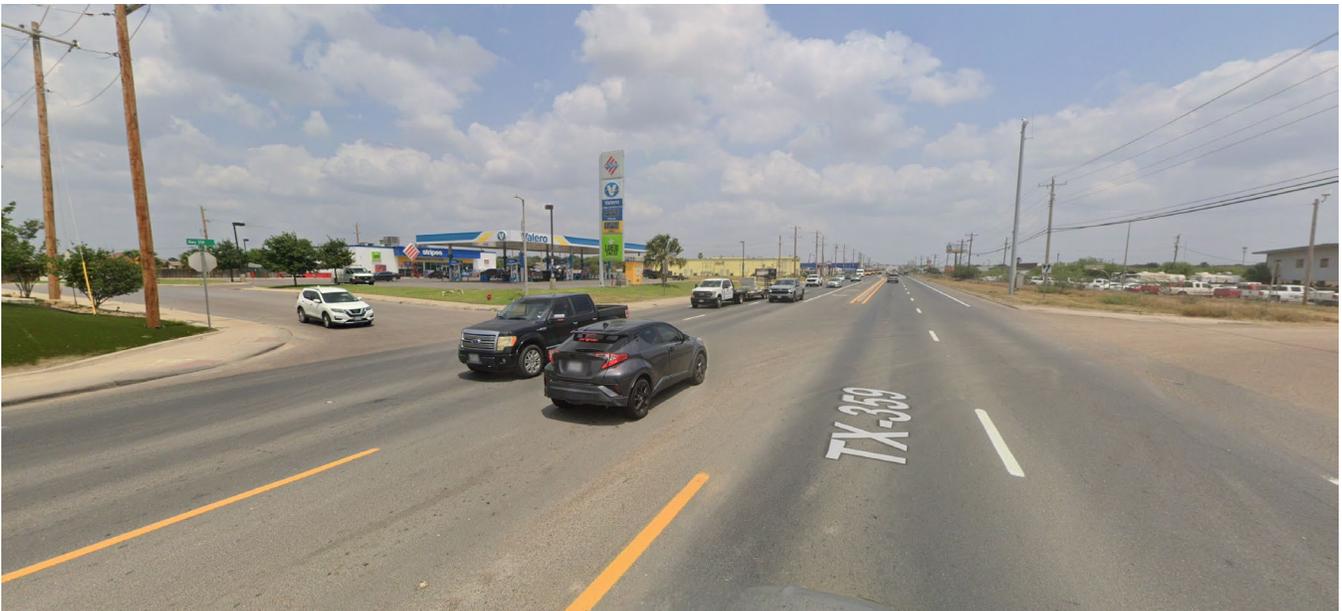
Figure 124 - Intersection of SH 359 and Royal Oaks Street

The intersection of Royal Oaks Street and SH 359 should be fully signalized to provide a crossing opportunity to pedestrians accessing the commercial, industrial, and residential developments which are in close proximity.

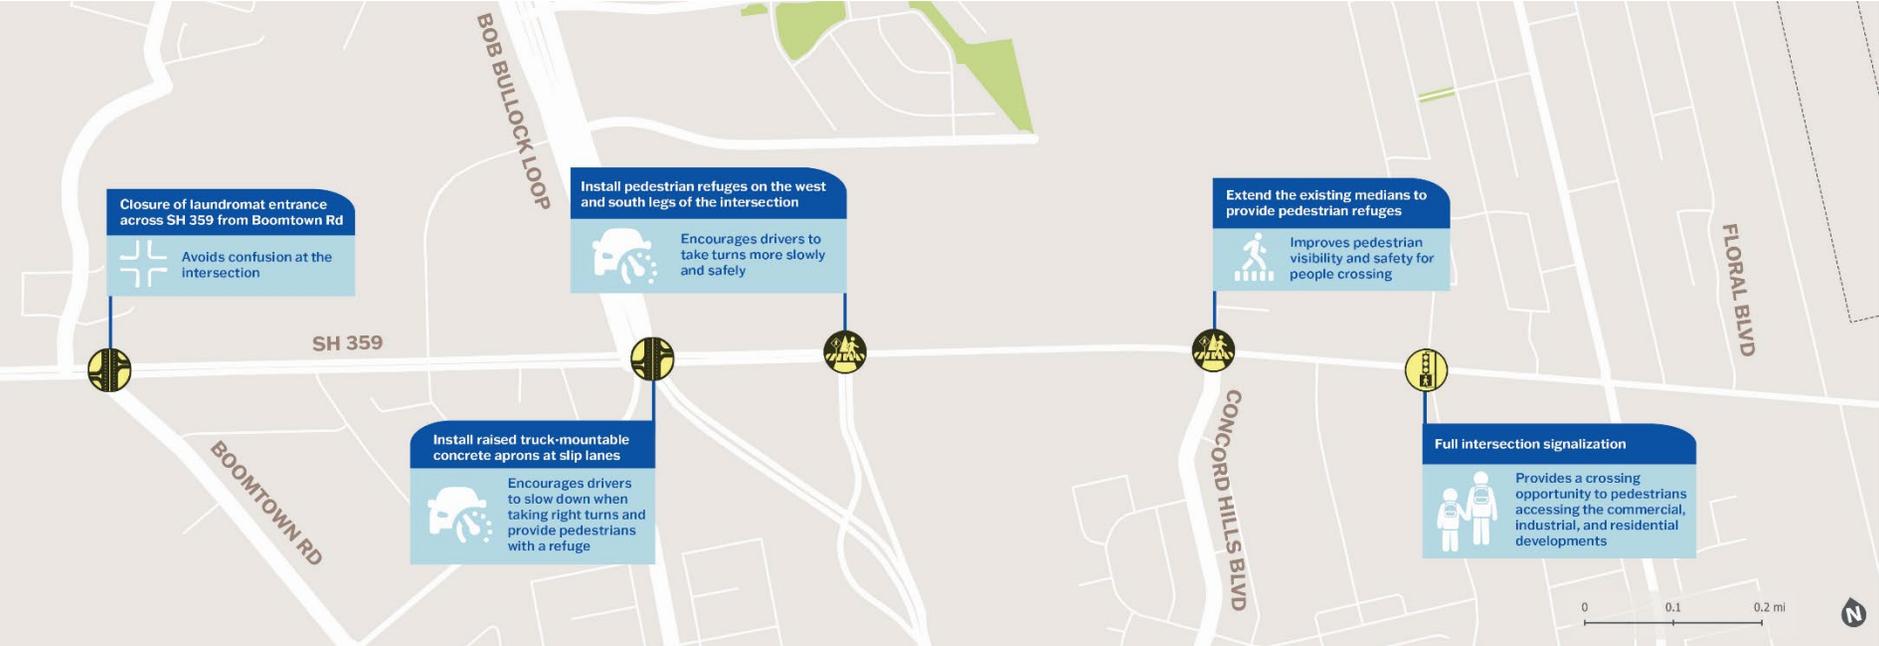
Figure 125 - Recommendations map of the SH 359 corridor

Countermeasure recommendations for the SH 359 corridor are summarized in Table 140 and Figure 125. Costs are based on TxDOT Bid Averages in fall of 2024 and project cost estimates from the 2025-2029 Laredo Capital Improvement Plan (CIP). Construction, engineering, and contingency are included in these costs.

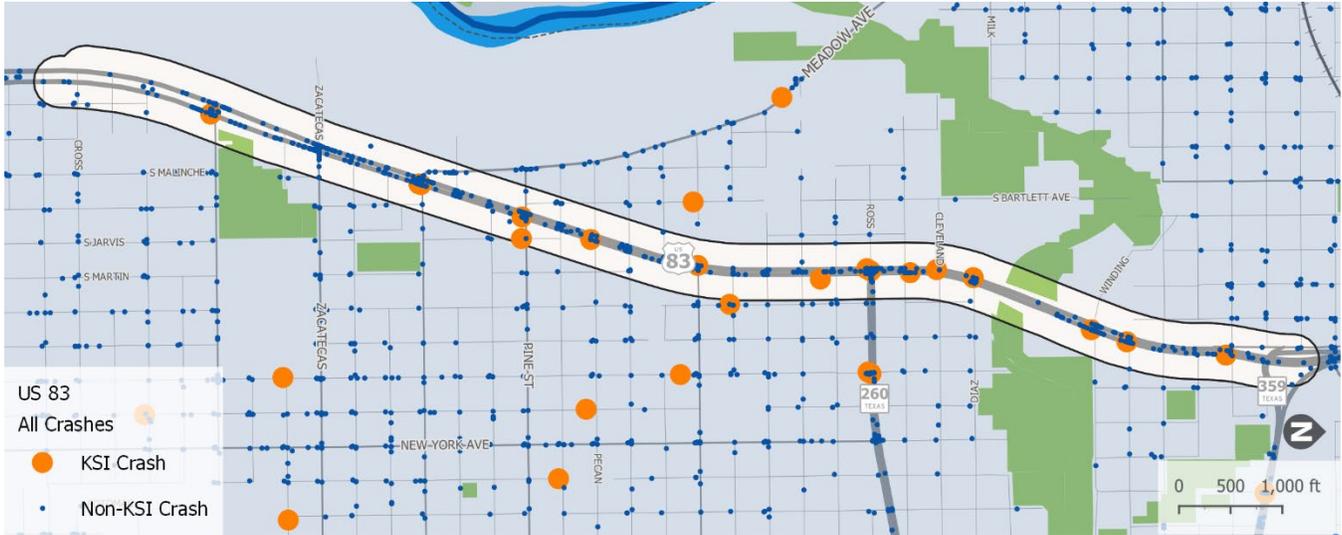
Figure 127 - Crash map of the Zapata Highway corridor

Figure 127 and Table 143 show the spatial distribution of crashes in the Zapata Highway corridor. It is apparent that most of the crashes occurred at intersections and KSI crashes occurred at intersections with signal control in place. The intersections with the most crashes were Jaime Zapata Memorial Highway, which also had the most KSI crashes, and Zacatecas Street. A majority of KSI crashes occurred near unsignalized intersections where left turns are prohibited by a hardened centerline, except for the Diaz Street intersection, which allows unsignalized left turns.

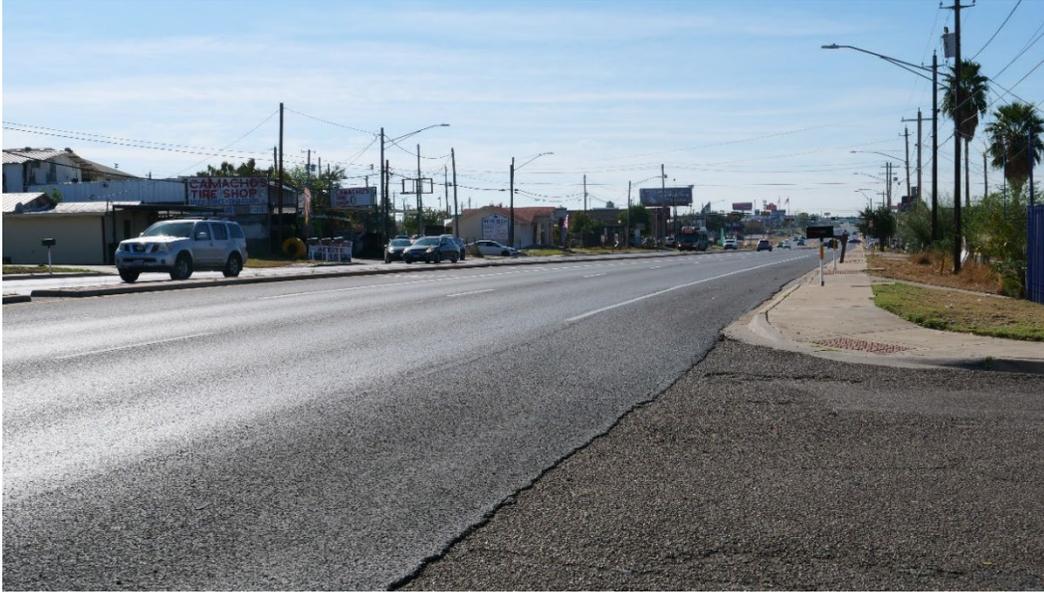
Figure 128 - Typical segment of Zapata Highway

Most crashes in the Zapata Highway corridor were caused by speeding or driver inattentiveness, and measures should be taken to reduce those types of crashes. The high number of crashes which occurred in the dark also indicated that visibility at night needs to be improved. A majority of the road in this segment has a paved shoulder between the edge of the outer lane and the curb, which provides drivers with large margins for error and encourages them to drive too quickly. The following countermeasures should be applied along mid-block segments of the corridor:

- Install additional corridor lighting
- Install vertical separation to convert existing paved shoulder into protected bike lane
- Consolidate access points

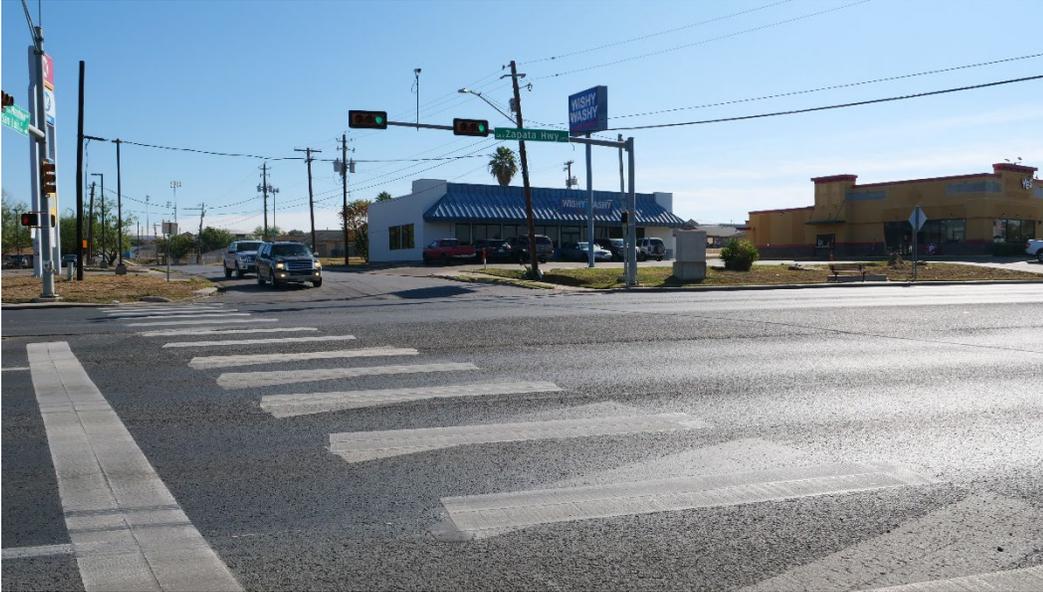
Figure 129 - Typical signalized intersection on Zapata Highway (Meadow Avenue)

Most of the crashes in the Zapata Highway corridor occurred at intersections. Six of the KSI crashes that occurred were a result of drivers failing to yield the right-of-way when turning left. There are also several instances of KSI crashes resulting from cars failing to control their speed and running into cars slowing or stopped at an intersection.

- Implement leading pedestrian intervals at all signalized intersections
- Eliminate permissive left (flashing yellow) and implement longer green arrow at all intersections
- Install/refresh high-visibility crosswalks at all signalized intersections
- Install continental style intersections at all unsignalized cross streets
- Install pedestrian signal heads at signalized intersections where they don't currently exist
- Upgrade curb ramps to meet ADA standards

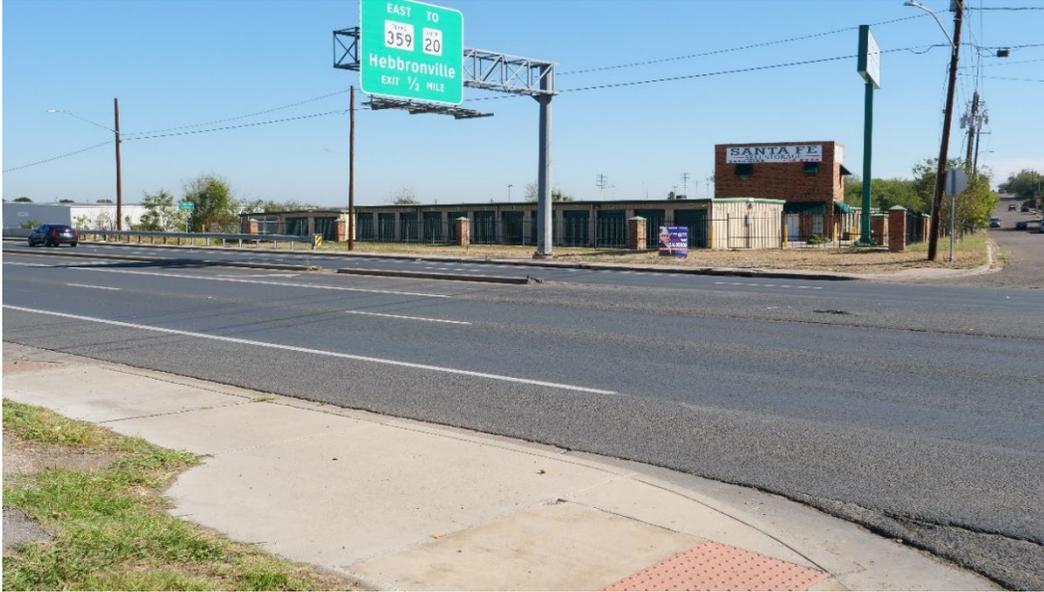
Figure 131 - Median break for Diaz Street on Zapata Highway

These streets have a traffic volume of less than 1000 vehicles per day that does not warrant the current breaks in the median that serve them today. The median should be closed, and drivers should make U-turns at the closest signalized intersections.

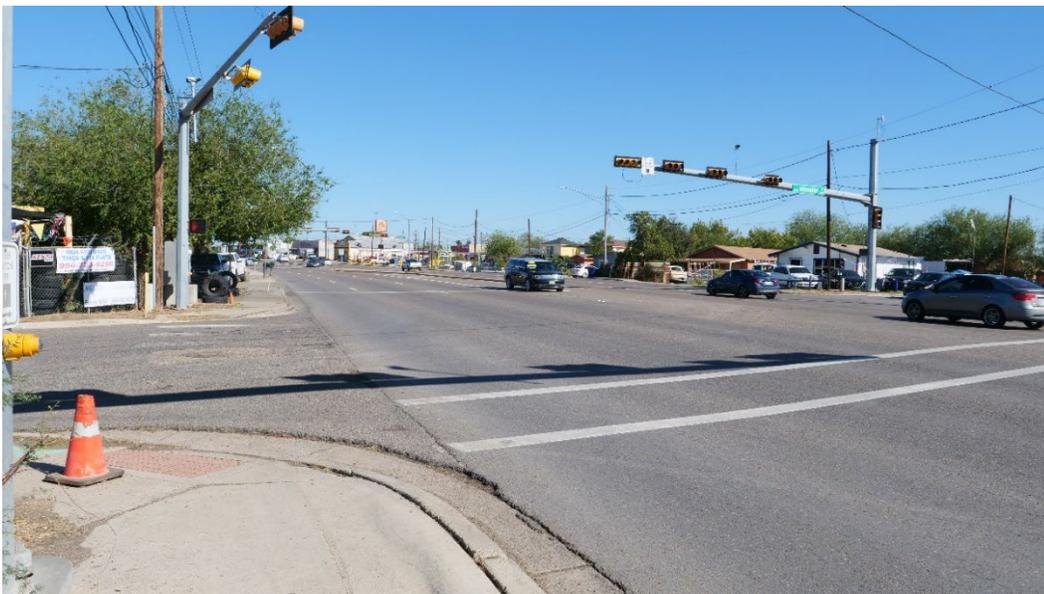
Figure 132 - Southern approach to Wooster Street on Zapata Highway

Mercer Street, Wooster Street, Jaime Zapata Memorial Highway, and Palo Blanco Street all have long approaches leading up to them where drivers are more likely to speed and be caught off guard by these signalized intersections. Advance warning signs should be installed to alert drivers to the potential need to stop at traffic signals. There should be a warning sign on either side of the southern approach to Palo Blanco Street.
